Technical Note No. TN-85
August 1985

**Production and Performance of
Mechanical Felling Equipment
on Coastal B.C.:**

Timbco Feller Buncher with RotoSaw Head

Bruce McMorland

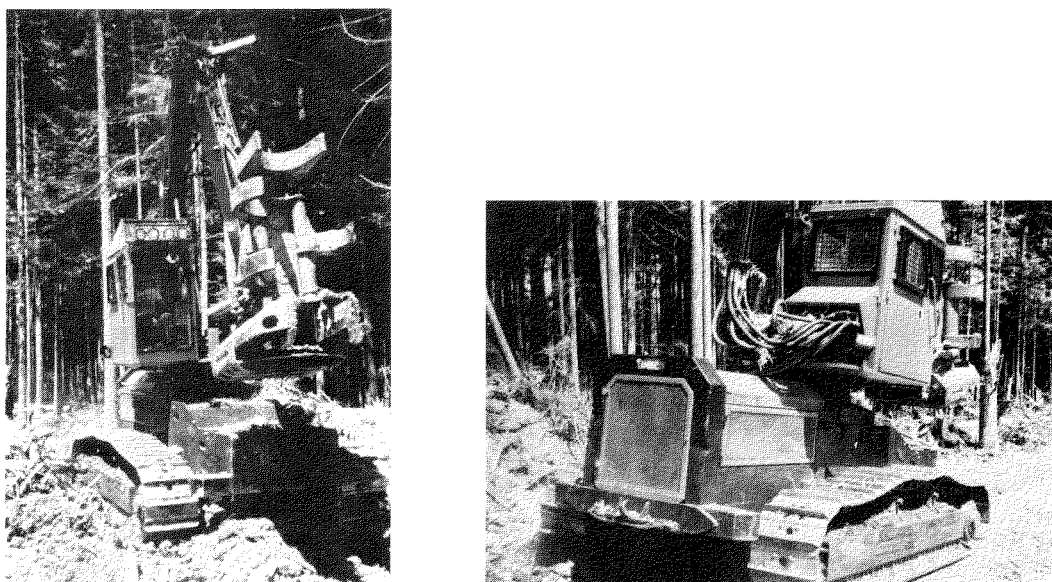
FIGURE A. Timbco Model 2518 Hydrobuncher and RotoSaw Felling Head.

As shown in Figure A, only the cab and boom are located above the turntable. This gives the machine a low centre of gravity which means a counterweight is not necessary. The Timbco also has a unique 3-way tilting upperworks--cab and boom assemblies can tilt forward 27° and to each side up to 22.5 degrees. (The forward tilt permits the cab to be levelled while the Timbco is on grades up to 51 percent.) Boom geometry is such that a tree in the felling head can be rotated in a 1.83-m (6-ft) radius from machine centre. These combined factors mean that mechanized felling can be extended to ground slopes previously inoperable with excavator-type machines.

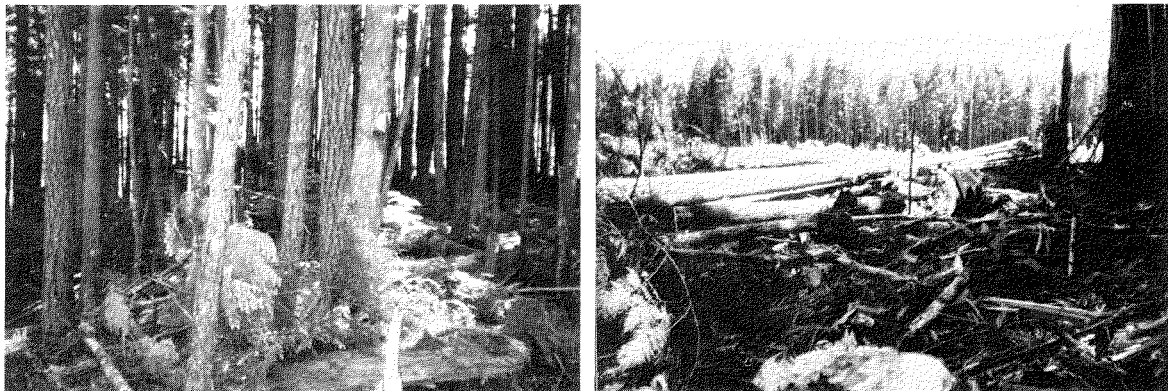
FIGURE C. Lower Portion of Cut Block.

Figure C further illustrates ground and site conditions. The photos show the lower portion of the block, which is generally less than 10% slope. The surface, however, is broken and rough, and ground debris frequently obstructed head placement on trees. The previous stand had completely blown down in 1875 and, while much of the Douglas-fir and hemlock blowdown had rotted, the remains of stems and root systems caused many hummocks. The block's upper portion was steeper, rising to a constant 20% slope, and larger blowdown was more common. The largest cedar windfalls in this area ranged from 1 to 1.5 metres in diameter and required manual bucking.

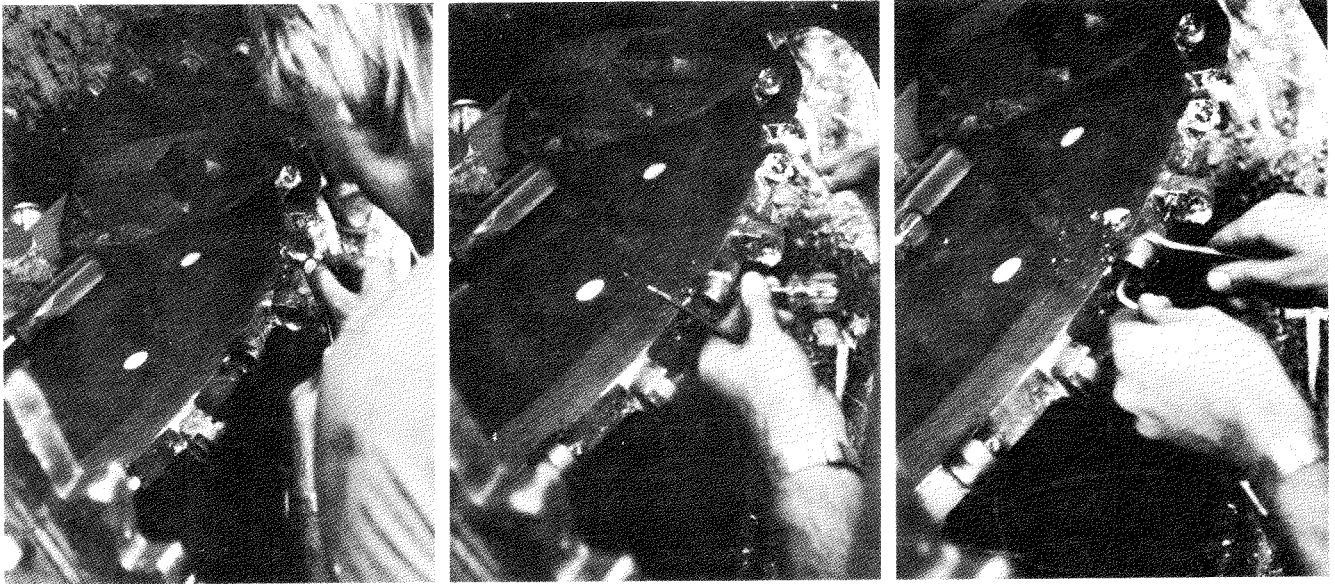
FIGURE D. RotoSaw Tooth Maintenance.

RotoSaw teeth are not sharpened. They are either rotated or replaced. The teeth required attention seven times during the 59 working shifts. The sessions averaged just over half an hour each. Figure D illustrates the procedure for either rotating or replacing the cutters.

Both the bolt head and nut area must be cleaned (photos 1 and 2) before the bolt can be loosened (photo 3). The circular tooth can be rotated to a new cutting position or a new tooth can be installed if the old one is worn out. The complete procedure takes between 1.5 and 4 minutes per tooth. Not all teeth require attention each time.
