# Ethical Case Study: Texas City Refinery Explosion

Duy Duong  
UID: 505183737  
Discussion 1B  
xxx words

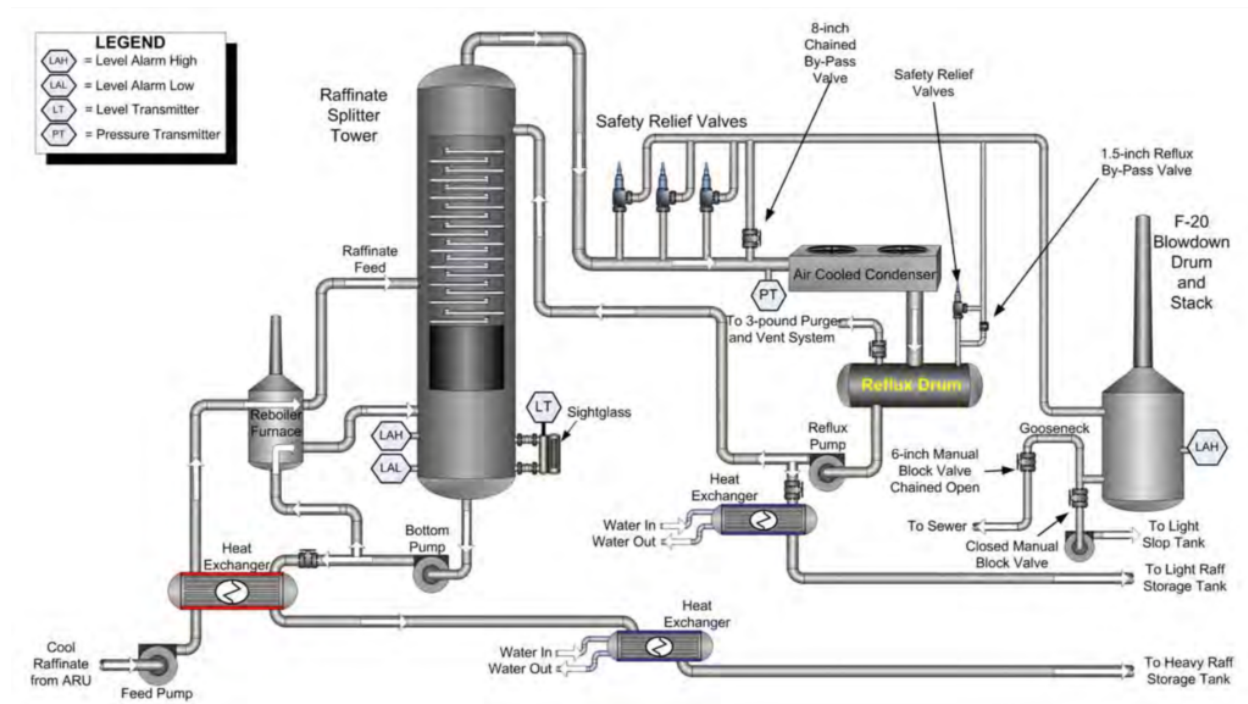
Figure 1: Flow diagram of the ISOM. Hydrocarbons were fed into the raffinate splitter, which split the feed into three parts: heavy and light hydrocarbons, and vapors, which went into the heavy storage tank, light storage tank, and the blowdown drum respectively. (cite BP report)

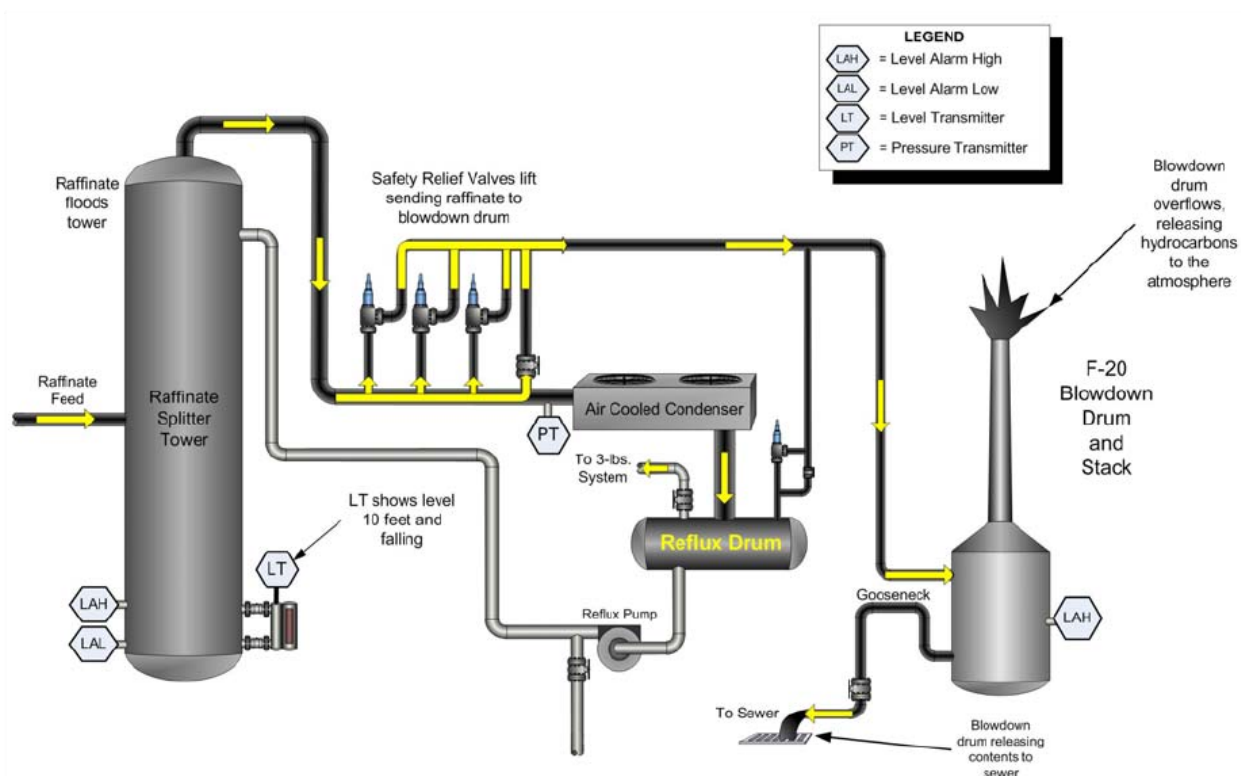
The raffinate splitter, in normal operation, would have around 2m of liquid from its base. This liquid level was controlled by many overlapping safety systems, all of which had one or more major issues that were not acknowledged nor resolved. On the day of the accident, the heavy storage tank was nearly full from the previous night's operation and the level control valve was shut off, cutting the downward flow to the heavy tank. When the raffinate splitter was filled the next morning, the liquid level went up many times the safe amount as there was nowhere else for the materials to go. The raffinate splitter tower overflowed when the liquids expand due to the heat during operation, sending liquid hydrocarbons to the blowdown drum, as seen in Figure 2. As the blowdown drum inevitably overflowed, hot liquid hydrocarbons shot off from the top and flowed through the drain pipes for sewer disposal.

Figure 2: Incident diagram of the explosion. Compared to the normal flow diagram, the flow to the heavy storage tank was blocked, and raffinate feed overflowed through the top to the blowdown drum. (cite BP report)
