Ethical Case Study: Texas City Refinery Explosion

Duy Duong
UID: 505183737
Discussion 1B
3000 words

November 25, 2019

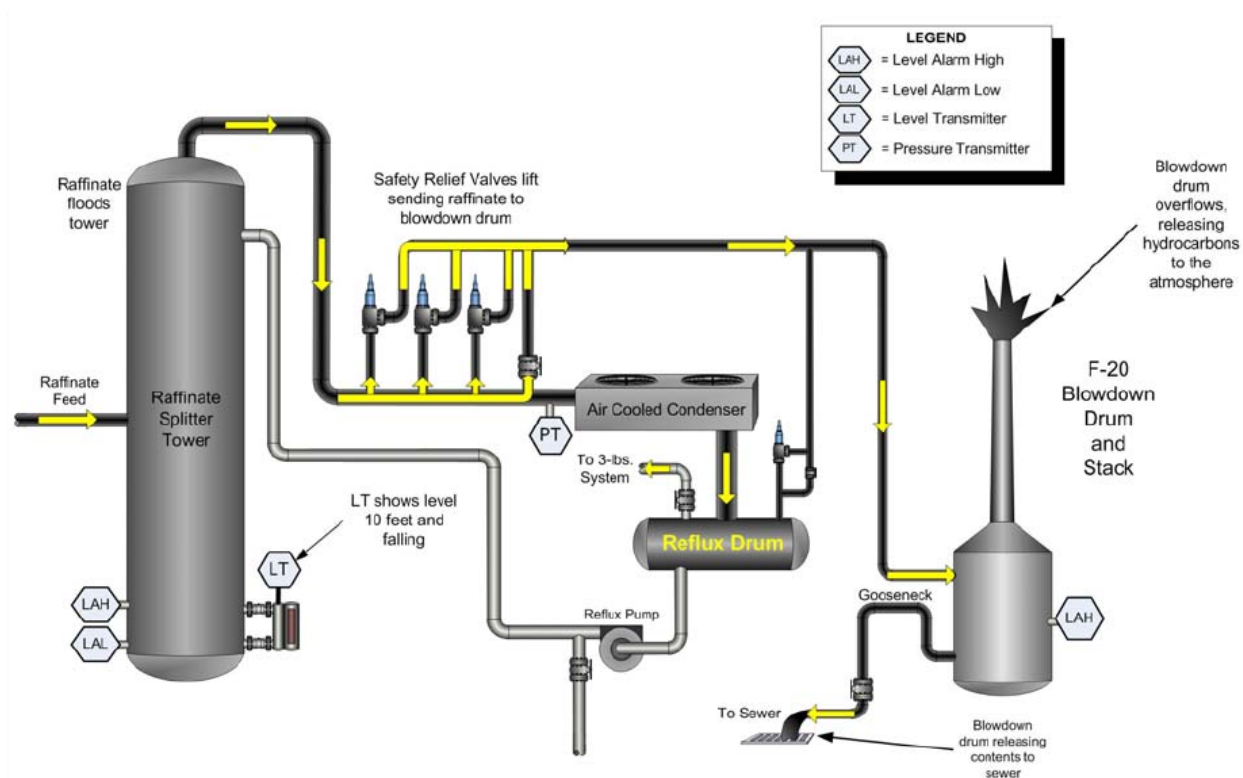
Figure 1: Incident diagram of the explosion. Compared to the normal flow diagram, the flow to the heavy storage tank was blocked, and raffinate feed overflowed through the top to the blowdown drum. (BP, 2005)

The raffinate splitter, in normal operation, would have around 2m of liquid from its base. This liquid level was controlled by many overlapping safety systems, all of which had one or more major issues that were not acknowledged nor resolved. On the day of the accident, the heavy storage tank was nearly full from the previous night's operation and the level control valve was shut off, cutting the downward flow to the heavy tank. When the raffinate splitter was filled the next morning, the liquid level went up many times the safe amount as there was nowhere else for the materials to go. The raffinate splitter tower overflowed when the liquids expand due to the heat during operation, sending liquid hydrocarbons to the blowdown drum, as seen in Figure 1. As the blowdown drum inevitably overflowed, hot liquid hydrocarbons shot off from the top and flowed through the drain pipes for sewer disposal.

Many of the safety equipments in the raffinate tower were also defective, playing a major part in the accident’s progress. When the raffinate splitter tower was refilled in the morning, it overfilled many times its capacity, but this was not caught by any of the engineers involved as the defective level indicators did not give any warning, and the sight glass for manual checking was broken. Another system that could have prevented the issue was the level alarm in the blowdown drum that did not go off even though hydrocarbons were bursting out of its top.
