# Field Application of UAS-Based Bridge Inspection

Junwon Seo<sup>1</sup>, Luis Duque<sup>1</sup>, and James P. Wacker<sup>2</sup>

Transportation Research Record  
1–10

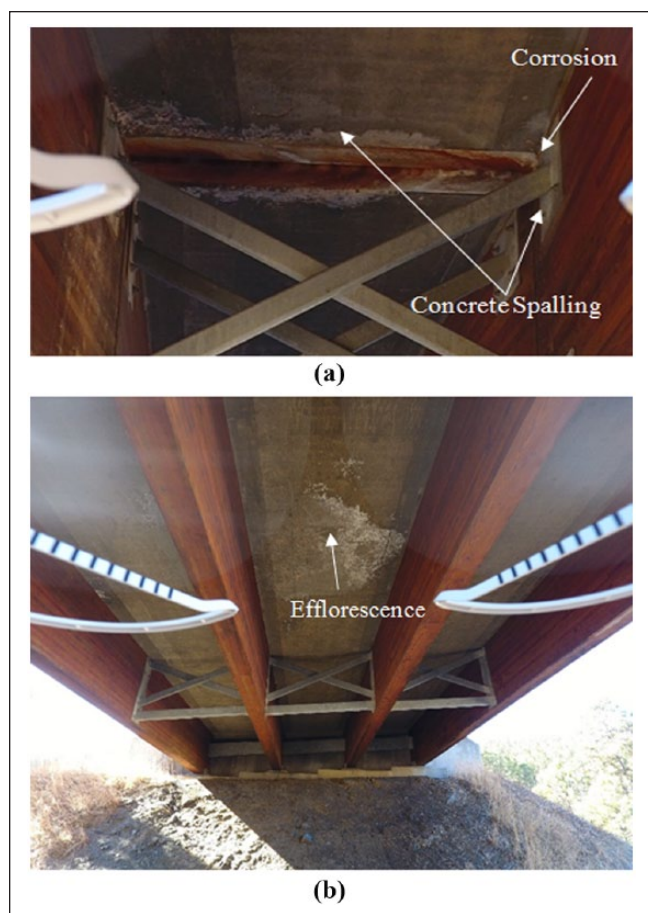
**Underside of Deck.** Overall, the deck had several water leakage areas causing moisture-related damage such as corrosion. Sample images of the damage are presented in Figure 5. Figure 5a corresponds to corrosion, spalling and exposed rebar at Girder 4 and Joint 1, and Figure 5b shows efflorescence in Bay 2 between South Abutment and Joint 1.

**Figure 5.** Underside of deck damage detected using UAS: (a) concrete spalling and corrosion with exposed rebar at Girder 4 and I and (b) efflorescence in Bay 2 between South Abutment and Joint I.

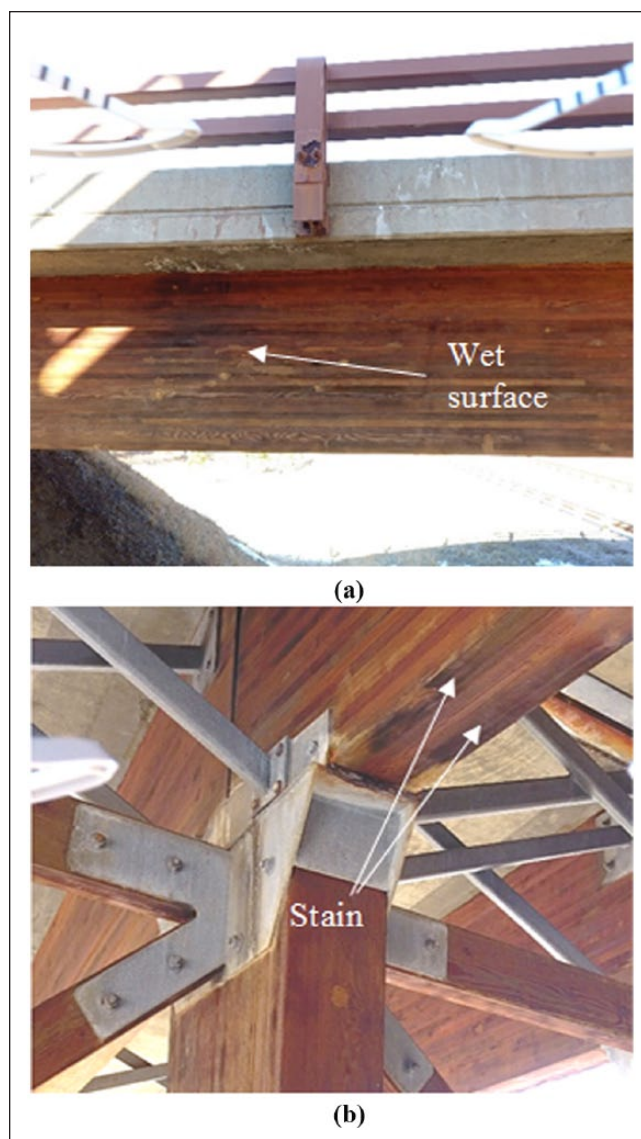
**Girders.** The girders were generally in good condition, with some moisture caused by water leakage resulting from the deck. Some stains and discoloration were also apparent on some girders, possibly caused by calcium deposits and corrosion coming from the chemical reaction of the water with concrete and steel. Sample images of the damage identified on the

girders are shown in Figure 6, *a* and *b*. Figure 6*a* shows visible moisture corresponding to Girder 4 between South Abutment and Joint I, and Figure 6*b* shows stains under Girder 3 at Joint I caused by corrosion of the steel connection bracket.

**Figure 6.** Girder damage detected using the UAS: (a) moisture damage on the side of Girder 4 between South Abutment and Joint I and (b) stains under Girder 3 at Joint I.
