Technical Notice

Engineering Change Notice for 00.00.15.357787 Software

TN S/N: TN-JY-2406001

FROM: Lifotronic International Service Department

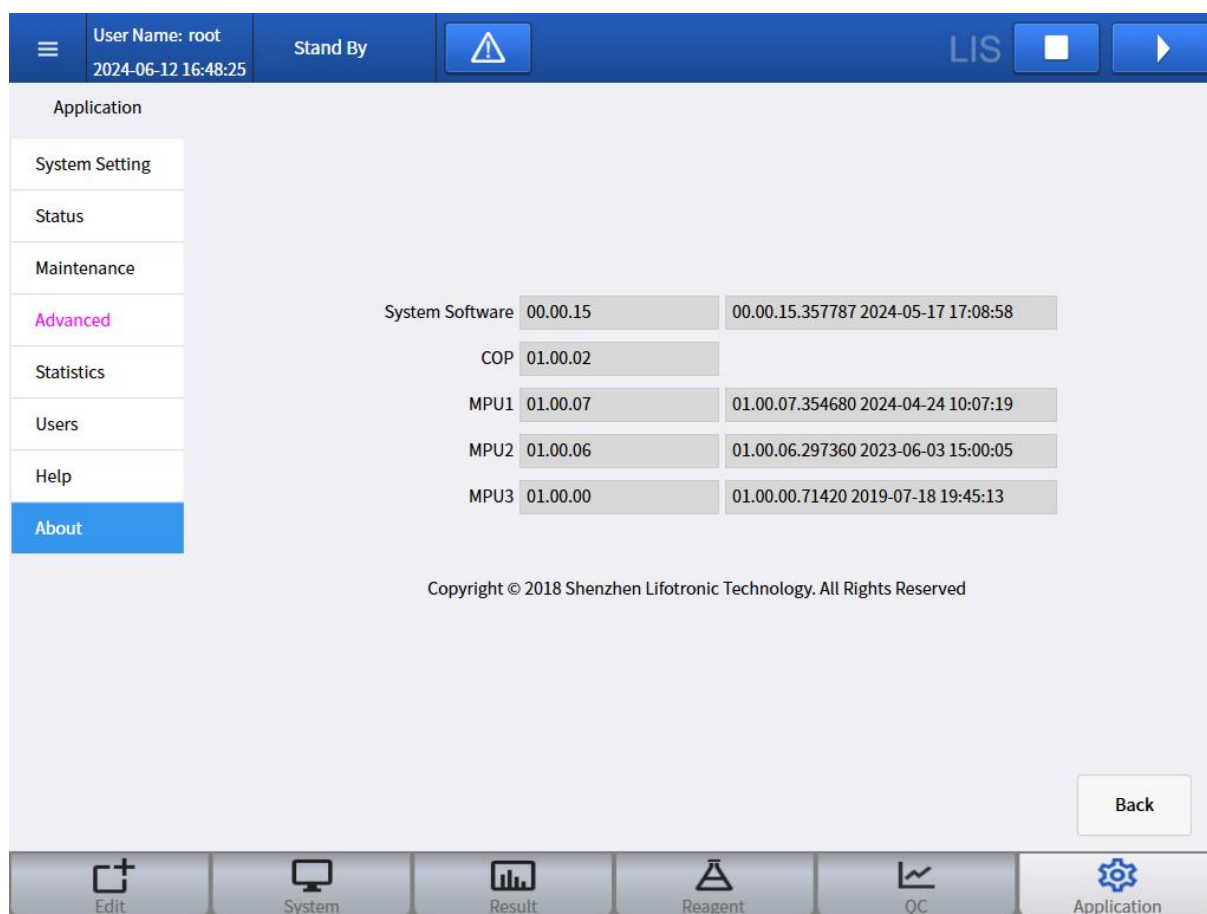
Software information after successful upgrade

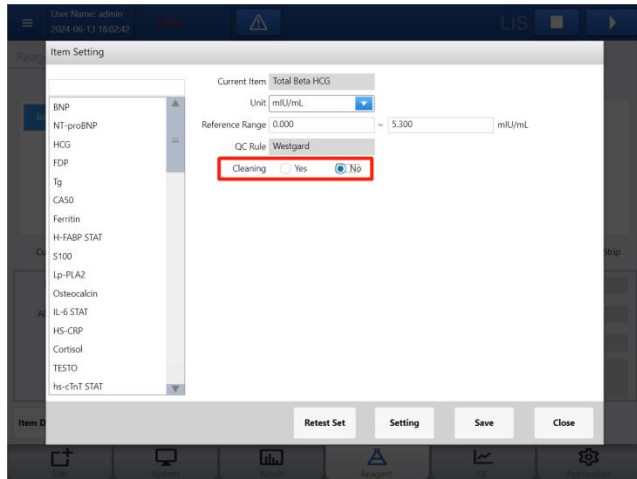
6. All accounts have the authority to enable the enhanced cleaning program.

The admin account, which has the second-highest authority after root, is used for demonstration here

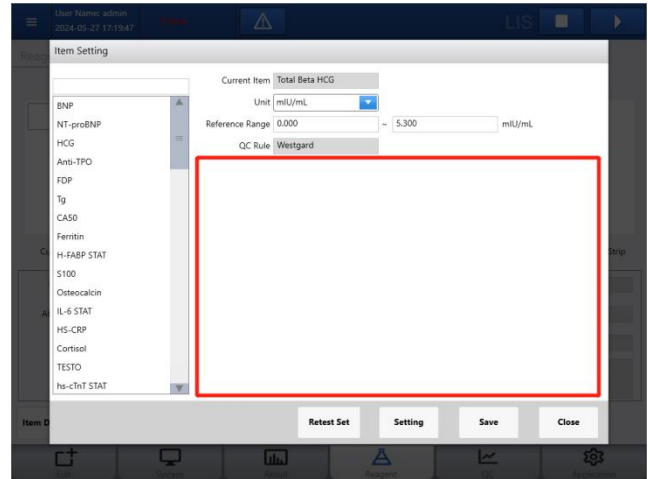
6. Added restriction that only the root account has the authority to enable or disable the enhanced cleaning program.

The admin account, which has the second-highest authority after root, is used for demonstration here

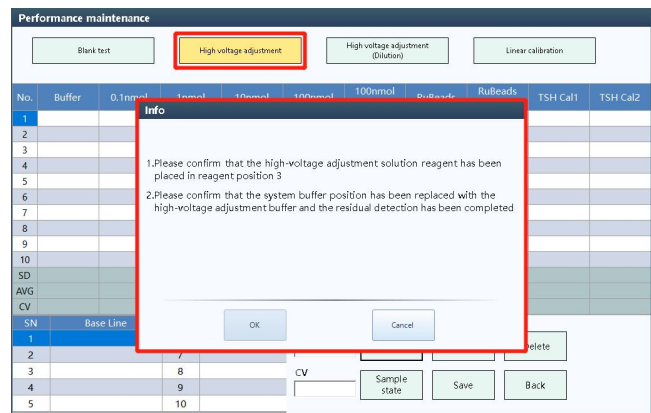
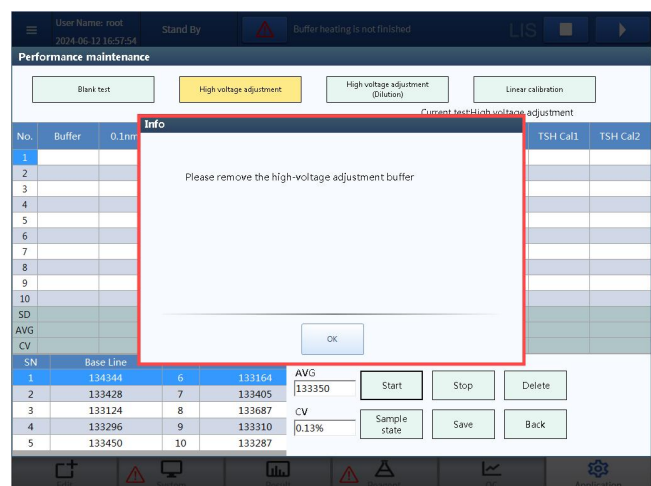
7. No such prompt.

7. Added prompts on using related reagents before and after performing High-voltage Adjustment test.

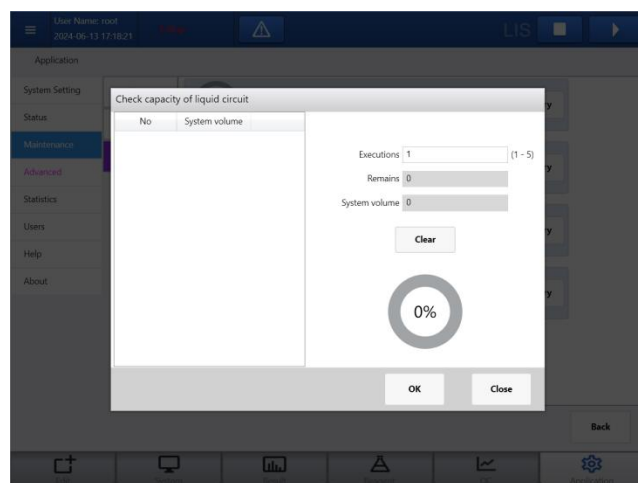
8.2. There is no System Volume Offset value column in the Check Capacity of Liquid Pathway (System Volume) test interface.

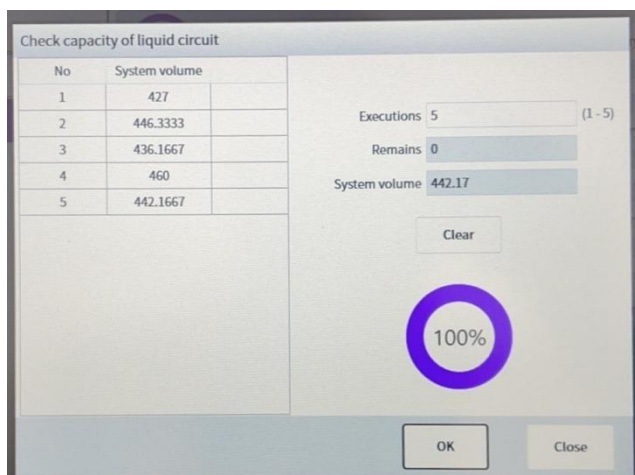
9. System volume test results are actual test values.

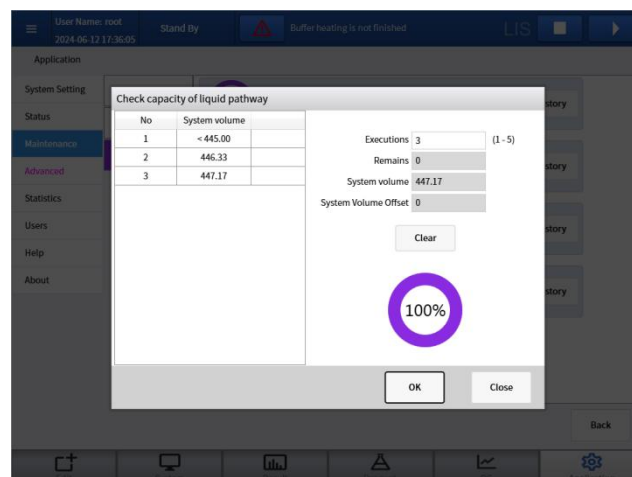
**Note: When the system volume result exceeds 445~487 or unstable, the offset function cannot be used for adjustment, it is necessary to check the instrument hardware.*

Here <445 is taken as an example

9. Optimize the display of system volume test results. Results within the range of 445~487 will display values, and results outside the range will display <445 or >487.
