## STM32L476xx/STM32L486xx device limitations

### Silicon identification

This errata sheet applies to revisions '3' and '4' of the STMicroelectronics STM32L476xx and STM32L486xx products. The STM32L4x6xx family features an ARM® 32-bit Cortex®-M4 core.

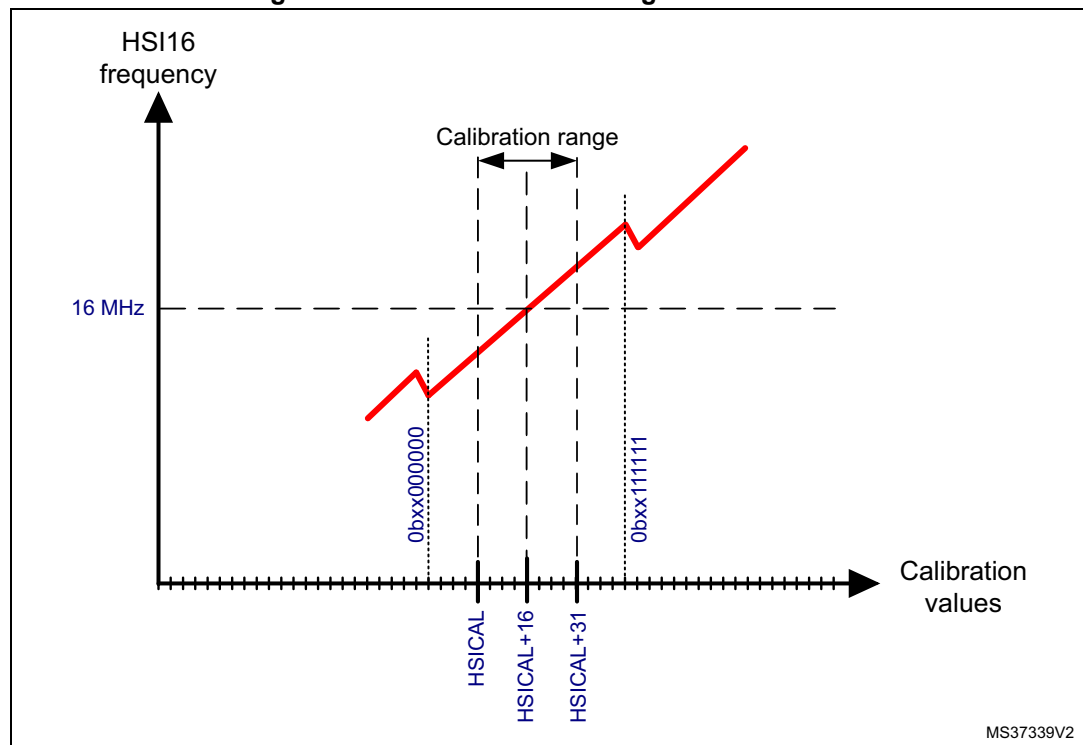
**Figure 1. HSI oscillator trimming characteristics**

**2.1.10 HSI user trim is limited on some samples****Description**

The HSI user trimming step is typically:

- +0.3% of frequency when the trimming code is not a multiple of 64;
- -7% of frequency when the trimming code is a multiple of 64.

As shown in [Figure 1](#), the HSI user trimming allows to add or to subtract up to 16 steps compared to the factory trim value.

If the HSI factory trim value is close to a multiple of 64, with only 16 steps for positive or for negative correction, it is not possible to compensate the 7% drop when the code is a multiple of 64.

Consequently, the user trim correction must not jump over the codes multiple of 64, which can limit the user correction either in positive or in negative direction.

None.

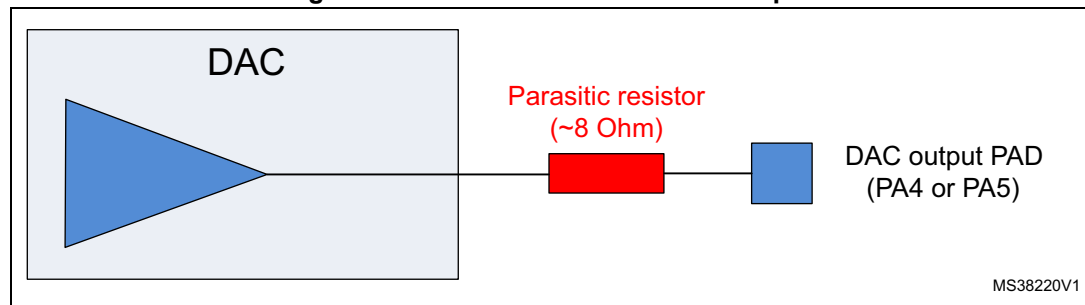
**Figure 2. Parasitic resistor on DAC output**

## 2.15.4 DAC characteristics can be degraded depending on the current sunk on DAC output

Resistor value between DAC outputs and I/O ( PA4 or PA5 ) is greater than expected: 8ohm typical, as shown in [Figure 2](#). As a consequence the DAC characteristics can be impacted depending on the current sunk on DAC output.

None.

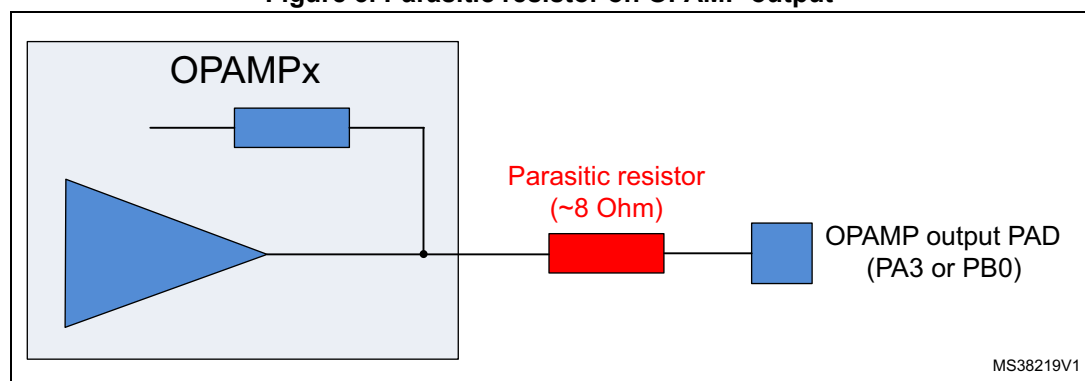
**Figure 3. Parasitic resistor on OPAMP output**

### 2.16.1 OPAMP characteristics can be degraded depending on the current sunk on OPAMP output

Resistor value between OPAMP outputs and I/O ( PA3 or PB0 ) is greater than expected: 8 ohm typical, as shown in [Figure 3](#). As a consequence the OPAMP characteristics can be impacted depending on the current sunk on the output.

None.
