Wood Destroying Insect Report

Inspection Performed by Stephen Lozano TPCL #888536 11/12/2024

2121 Bolsover St

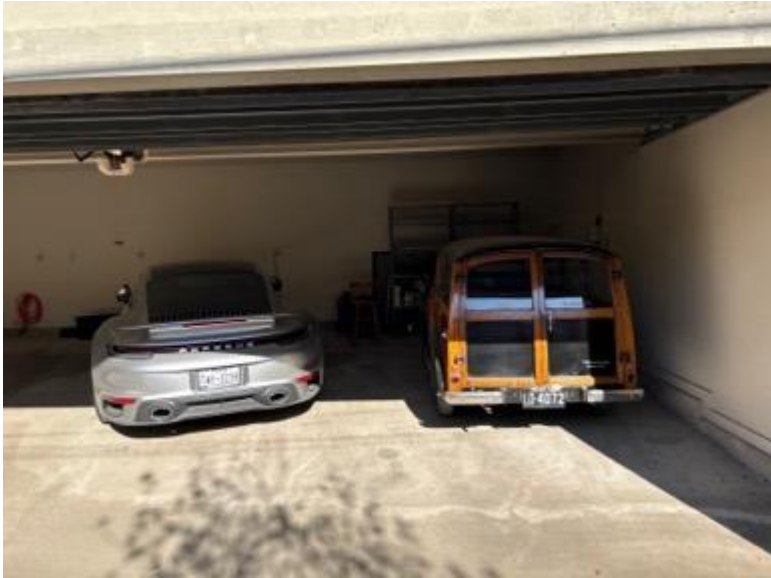
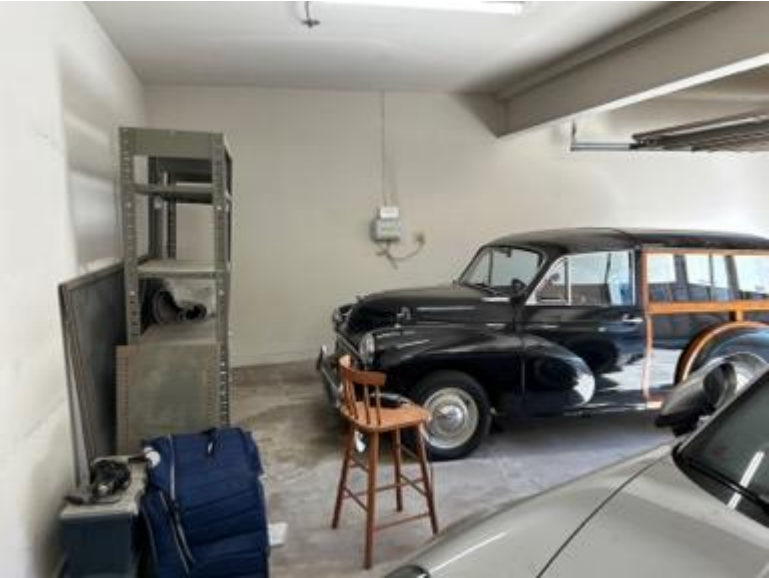
Stored items in garage.

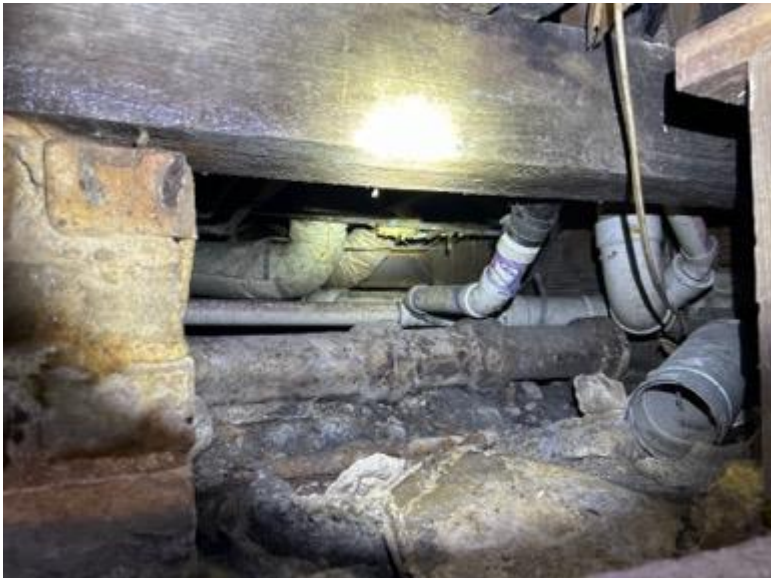
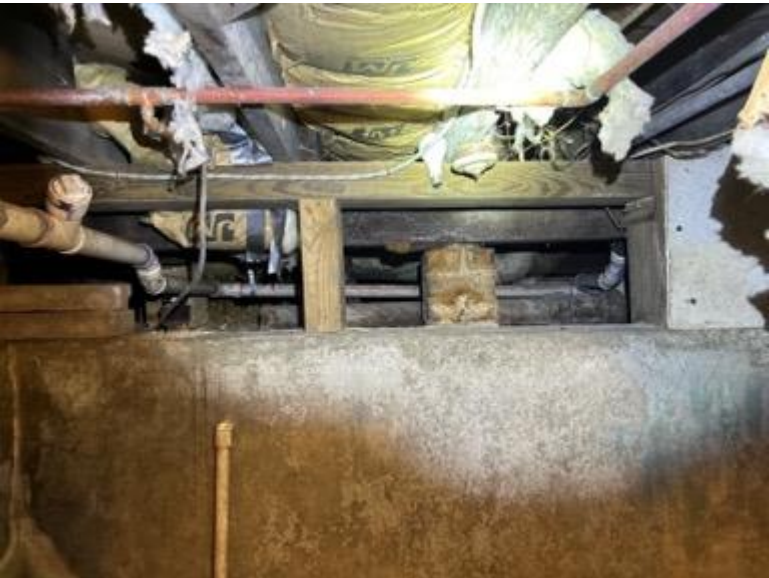
Adequate access was not present to the crawlspace; therefore, the crawlspace was not entered for inspection. We recommended that access be provided, and you contact our office to complete the inspection.

Adequate access was not present to the crawlspace, therefore the crawlspace was not entered for inspection. We recommend that access be provided and you contact our office to complete the inspection.

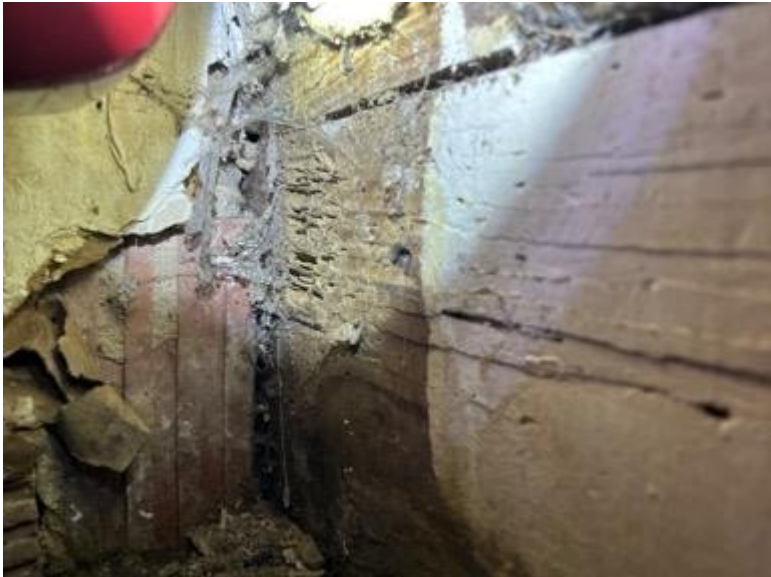
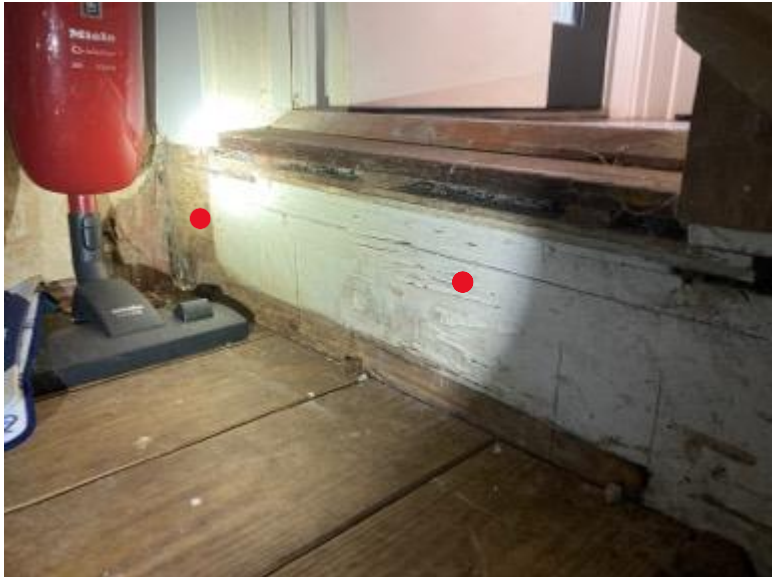
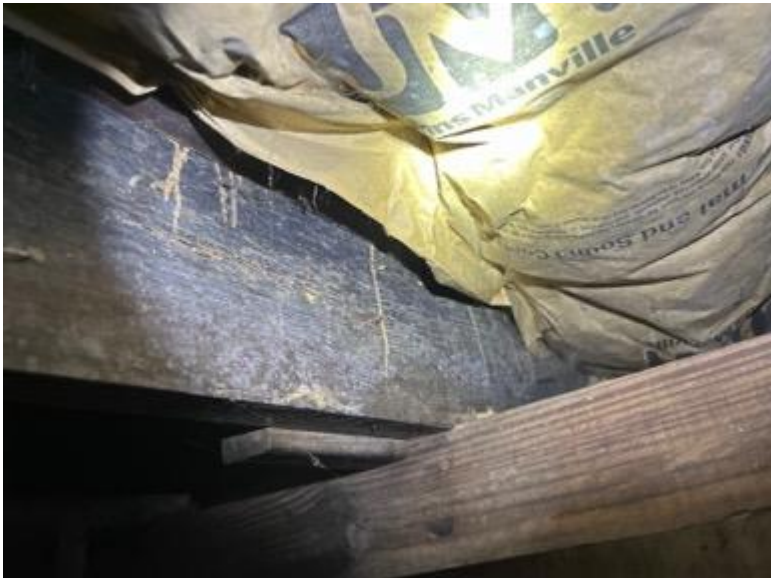
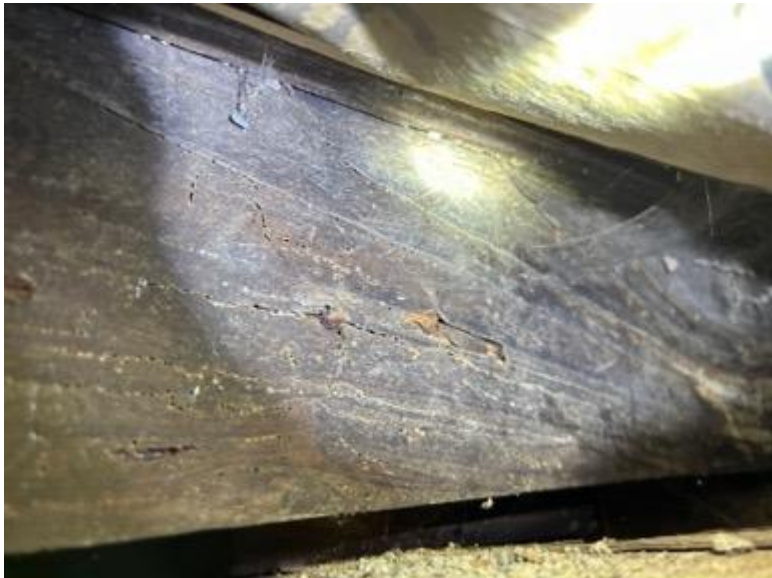
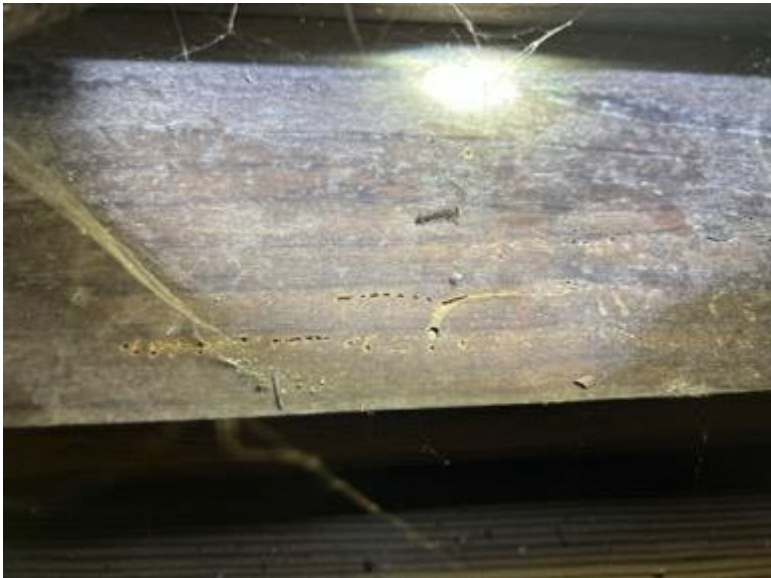
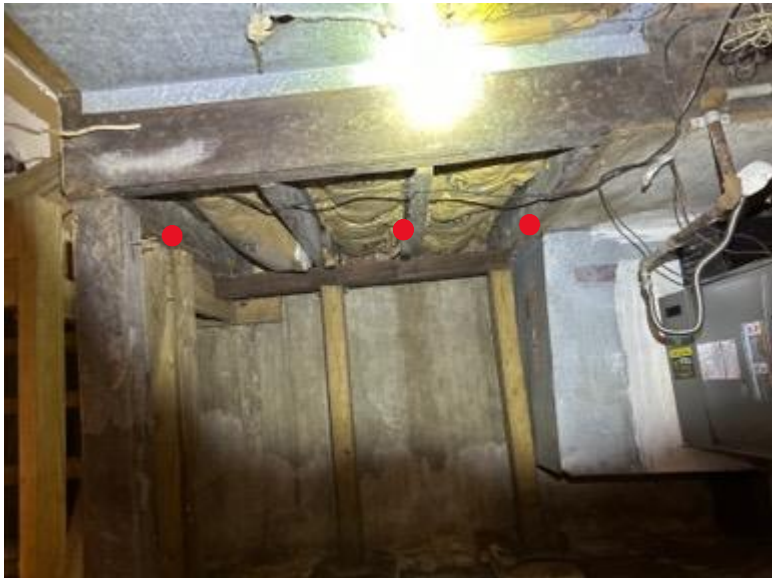
11G.Visible evidence of: **Subterranean Termites** has been observed in the following areas: **Basement**

(PS) Subterranean Termites - Evidence of previous infestation - evidence of previous treatment - No additional treatment recommended.

Evidence of Previous Subterranean termite activity was observed in basement.

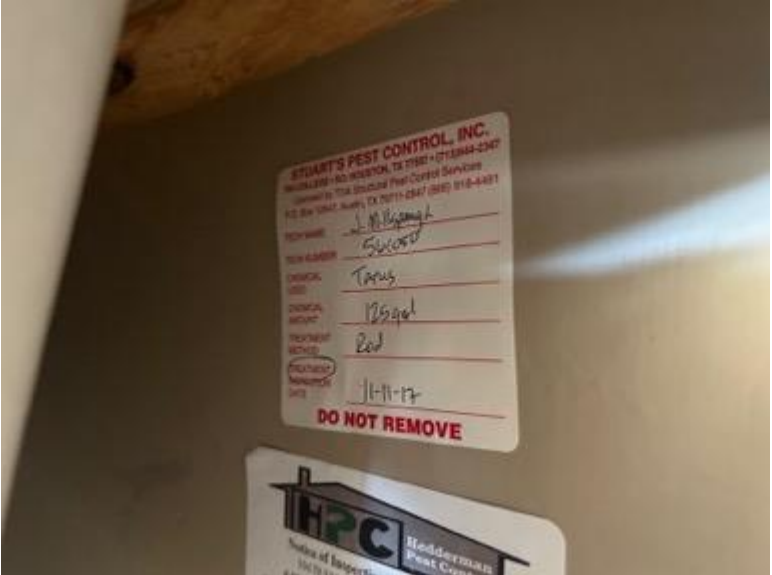
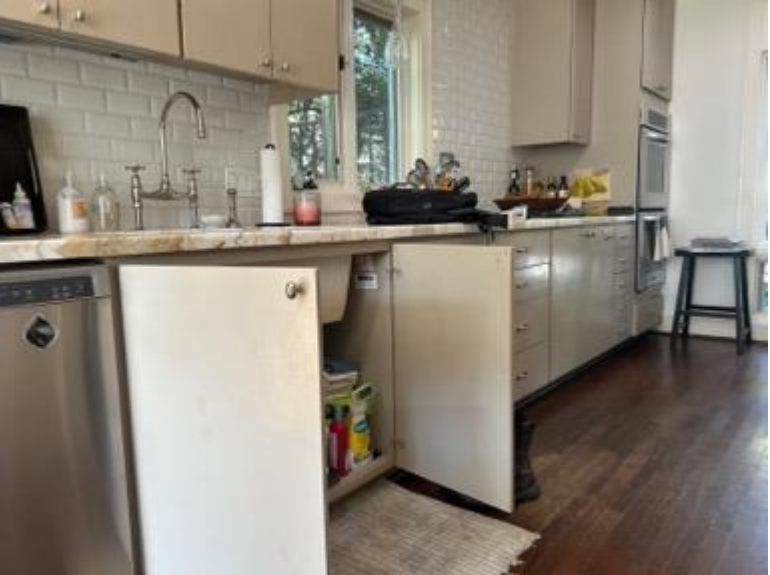
A sticker indicating previous treatment for subterranean termites was observed. Further investigation is recommended with owner regarding treatment and warranty.

A sticker indicating previous treatment for subterranean termites was observed. Further investigation is recommended with owner and treating company regarding treatment and warranty.

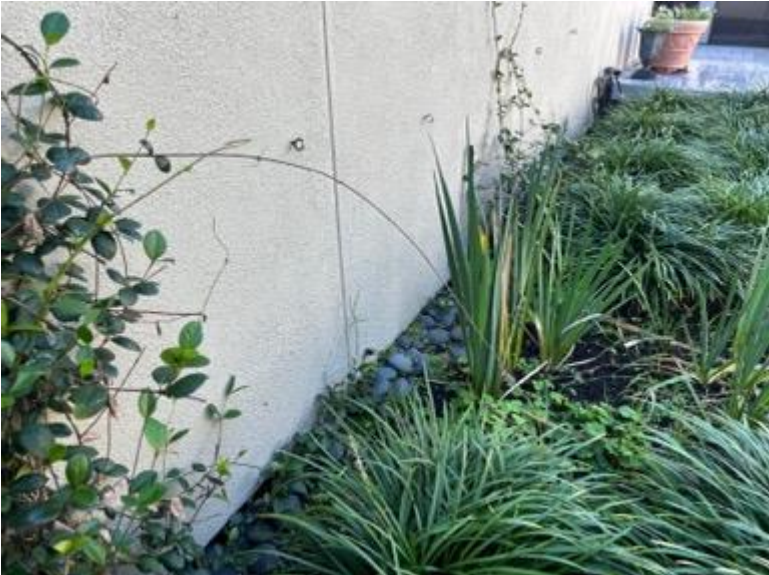
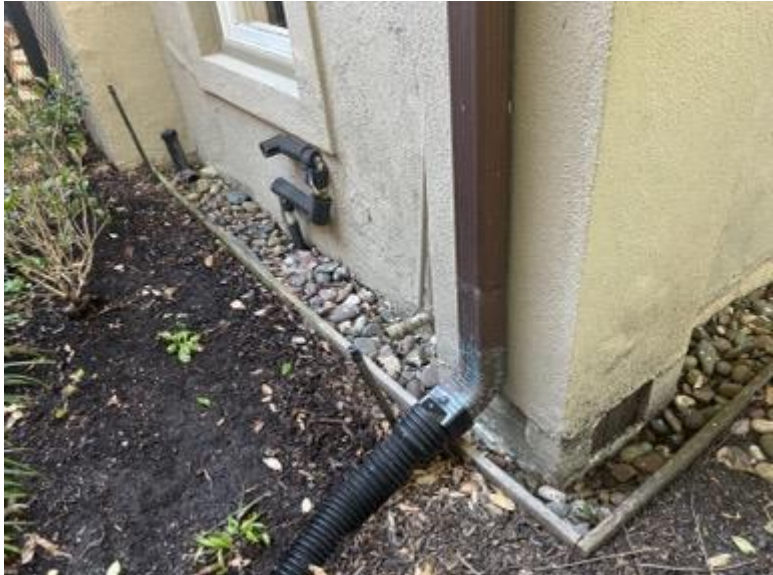
High soil should be lowered.

Additional Comments: **(L) High Soil – Soil should be lowered to below the top of the foundation.**

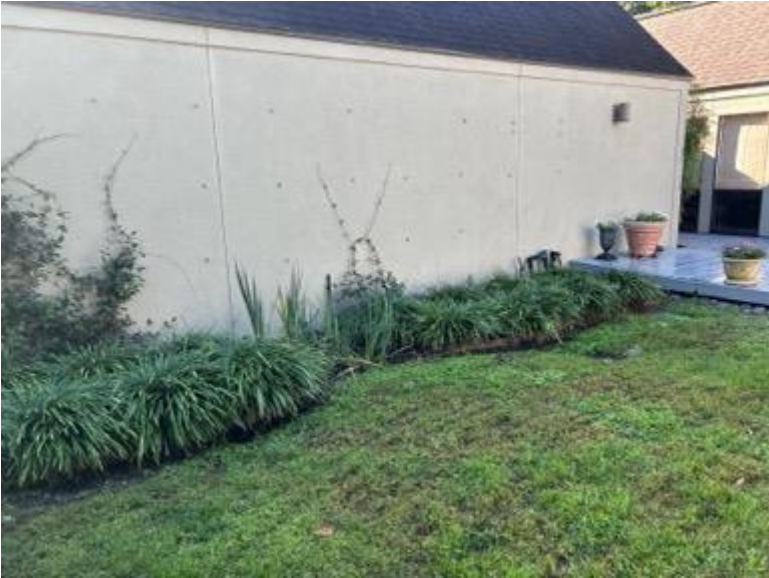
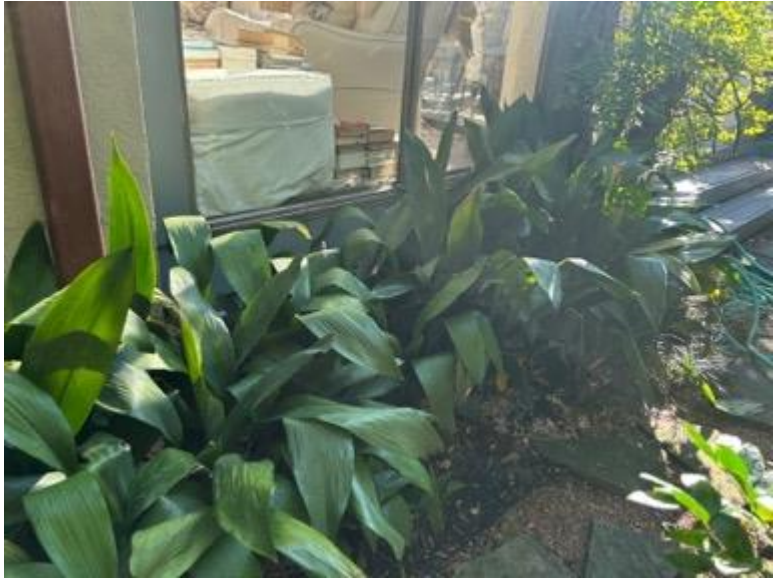
Heavy foliage should be trimmed back from structure.

(N) Heavy Foliage – Foliage should be cut back to provide at least 3 inches of clearance to the structure.

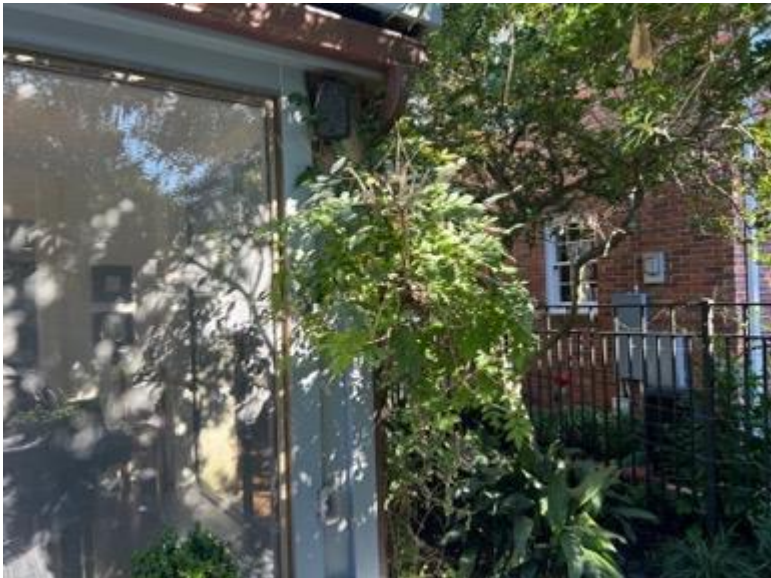
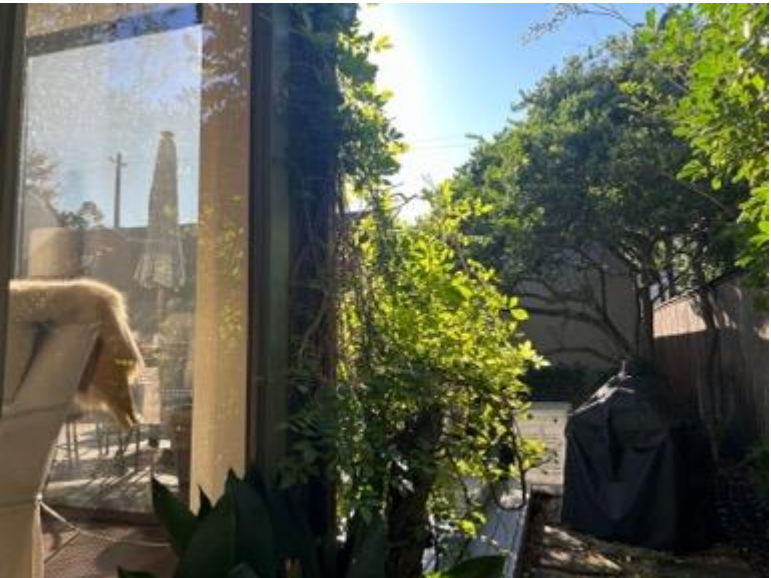
It is recommended to remove all vines from the structure.

(N) Heavy Foliage - Vines growing on the structure should be removed.

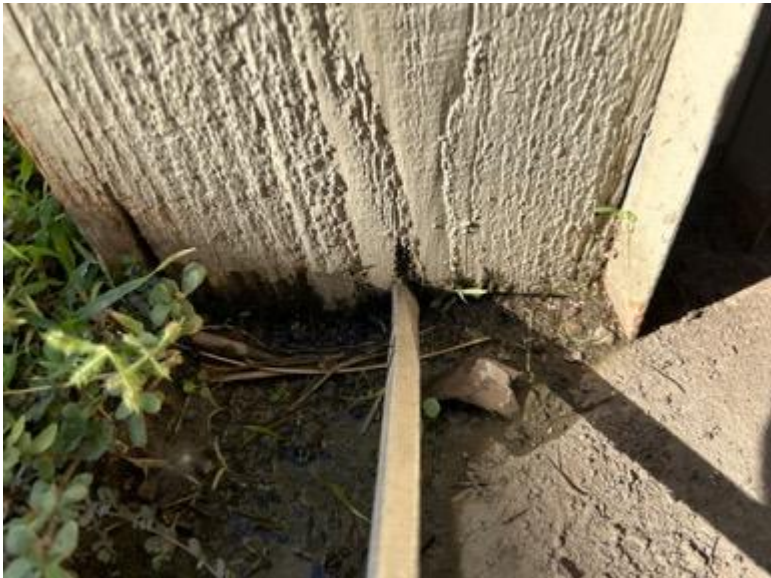
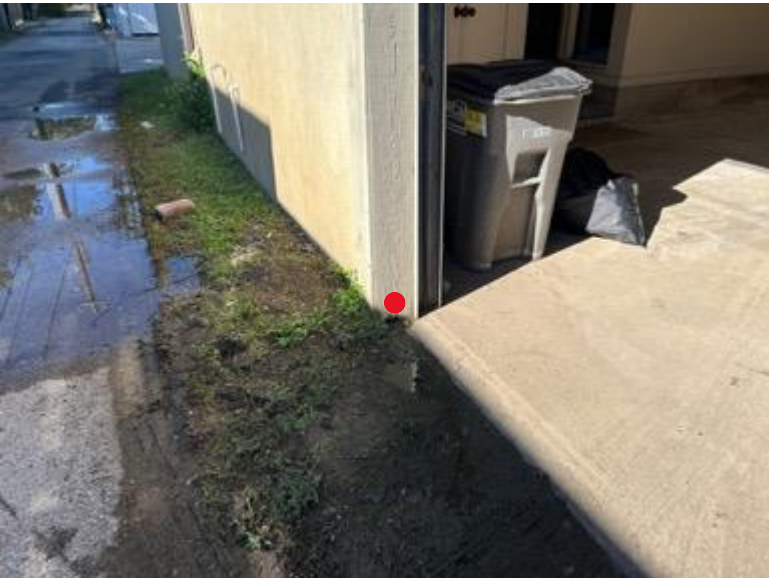
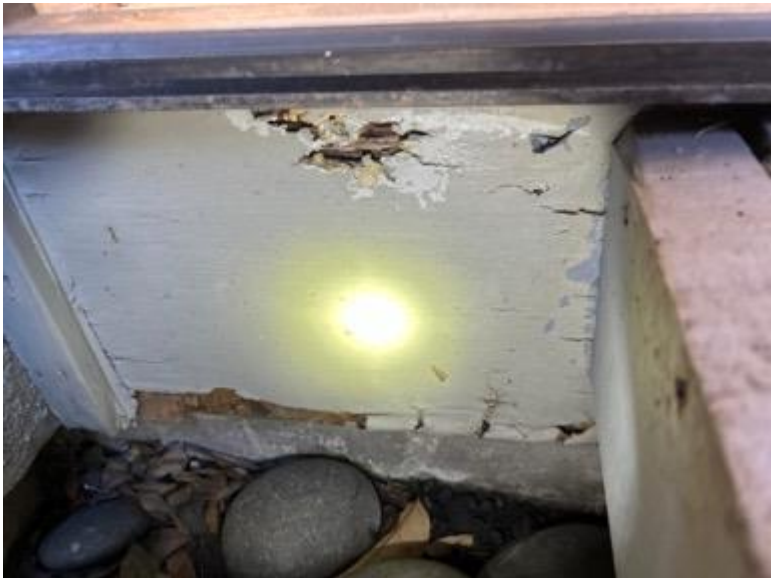
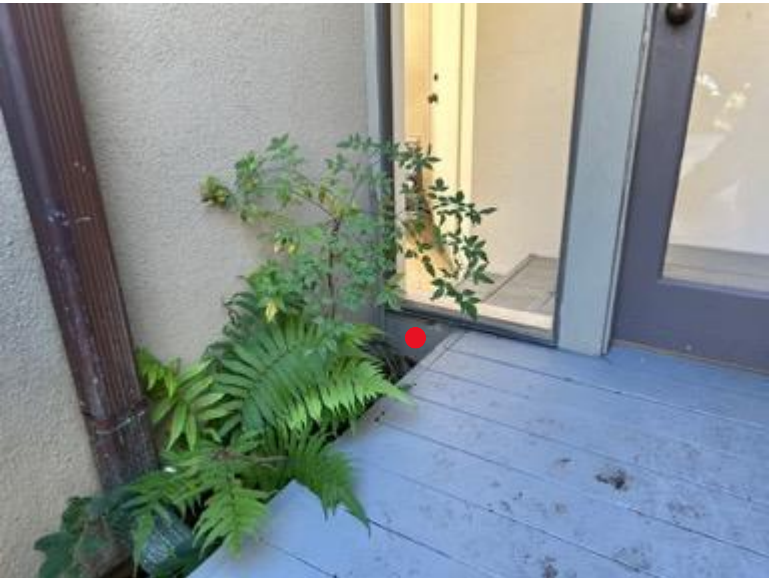
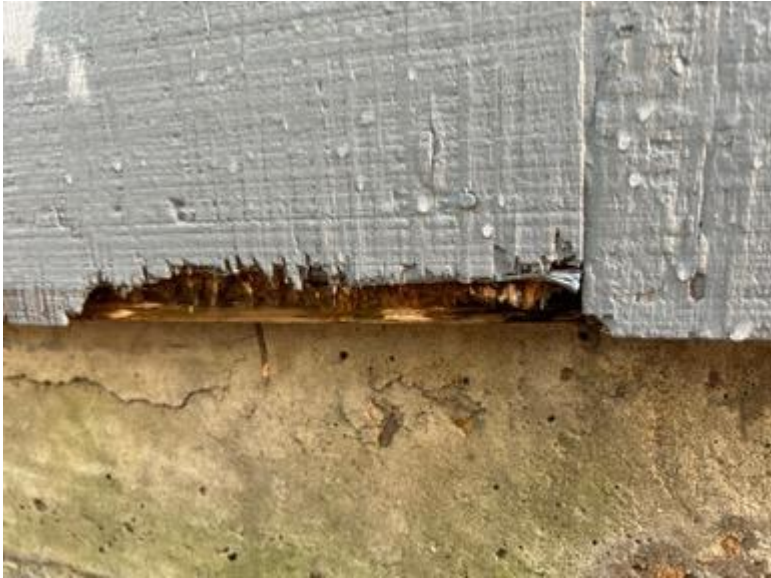
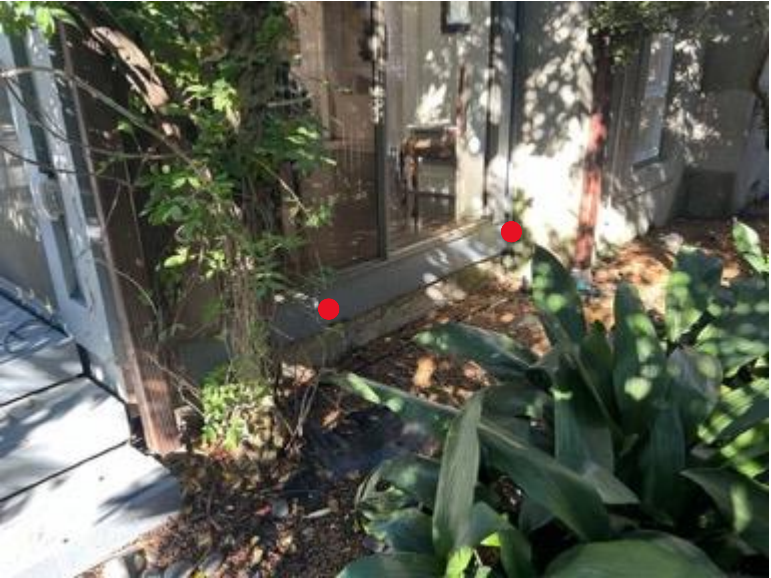
Wood rot should be repaired.

(M) Wood Rot – All damaged or affected wood materials should be properly repaired or replaced.

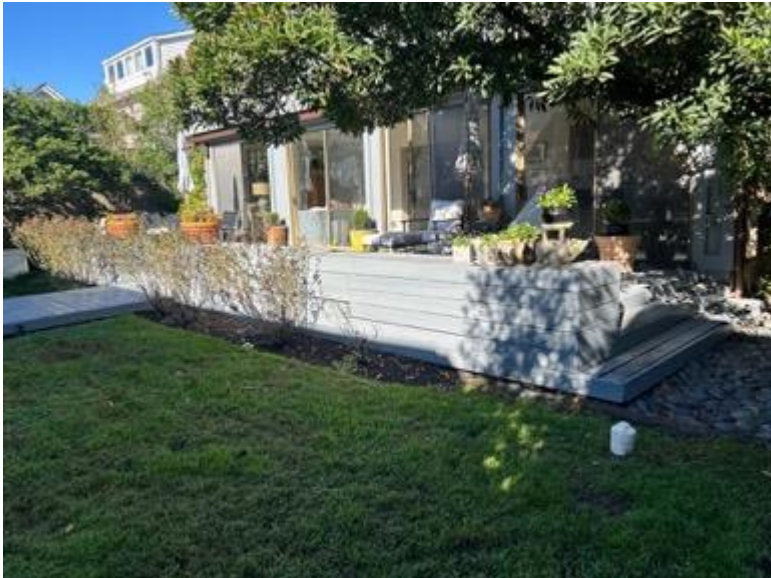
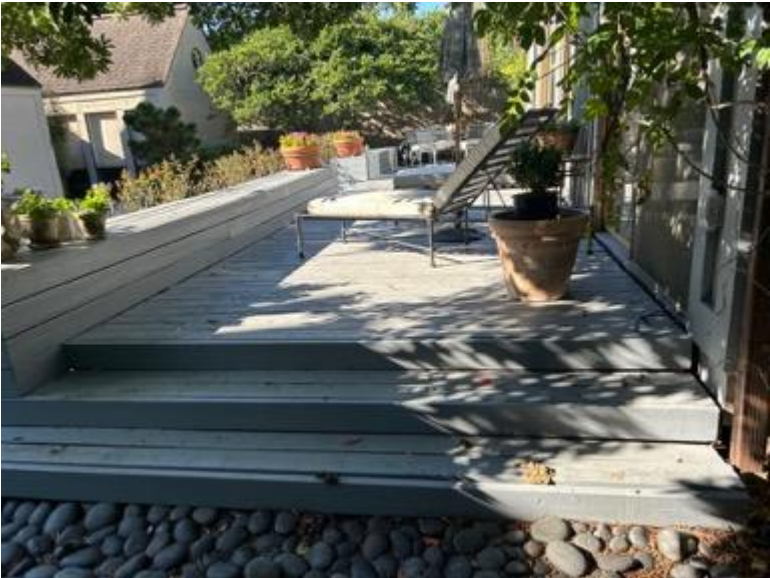
Wood to ground contact – Deck should be monitored for insect activity.

(G) Wood to Ground Contact – Wood decks/porches are conducive by design - Area should be monitored for insect activity.

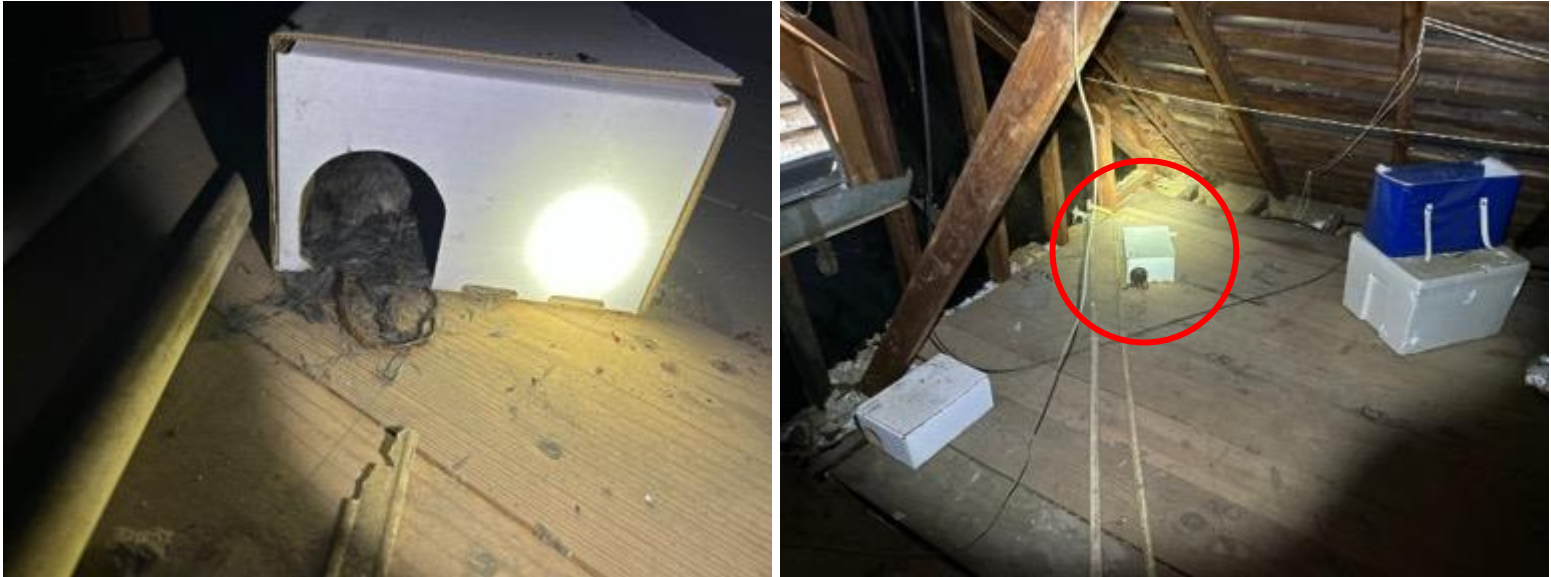
Evidence of rodent activity was observed in house attic.

Although this report does not include pest infestations, we noticed evidence of pest infestation during the course of our inspection. The following conditions were observed that indicate current or previous pest activity. Further investigation is recommended with the owner regarding the condition(s) and with a pest control company to obtain a cost estimate for any needed treatment to resolve the issue.

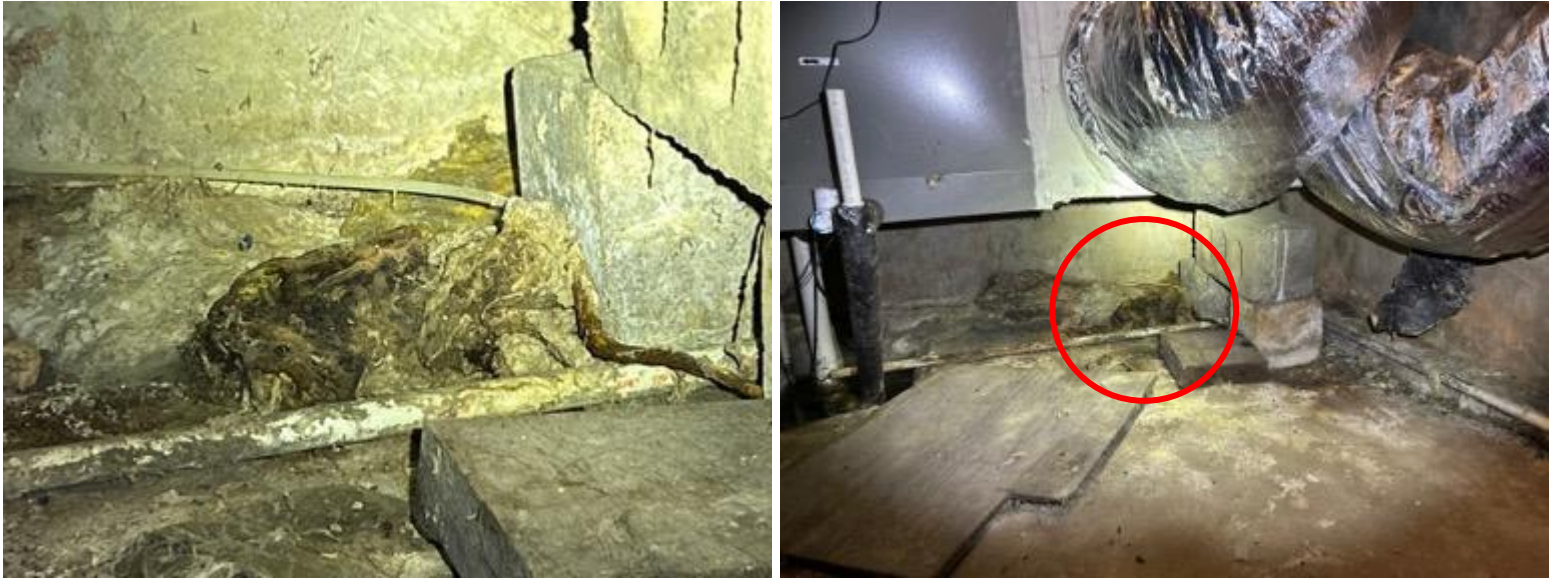
Evidence of rodent activity was observed in basement.
