Detailed Diagnostic Report

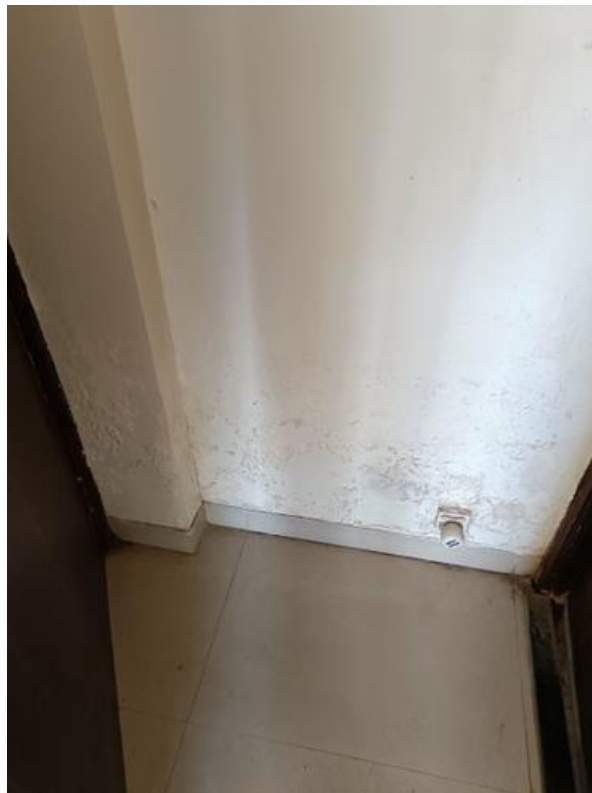
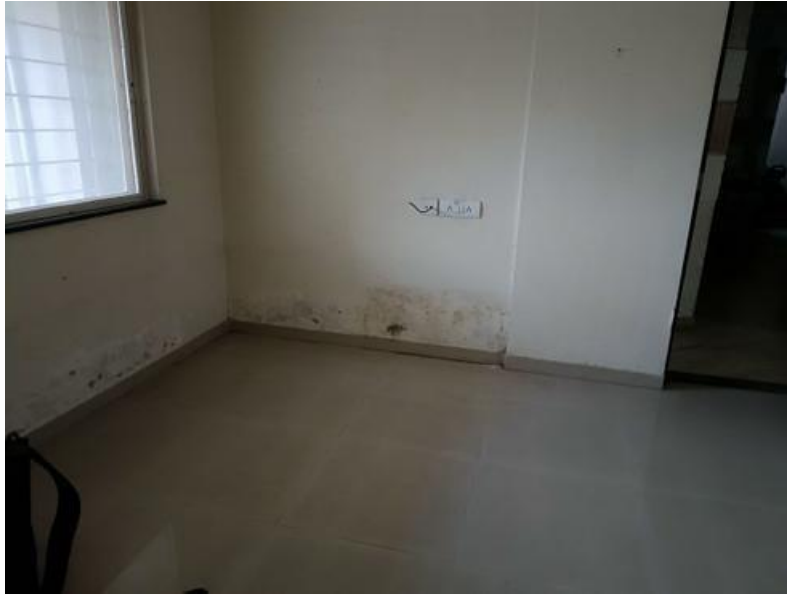
Hall

- Dampness was observed at the skirting level.
- Gaps were observed between the tile joints.

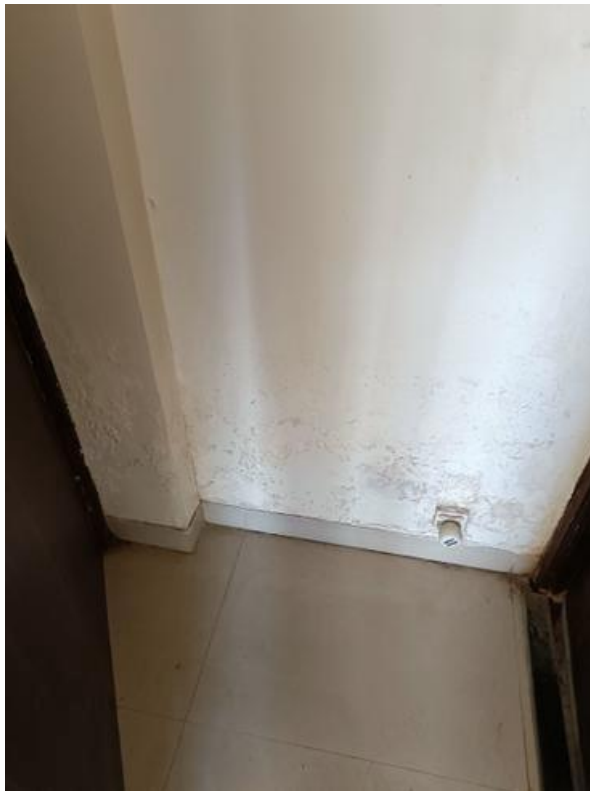
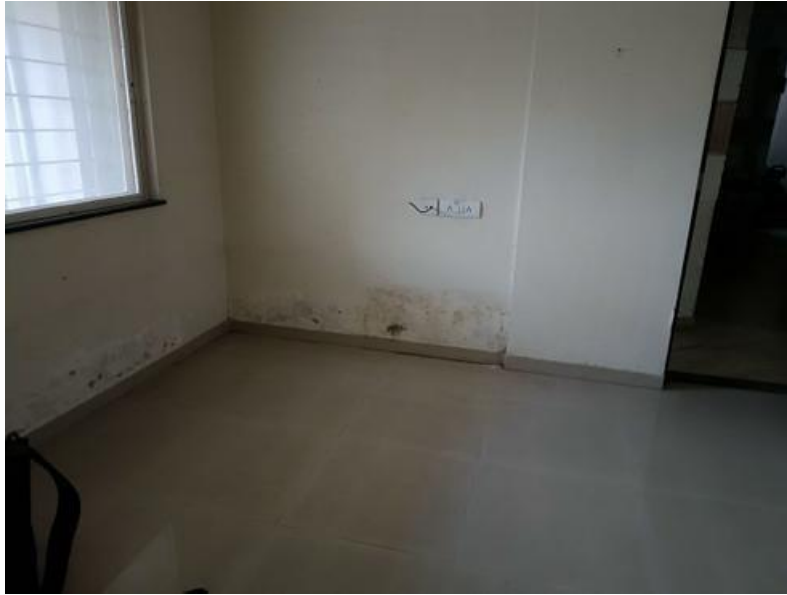
Bedroom

- Dampness was observed at the skirting level.
- Gaps were observed between the tile joints.

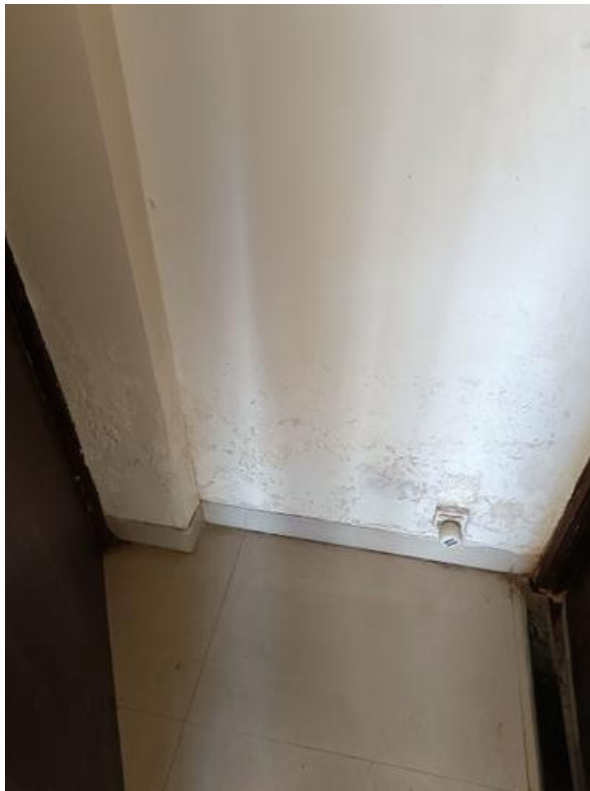
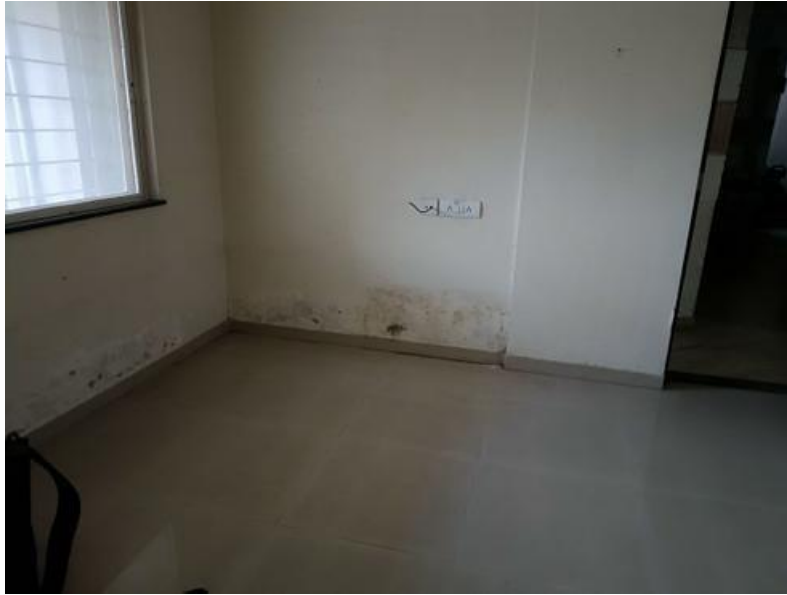
Kitchen

- Observed dampness at the skirting level.
- Observed gaps between the tile joints.

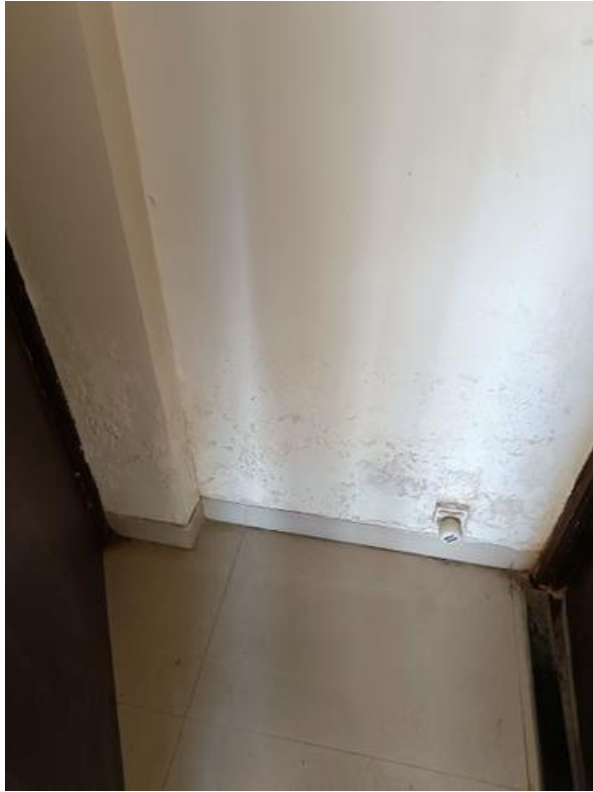
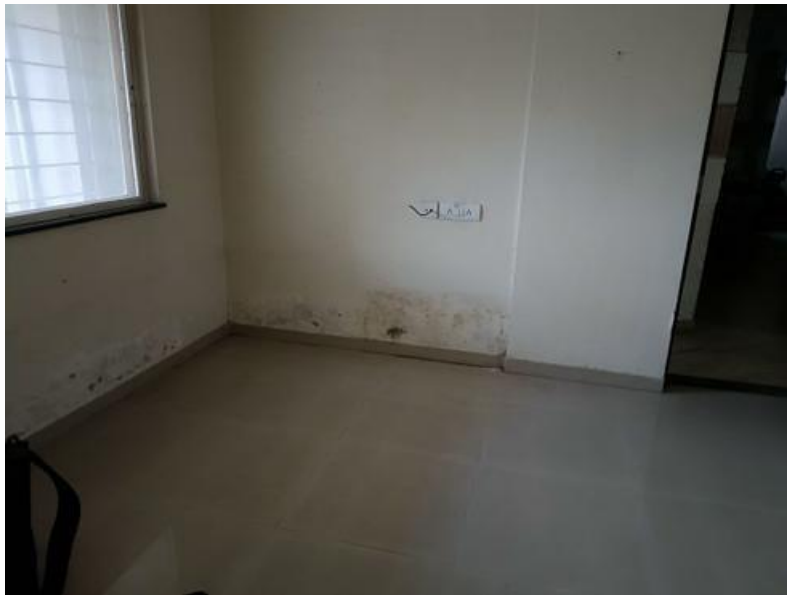
Common Bathroom

1. Observed dampness at the skirting level.
2. Observed gaps between the tile joints.
3. Observed hollowness in the tiles.
4. Observed plumbing issue and gaps between the tile joints.
5. Observed mild dampness at the ceiling of the Common Bathroom.
6. Observed gap between tile joints of Common Bathroom.
