# An Investigation of the Therac-25 Accidents

Nancy G. Leveson, University of Washington

Clark S. Turner, University of California, Irvine

**A thorough account of the Therac-25 medical electron accelerator accidents reveals previously unknown details and suggests ways to reduce risk in the future.**

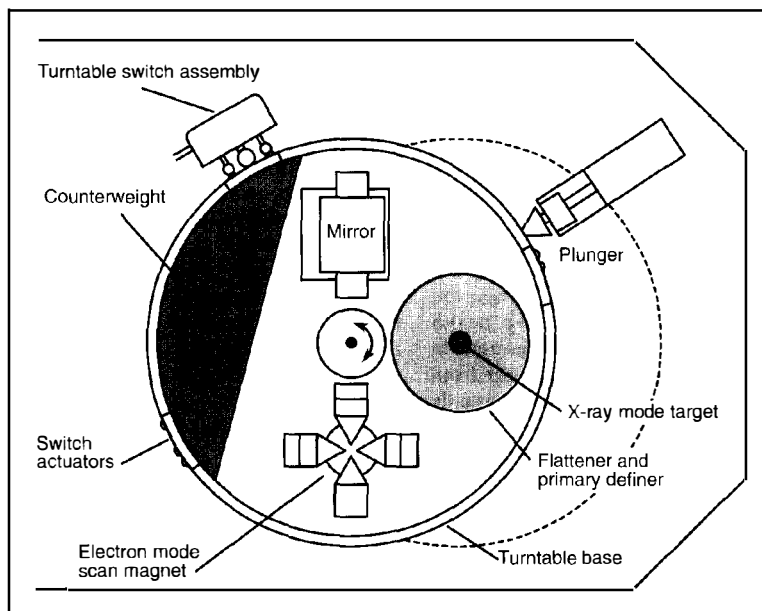
Figure B. Upper turntable assembly.

hazard of dual-mode machines: If the turntable is in the wrong position, the beam flattener will not be in place.

No accelerator beam is expected in the field-light position. A stainless steel mirror is placed in the beam path and a light simulates the beam. This lets the operator see precisely where the beam will strike the patient and make necessary adjustments before treatment starts. There is no ion chamber in place at this turntable position, since no beam is expected.

cate turntable position that tolerated a 1-bit error: The code would still unambiguously reveal correct position with any one microswitch failure.

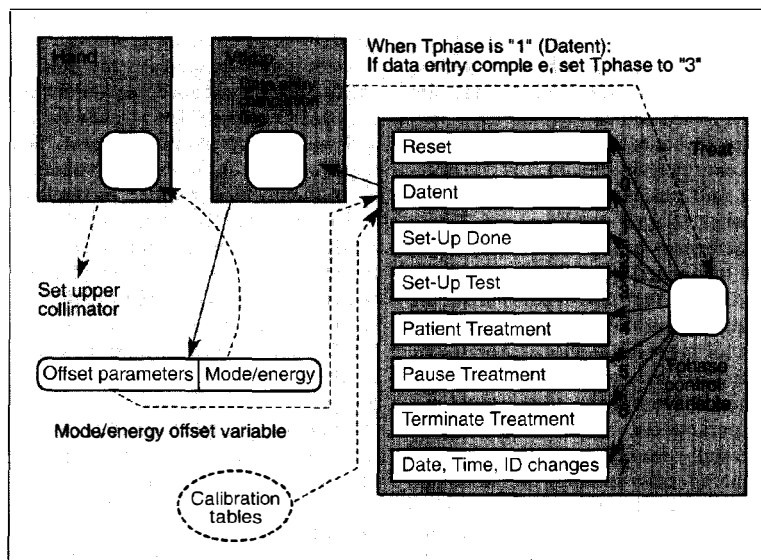
**Figure 2. Tasks and subroutines in the code blamed for the Tyler accidents.**

As described in the sidebar on Therac-25 software development and design, the treatment monitor task (Treat) controls the various phases of treatment by executing its eight subroutines (see Figure 2). The treatment phase indicator variable (Tphase) is used to determine which subroutine should be executed. Following the execution of a particular subroutine, Treat reschedules itself.

One of Treat's subroutines, called Datent (data entry), communicates with the keyboard handler task (a task that runs concurrently with Treat) via a

shared variable (Data-entry completion flag) to determine whether the prescription data has been entered. The keyboard handler recognizes the completion of data entry and changes the Data-entry completion variable to denote this. Once the Data-entry completion variable is set, the Datent subroutine detects the variable's change in status and changes the value of Tphase from 1 (Data Entry) to 3 (Set-Up Test). In this case, the Datent subroutine exits back to the Treat subroutine, which will reschedule itself and begin execution of the Set-Up Test subroutine. If the Data-entry completion variable has not been set, Datent leaves the value of Tphase unchanged and exits back to Treat's main line. Treat will then reschedule itself, essentially rescheduling the Datent subroutine.

Upon exit from the Magnet subroutine, the data-entry subroutine (Datent) checks the data-entry completion variable. If it indicates that data entry is complete, Datent sets Tphase to 3 and Datent is not entered again. If it is not set, Datent leaves Tphase unchanged, which means it will eventually be rescheduled. But the data-entry completion variable only indicates that the cursor has been down to the command line, not that it is still there. A potential race condition is set up. To fix this, AECL introduced another shared variable controlled by the keyboard handler task that indicates the cursor is not positioned on the command line. If this variable is set, then prescription entry is still in progress and the value of Tphase is left unchanged.
