Case study

Damage mechanism in Tournai limestone – The case of the tomb of Admiral Tromp in the Old Church of Delft (The Netherlands)

Barbara Lubelli ^{a,b,*}, Timo G. Nijland ^b

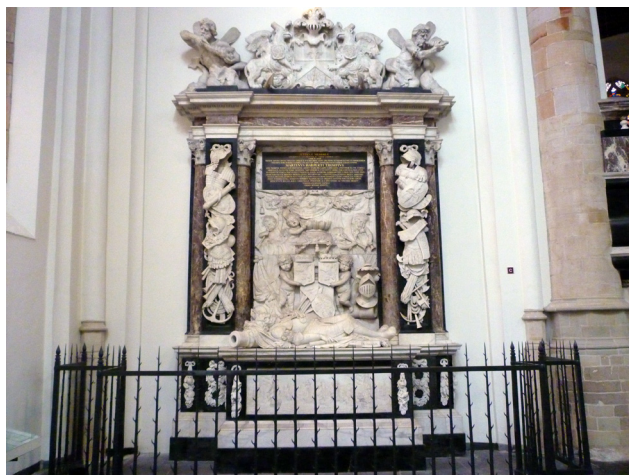
Fig. 1. The funeral monument of Maarten Tromp in the Old Church in Delft (The Netherlands).

The white and red marbles suffer only loss of gloss of the polished surfaces. Differently, the Tournai stone shows damage in the form of scaling and delamination of the surface; this has resulted, during the centuries, in material loss up to few centimeter depth.

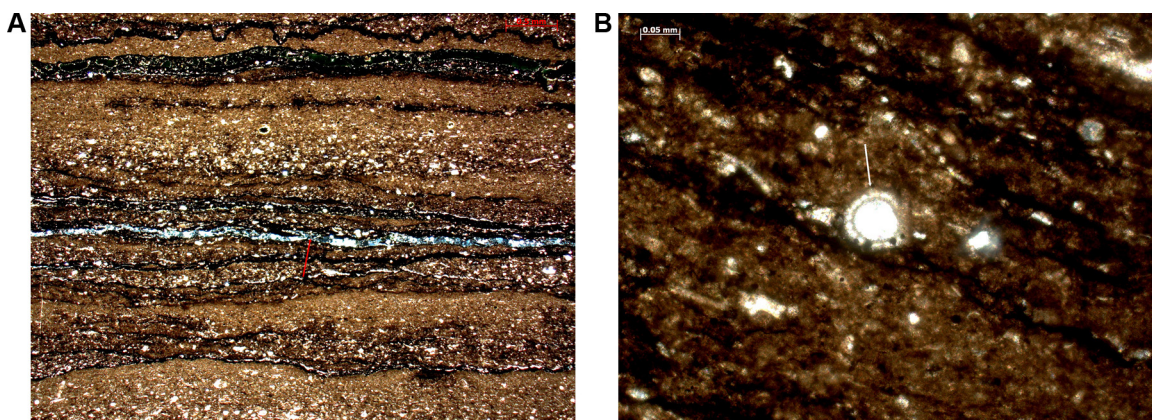
Fig. 2. Microphotographs illustrating the thin laminations and quartz layer (A) and crinoid fragments (B) typical for Tournai limestone, in a sample from the monument of Maarten Tromp.

The petrographic features of the black marble of the monument of Maarten Tromp (Fig. 2) correspond very closely to those of the Tournai limestone.

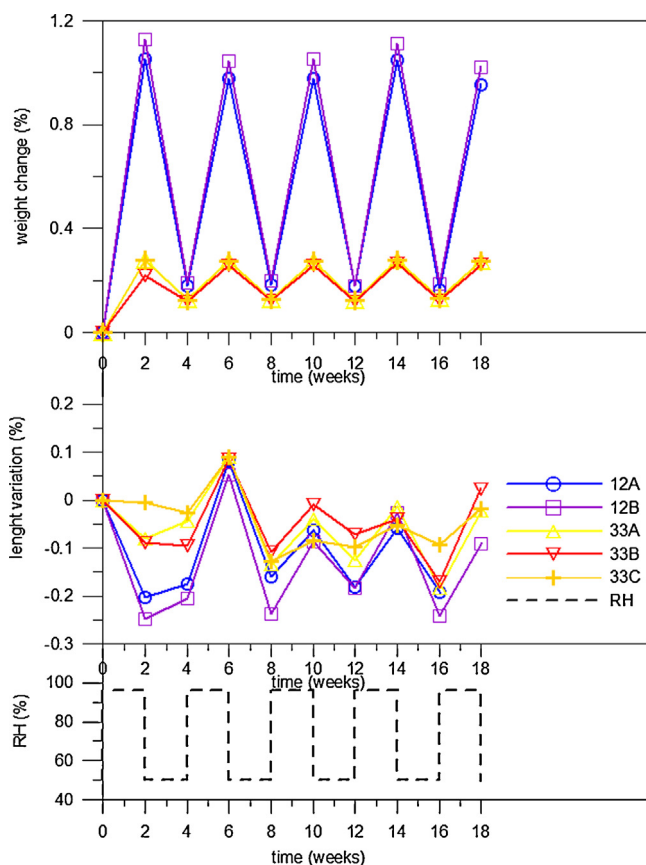
Fig. 3 reports the hygroscopic moisture uptake of Tournai limestone from the monument (samples 12A–B) and from the quarry (33A–B–C): the weight increase of the stone from the monument at high RH is about five times that of the fresh stone. This is due to the presence of hygroscopic salts (low amount of chlorides and nitrates) and gypsum (the RH of equilibrium of gypsum is about 98%, but this can be lower in the presence of NaCl [11]).

Fig. 3. Hygroscopic moisture uptake and hygric dilation of decayed Tournai limestone from the monument (12A and 12B) and of fresh stone from the quarry (33A, 33B and 33C) in response to RH changes.

The length variation of the decayed stone from the monument is only slightly larger ($\text{max} \pm 0.15\%$) than that of the fresh stone ($\text{max} \pm 0.10\%$). These values are very high for natural stone (see for example [12,13]) and can therefore be considered sufficient to cause damage.

The high hygric dilation and the only slight difference in dilation between the decayed gypsum-rich stone from the monument and fresh stone from the quarry, suggest that the combination of the high hygric dilation, possibly caused by the clay minerals present, and the naturally thin laminated structure of the stone is the main cause of the damage.

In order to limit damage development in the future, it is advised to improve the climate in the church by limiting RH changes and avoiding the occurrence of surface condensation.

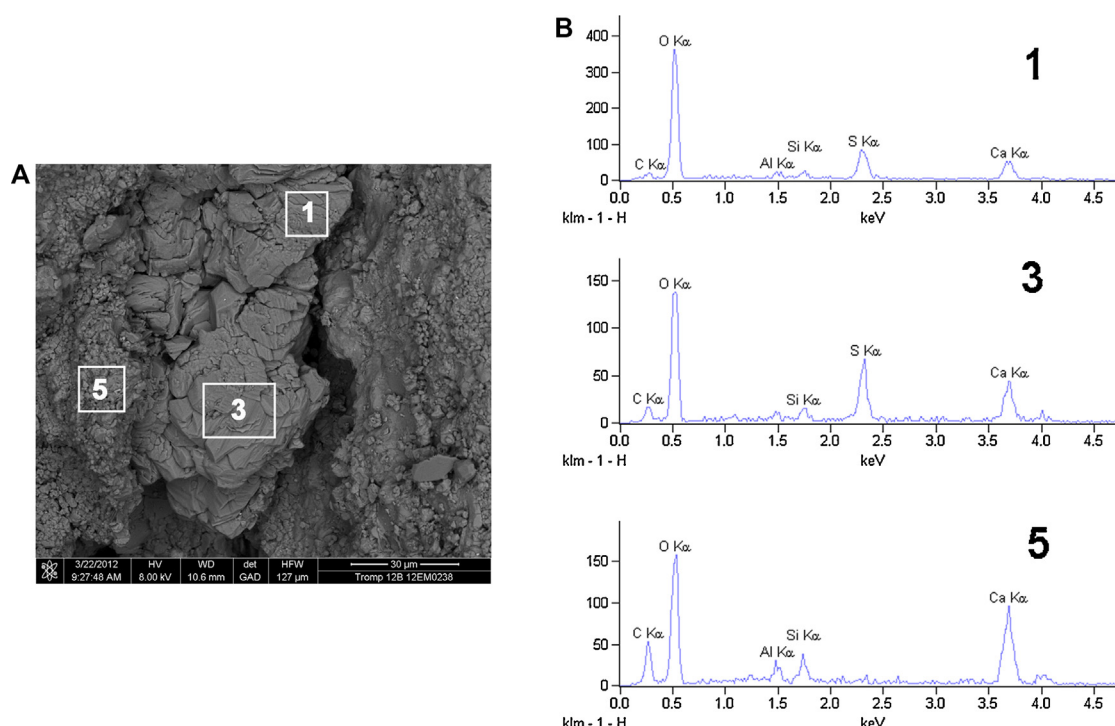
SEM-EDS observations on stone samples from the monument show the presence of cracks filled with crystals in between the natural layers of the limestone (Fig. 4). The EDS spectra measured on the crystals show the presence of Ca, S and O; these results allow to conclude that this deposit is constituted by gypsum. No gypsum has been observed in the fresh stone from the quarry. The presence of Al and Si in the matrix of the stone, combined with morphology, indicate the presence of clay minerals.

The SEM-EDS results confirm the finding of the chemical analysis and optical microscopy observations: the gypsum crystals present in the cracks are probably the result of a reaction of the calcite constituting the stone, with water and sulfur present at the surface.

Fig. 4. SEM microphotograph (GAD mode) of gypsum crystals in a crack between layers of Tournai stone from the monument (A) and EDS spectra (B) measured on areas in the stone matrix (location 5) and in the deposit in the crack (locations 1 and 3).
