## WORK ORDER/SERVICE REQUISITION FORM

Ship Name : Atlantis

WO/SR No : 0340524

Title : Replace/Repair poured deck in lower forward berthing

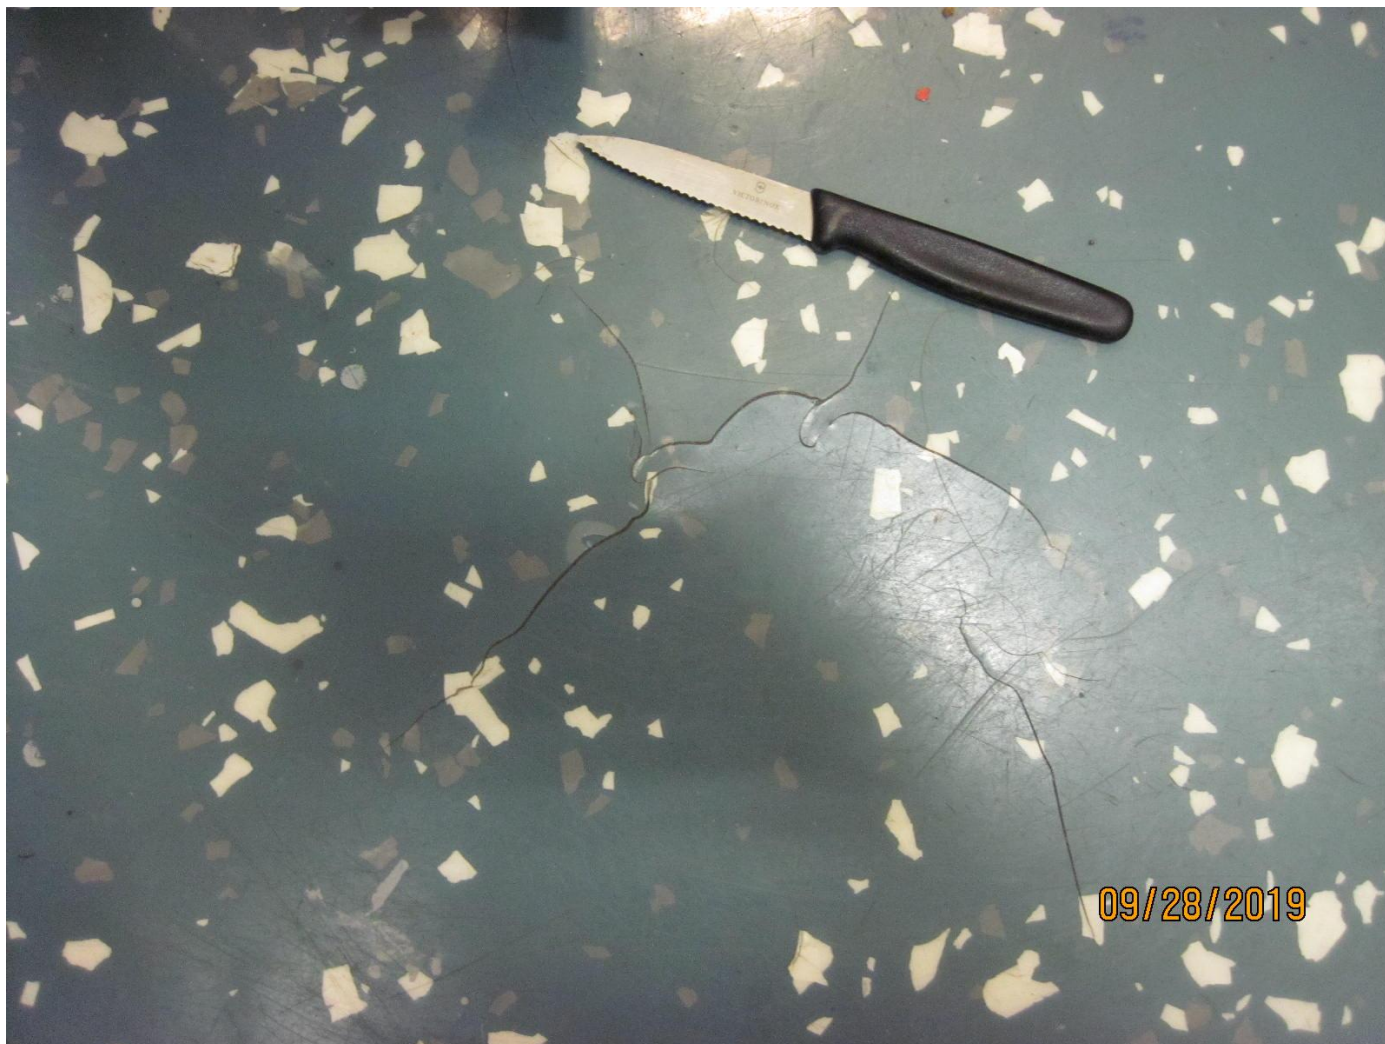
snake pit deck 1.JPG11

Replace or repair the damaged poured deck in lower forward berthing (1st platform deck berthing area forward of frame 40). In at least 3 places, the poured deck is cracked, most likely with corrosion underneath. Poured deck needs to be removed and steel deck below treated appropriately to remove rust and allow new poured deck to adhere. See attached pictures. Damage noted at bottom of ladder on either side of man door just forward of frame 40, as well as forward of cleaning gear locker. Consideration should be given to adding a poured deck to the cleaning gear locker.
