Service Report

CUSTOMER:	VESSEL/FACTORY/SITE:	DATE:
WHOI	R/V ATLANTIS	30 JUNE – 02 AUGUST 2015
LOCATION: WOODS HOLE, MA	ENGINEER/Technician	SERIAL/FILE No:
	CHUCK HOHING	118
WORKORDER / PO	ACCOUNT/PROJECT No:	SYSTEMS:
EM122 SERVICE		EM122 1X1

- EM122 TX transducer impedance testing and to investigate why TX36 boards are failing.

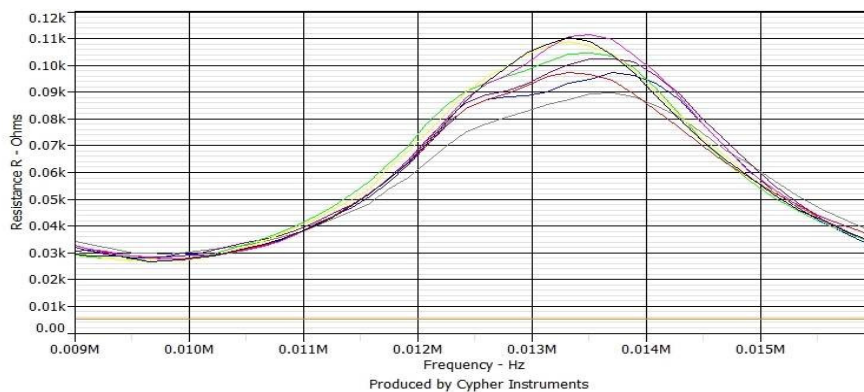
- Results of the TX transducer impedance tests.
 - TX module 13 has a single shorted channel: channel 4. This module and module 14 are connected to TX36 #7. TX36 #7 has no errors.
 - TX module 23 has 6 shorted channels: Channels 3,4,9,10,15,16. These channels all share a common ground. This module and module 24 are connected to TX36 #12. Two TX36 boards that were used in this slot now have faulty high voltage bridge 1 caused by transmitting into the shorts.

TX Module 13 with shorted channel 4

- I modified the TX beam weight files to turn off the one shorted channel in Slot 6 (actual board 7) and the six channels in Slot 11 (actual board 12). This was done by uploading the file from the TRU using FTP, modifying the file, saving it and then downloading it back to TRU. The original file and the modified file have been saved. If and when the modules get replaced then the modified file can be replaced with the original.

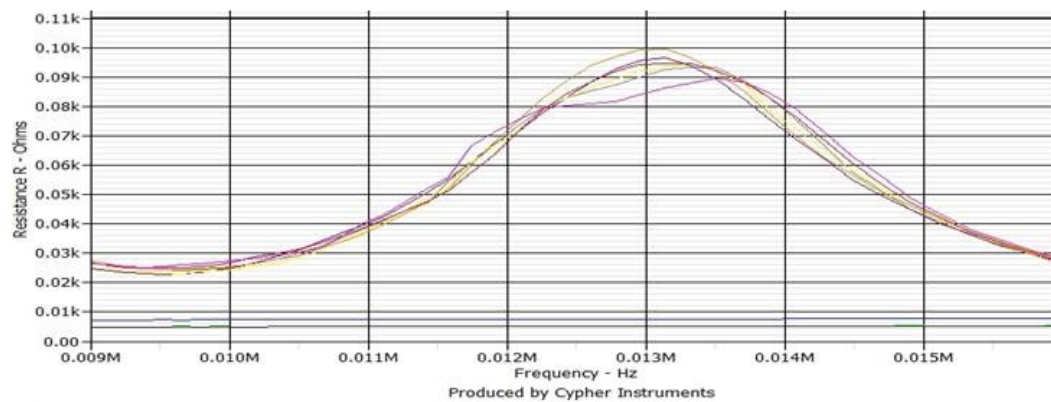
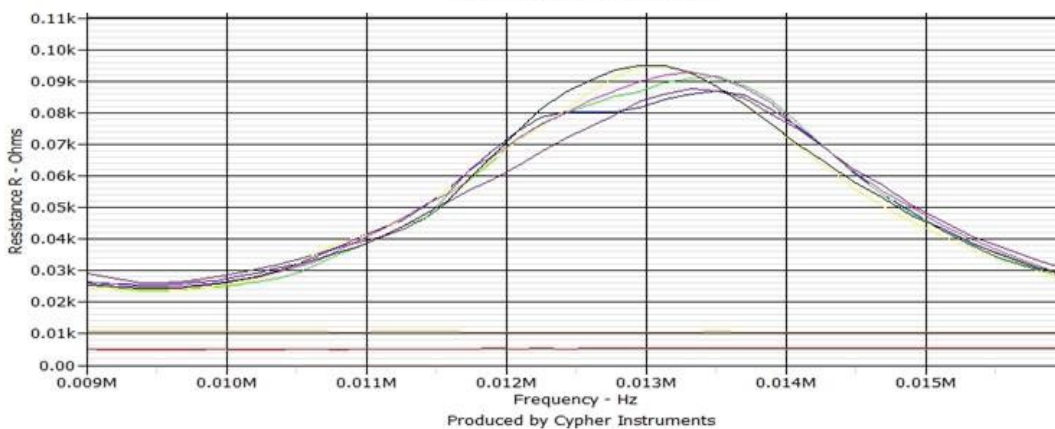
TX Module 23 with 6 shorted channels
