Multibeam Advisory Committee: Recap of investigation into Atlantis EM122 transient depth artifact

Updated 2016-10-26

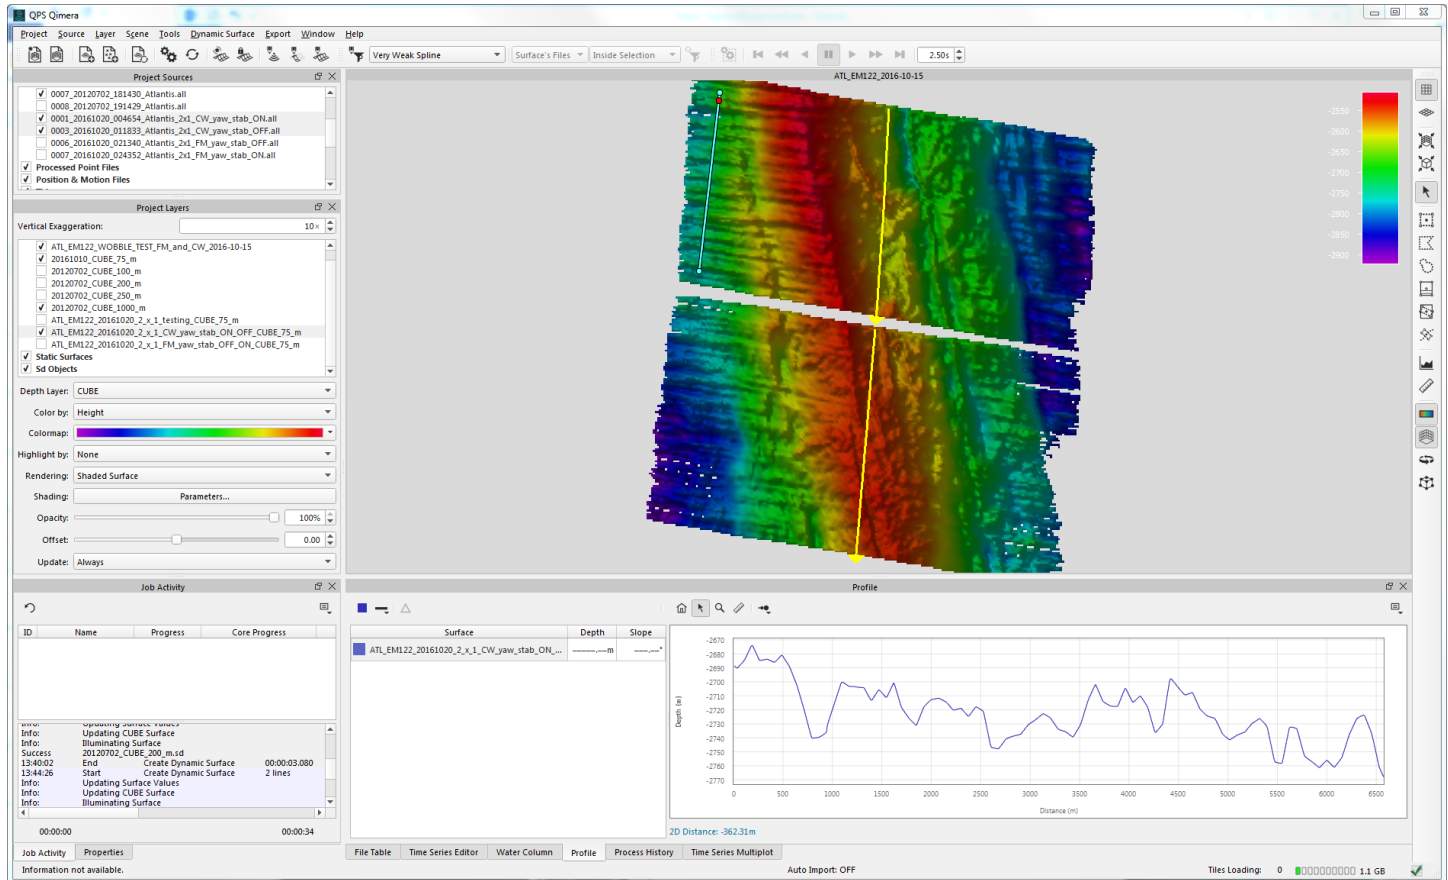
A periodic alternating deep/shallow bias extending across the swath. The surface shown below is illuminated to show the corresponding dark shadows extending across the track while the ship drives approximately south. The amplitude of the bias scales with the angle from nadir, approaching 1% of water depth on the outer beams (depth profile drawn across upper left of surface is shown in lower right window). It appears that the starboard side is generally biased shallower when the port side is deeper, and vice versa.

This artifact appears to exist in data examples going back to 2012. Its amplitude might technically be within spec for this system; however, it is a periodic, non-random bias that complicates processing and visualization. The example below exaggerates the effect visually due to shading.

This is similar to what we might see with an error in the vessel roll data, but the depth artifact does not appear to scale with roll period or amplitude. The artifact comes and goes over the course of many pings and many roll cycles (more discussion below).

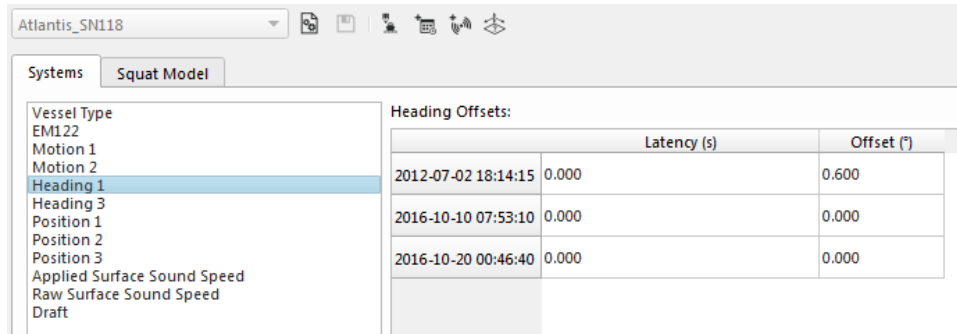
Examining data from 2012-2016 in Qimera, it is clear there was historically a 0.6 degree heading offset configured in SIS installation parameters. This is now zero in the SIS config for Motion 1 and Heading 1, as well as PHINS config for the MRU. *Clarification is needed on how and when the MRU heading offset was zeroed.*

Heading Offsets:		
	Latency (s)	Offset (°)
2012-07-02 18:14:15	0.000	0.600
2016-10-10 07:53:10	0.000	0.000
2016-10-20 00:46:40	0.000	0.000
