Subject: Fwd: Fwd: Results of electrical test of ~9km A301592 3-conductor sea cable on winch drum on dock Dec 12, 2017
From: Rick Trask <rtrask@whoi.edu>
Date: 12/26/2017 10:32 AM
To: cgriner@whoi.edu
CC: Ruthanne Molyneaux <rmolyneaux@whoi.edu>, Andrea M Harvey <aharvey@whoi.edu>

At Mike's request, I checked the electrical condition of a used 3-conductor Rochester A301592 sea cable on the drum at the west side of the dock today, to evaluate if the wire could be reliably used again.

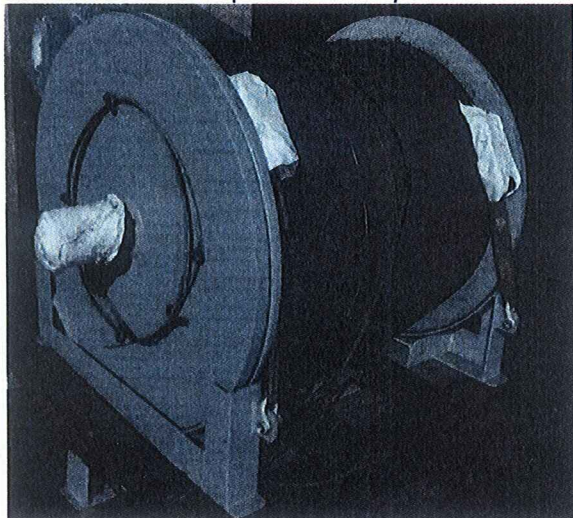
I found no markings or nameplate on the drum. See the photo below to identify the drum. Straps securing the drum were marked "Knorr".

View of A301592 cable spooled on Markey drum at West end of WHOI dock 12/12/2017.

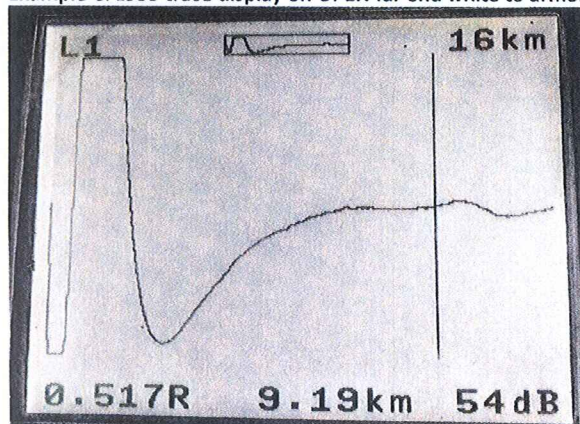
Setting the CFL535 cursor to the start of first repeatable and reliable inflection point of the trace yielded 9.2km at Vf = 0.519.

Example CFL535 trace display on OPEN far end white to armor lead pair with rising inflection at cursor:

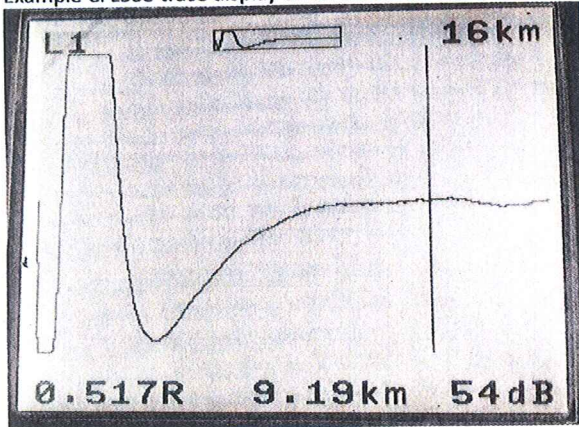
2. The two CFL535 Cable Fault Locator instruments could not reliably determine the end of the cable in automatic determination mode with either a temporary short or open condition.. Manual over-ride of the range mode had to be used. See the example trace photos below.

Example CFL535 trace display on SHORTED far end white to armor lead pair with flat inflection at cursor:
