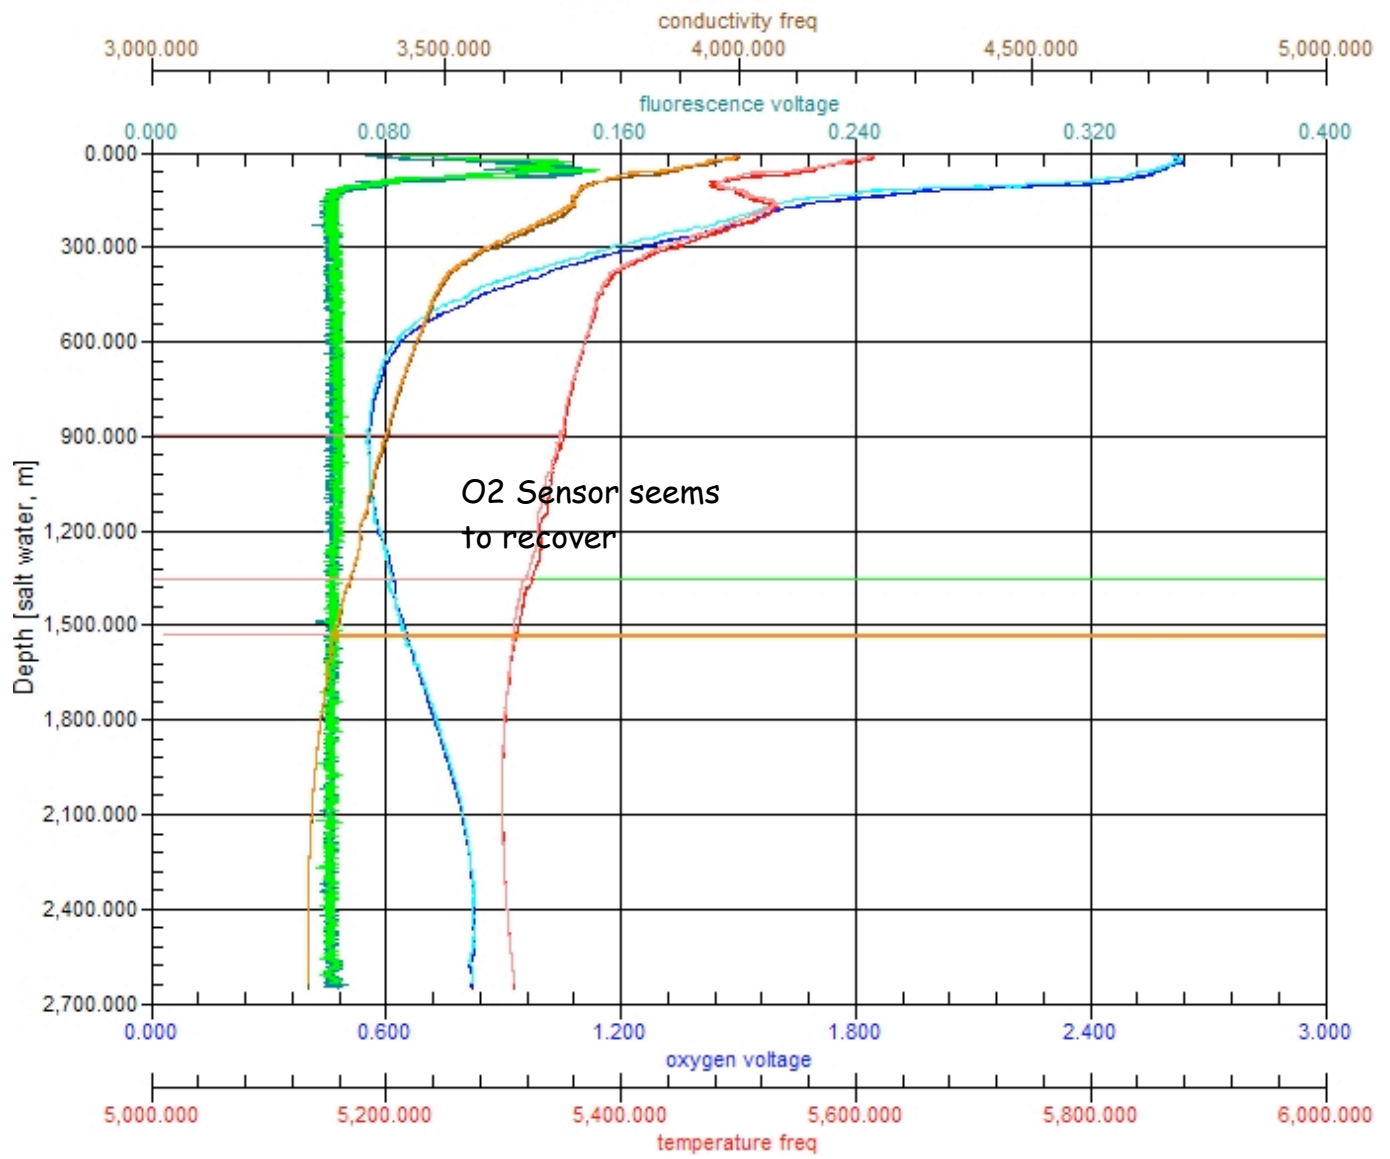
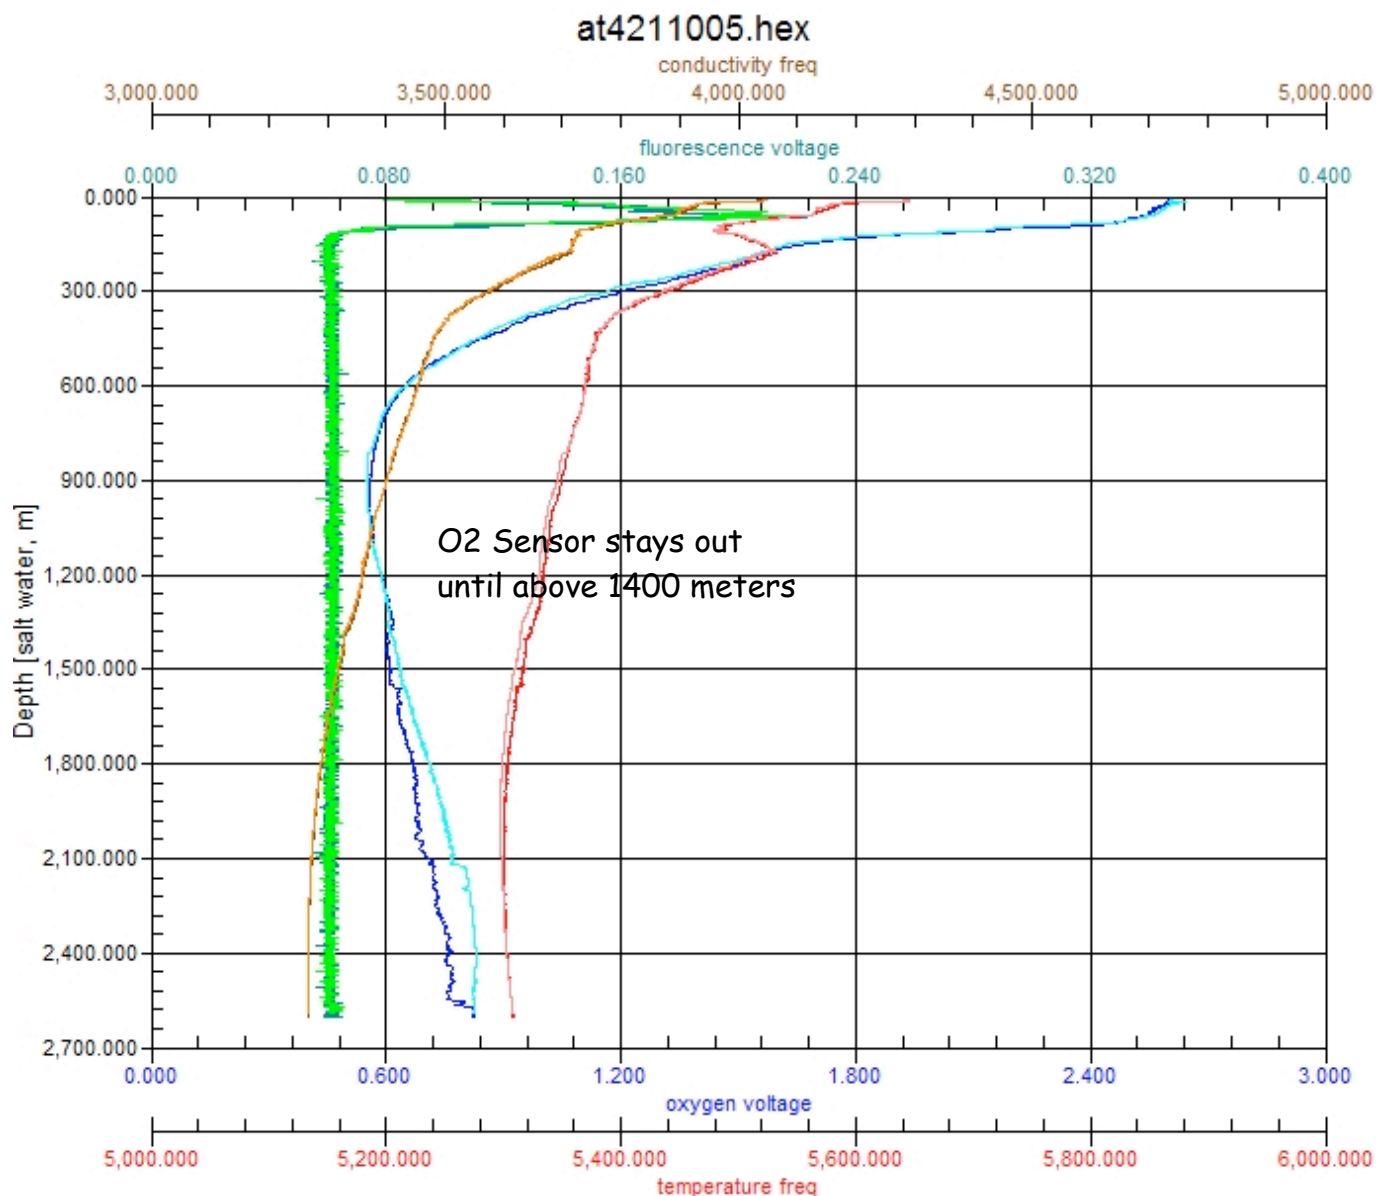
at4211003.hex

A third cast was performed. The entire downcast looked completely fine - down to 2660 meters (Upon later examination, one spiking event did occur around 1500 meters depth, but it was not reflected in the real-time data plots). On the up cast (~1550 meters) the sensors again started going crazy (O2 being the worst). Upon examining the data it could be seen that the pressure was registering obscene values (like -24433.969). Sometimes, all of the sensors followed suit and registered some type of spike at the same time. On several occasions it appeared that the sensors on v0/1 (O2) and V2/3 (Xmiss) would lead the charge – spiking first, and then most all sensors spiking on the next recorded sample time.

Oddly, the T0 sensor was affected much less often (of the 55 times that were found when almost all the sensors spiked during cast 3, the T0 sensor only spiked 9 times). In fact, out of some 223 spiking events (when almost all sensors spiked on a regular basis) the T0 sensor only spiked 17 times and 13 of those were within the first three casts. Maybe this doesn't mean anything, but here's hoping it is a clue!

After each spiking incident, most of the sensors would recover and return to a normal behavior. This was not so true of the O2 sensor.

It was discovered that the Tau & Hysteresis corrections were turned on. This really messed with the O2 sensor values during the cast (particularly the Hysteresis correction as it depends on pressure). When those were turned off, and/or just the voltage channel plotted, it could be seen that the O2 data “usually” came back to normal after the spiking events (sometimes it took a long time though).

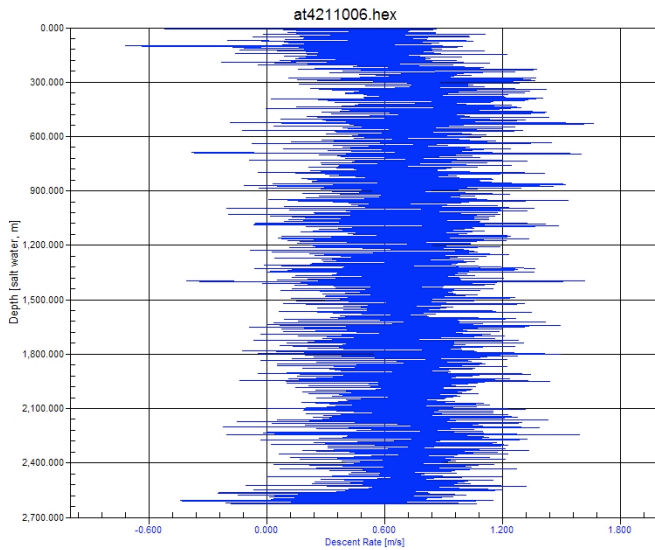
CAST 6 – Before weight added

Part of the issue seemed to be that the rosette frame was underweighted for the conditions. ~75 pounds of extra weight was added to the frame. We saw a vast improvement in the loading on the wire during the cast we just did after the weight was added. We were experiencing large sudden rolls that would pull the rosette up through the water and then when we rolled back the

other way the rosette had not been appearing to sink fast enough with the roll. I (Allison) believe that is where the kinks happened. The rosette might be at a slight angle still seemingly stationary or moving up due to momentum from the initial pull while the wire/termination are forcing downward.

Cast 6 was in slightly rougher weather, but not rougher enough to justify the move away from zero loading and the diminishment of the range of fluctuation of the descent rate.
