Analysis of photostimulable phosphor plate image artifacts in an oral and maxillofacial radiology department

Hui-Lin Chiu, BS,^a Shui-Hui Lin, BS,^a Chia-Hui Chen, BS,^a Wen-Chen Wang, DDS, MS,^b Jin-Yi Chen, DDS,^c Yuk-Kwan Chen, DDS, MS,^d and Li-Min Lin, DDS, MS, PhD,^e
Kaohsiung, Taiwan
DEPARTMENT OF ORAL AND MAXILLOFACIAL RADIOLOGY, SCHOOL OF DENTISTRY, KAOHSIUNG
MEDICAL UNIVERSITY AND HOSPITAL

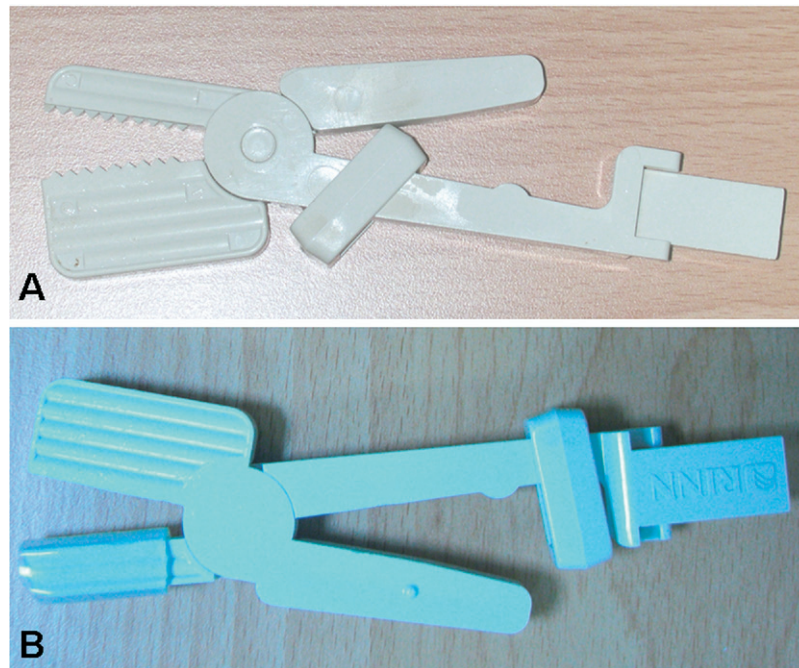
Fig. 1. **A**, The original Snap-A-Ray holding device. **B**, The modified Snap-A-Ray holding device, in which the teeth of both jaws were ground down until smooth and a plastic tube was inserted into the smaller jaw.

In the first 4 weeks of PSP digital radiography implementation, 1 intraoral PSP was accidentally lost; moreover, 12 out of the 50 new intraoral PSP needed replacing, owing to various damage sustained to the plates, such as scratches, pressure from the teeth of Snap-A-Ray intraoral positioning devices (Dentsply Rinn, Elgin, IL), or tooth marks, which would result in permanent degradation of all subsequent images. The XCP ring positioning device (Dentsply Rinn) used for intraoral paralleling of the radiographic projection did not cause damage to the sensor plates. To reduce the damage to the intraoral sensor plates, especially from the teeth of the jaws of Snap-A-Ray film holders, we searched the literature to find a potential method of overcoming this problem. Consequently, a modified clinical technique innovated by Roberts and Mol¹¹ (2004) was adopted. Briefly, the teeth from both sides of the jaws were removed with an acrylic bur and polished. An autoclavable 3/8-inch inside dimension vinyl tubing was cut to length and inserted over the smaller jaw (Fig. 1). Furthermore, to avoid the risk of tooth marks indenting the PSPs in occlusal image taking, we placed 2 double-sided pieces of tape (2–3-mm in thickness, 5–6 cm in length; 3M Co., St. Paul, MN) on the disposable covering of a size 4 sensor plate (one on each side).

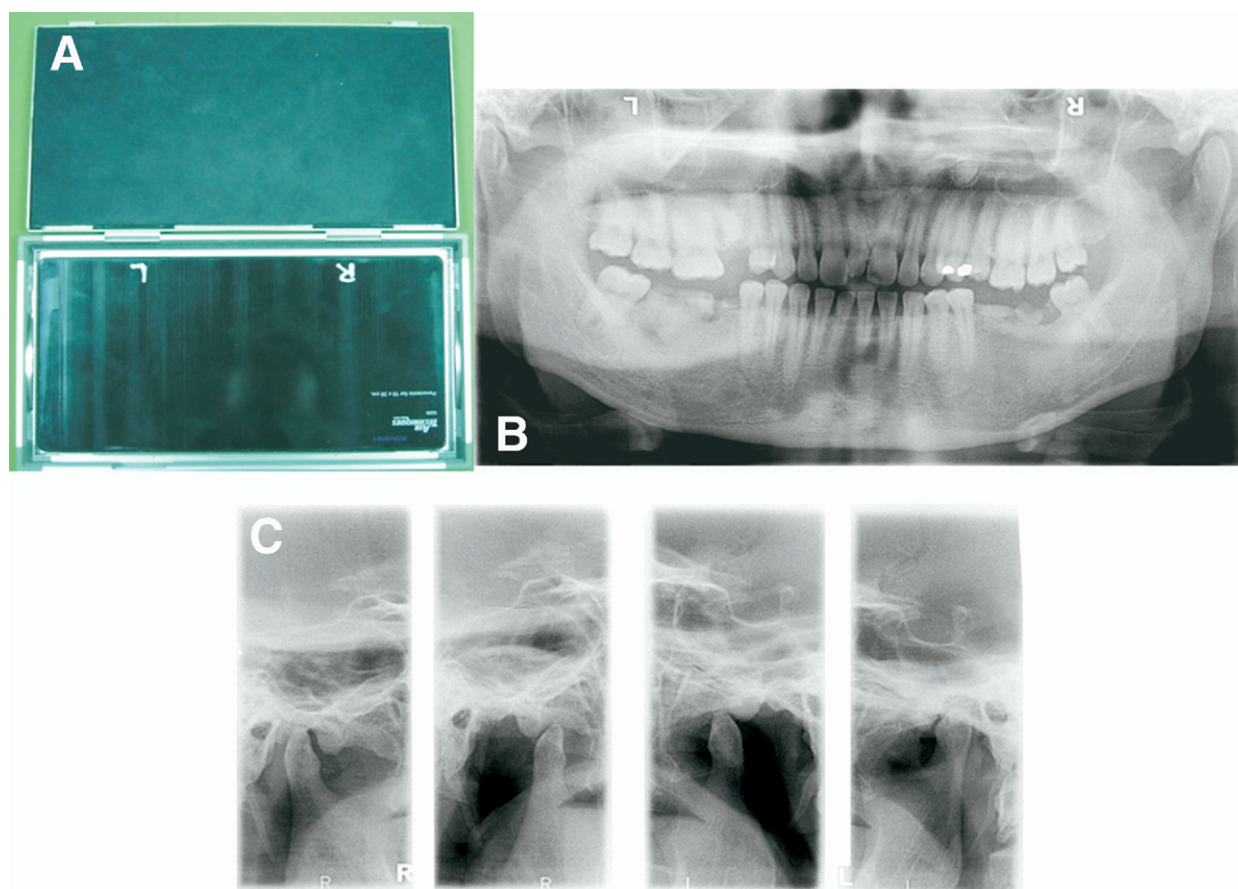
Fig. 2. **A**, The sensor plate incorrectly placed upside down within the panorex cassette, with a resultant image (**B**) in which it is difficult to determine the actual “right” or “left” side. **C**, An inclined image resulting from an incorrect inclination of the extraoral sensor plate during the scanning process.

Some image artifacts such as error item 6 of the operator errors were unique to the A/T ScanX system (Table I; Fig. 2, C), because the x-ray–exposed surface of the sensor plates in this system needed to be pressed horizontally with both hands against the wall of the scanner to induce the scanning motion. Therefore, there was a possibility that inexperienced operators pressed the sensor plate incorrectly, causing it to incline to one side. Fortunately, such artifacts did not affect the quality of the image in terms of clinical evaluation. Also, as the markers “R (right)” and “L (left)” on the extraoral sensor plate were manufacturer made, error item 4 (Table I; Fig. 2, A and B) might be unique to the A/T ScanX system and there would be some confusion in determining the actual “right (R)” and “left (L)” side of the resulting images. In the 2 occasions of error item 9,

image could not be rescued when this kind of artifact occurred in film-based radiography, and the image had to be retaken. However, should this event happen in PSP digital radiography, the resultant image can easily be remedied by using the “mirror” function in the image acquisition software that accompanies the system.

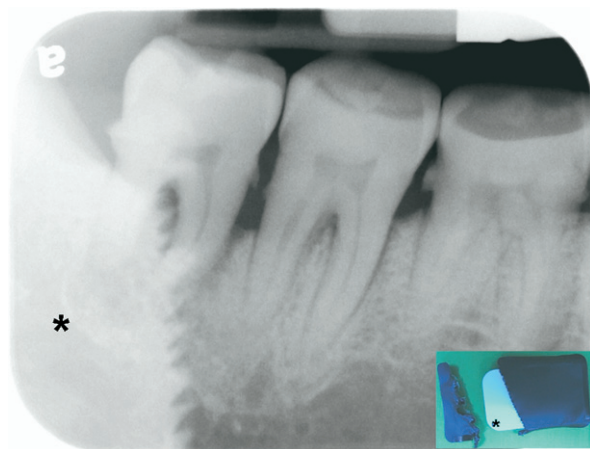
Fig. 3. Image is too bright where indicated by the asterisk; this resulted from delayed scanning of an intraoral sensor plate. **Inset**, the original situation in which the barrier envelope was torn off but the partially exposed area (indicated by the asterisk) of the intraoral sensor plate was exposed to room light for more than 10 min.

image scanning of the intraoral sensor plates was delayed by careless operators who had already torn off the barrier envelopes but left the partially exposed sensor plates on the shelf for more than 10 min while the imaging of other patients was completed (Table I; Fig. 3). Indeed, all of these operator errors could have been minimized to almost zero through sufficient radiographic technique training.

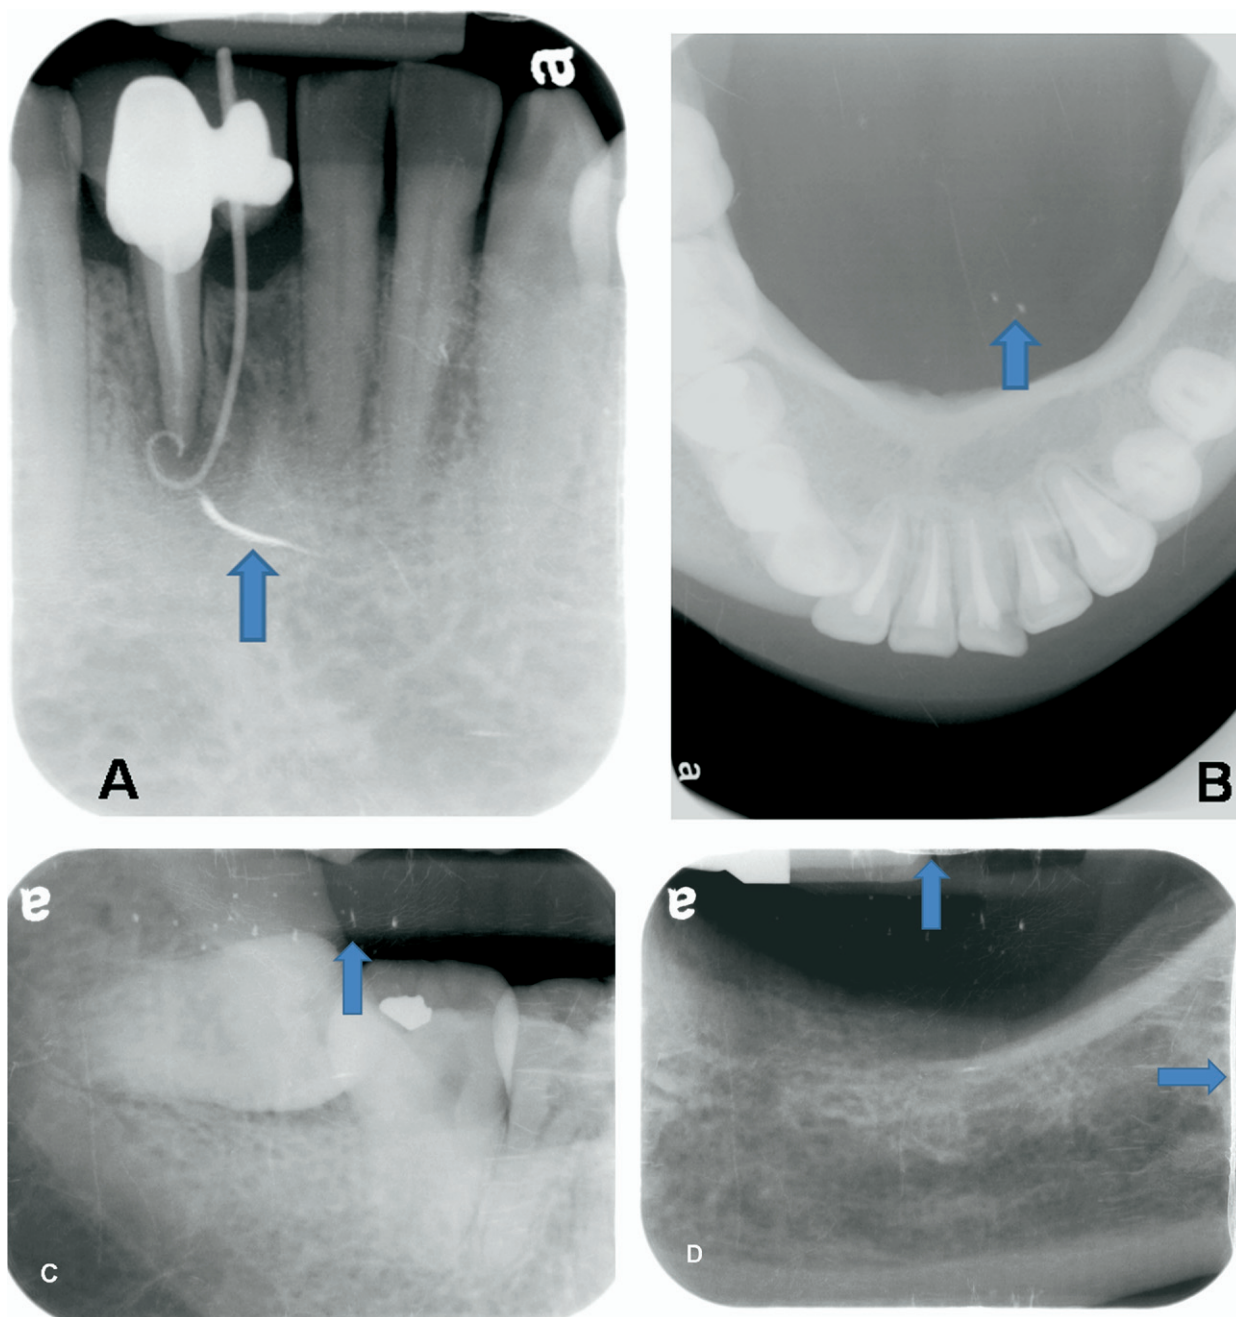
It is worth noting that the image artifacts that occurred owing to sensor errors were irreversible and the need to retake the image unavoidable, because the quality of the generated images usually affected clinical evaluation (Table III; Fig. 4). Also, significantly, such kinds of image artifacts could be critical, as demonstrated in Fig. 4, B, in which the image artifacts of 2 radiopaque shadows could have been misdiagnosed as

Fig. 4. **A**, A periapical image resulting from a scratched sensor plate, as indicated by the arrow. **B**, A defective occlusal image due to a tooth mark, as shown by the arrow. **C**, A defective image resulting from a sensor plate damaged by the teeth of the jaws of a Snap-A-Ray holder, as indicated by the arrow. **D**, A defective image resulting from the partial peeling of the coating of an intraoral sensor plate, indicated by the arrows.

salivary calculi of the mouth floor by inexperienced practitioners. This situation could cause a legal issue to arise, as most recently described by MacDonald-Jankowski.¹⁴

Item no.	Sensor defect	n (%)
1	Defective image resulting from sensor plate damaged by scratches or bite mark (Fig. 4, A and B)	32 (53.34)
2	Defective image resulting from sensor plate damaged by teeth of the jaws of a Snap-A-Ray (Fig. 4, C)	20 (33.33)
3	Defective image resulting from partial peeling of the coating of the intraoral sensor plate (Fig. 4, D)	8 (13.33)
	Total	60 (100)

Significantly, the coating of 4 intraoral PSPs suffered from a partial peeling off from the periphery (Fig. 4, D), which might be due to the plastic barrier envelopes possibly not providing perfect protection of the PSP plates from the potentially harmful effects of contamination with saliva during multiple placements of the plates within the oral cavity. Further studies concerning this issue are needed.

technique introduced by Roberts and Mol¹¹ (2004), as well as our own technique, the longevity of the intraoral sensor plates were dramatically lengthened.
