Motorcoach Roadway Departure
and Overturn on Interstate 95
Near Doswell, Virginia
May 31, 2011

NTSB/HAR-12/02
PB2012-916202

Highway Accident Report

Motorcoach Roadway Departure and Overturn on Interstate 95
Near Doswell, Virginia
May 31, 2011

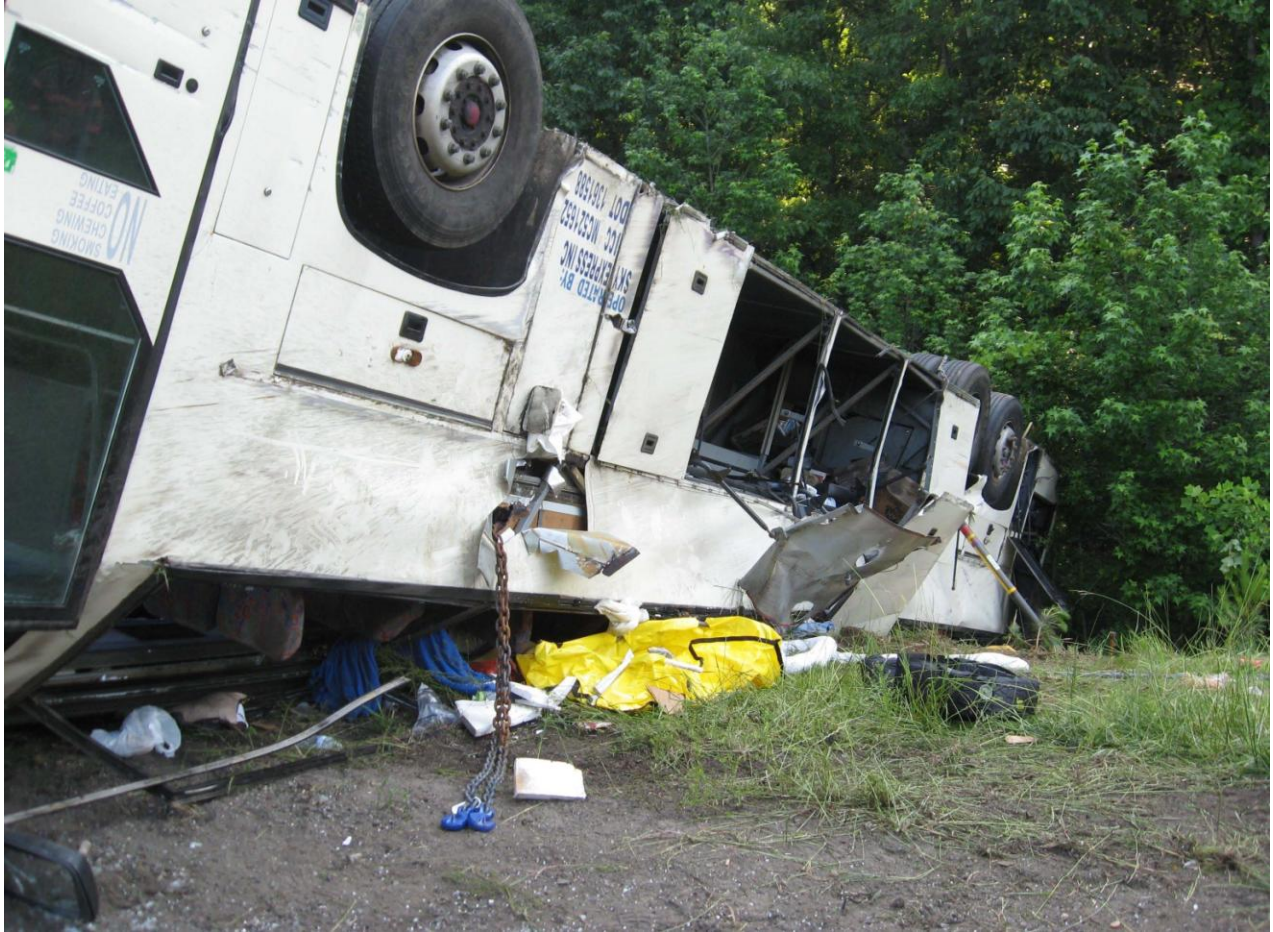
The motorcoach's impact with the low-tension cable barrier system caused a 6-foot cable deflection and displaced 21 cable posts. The maximum cable deflection occurred 273 feet from the location at which the motorcoach drifted from the road. Based on the ground scar evidence, investigators believe that, after striking the barrier, the motorcoach traveled several feet along the barrier while rotating counterclockwise (so its front was turning back toward the road) before overturning onto its passenger side, sliding, overturning onto its roof, and coming to final rest on its roof about 460 feet from where it left the roadway. (See figures 1, 2, and 3.)

Figure 1. View facing the passenger side of the overturned motorcoach at the accident scene. The front of the bus is to the left side of the photograph. (Photograph courtesy of the Federal Motor Carrier Safety Administration.)

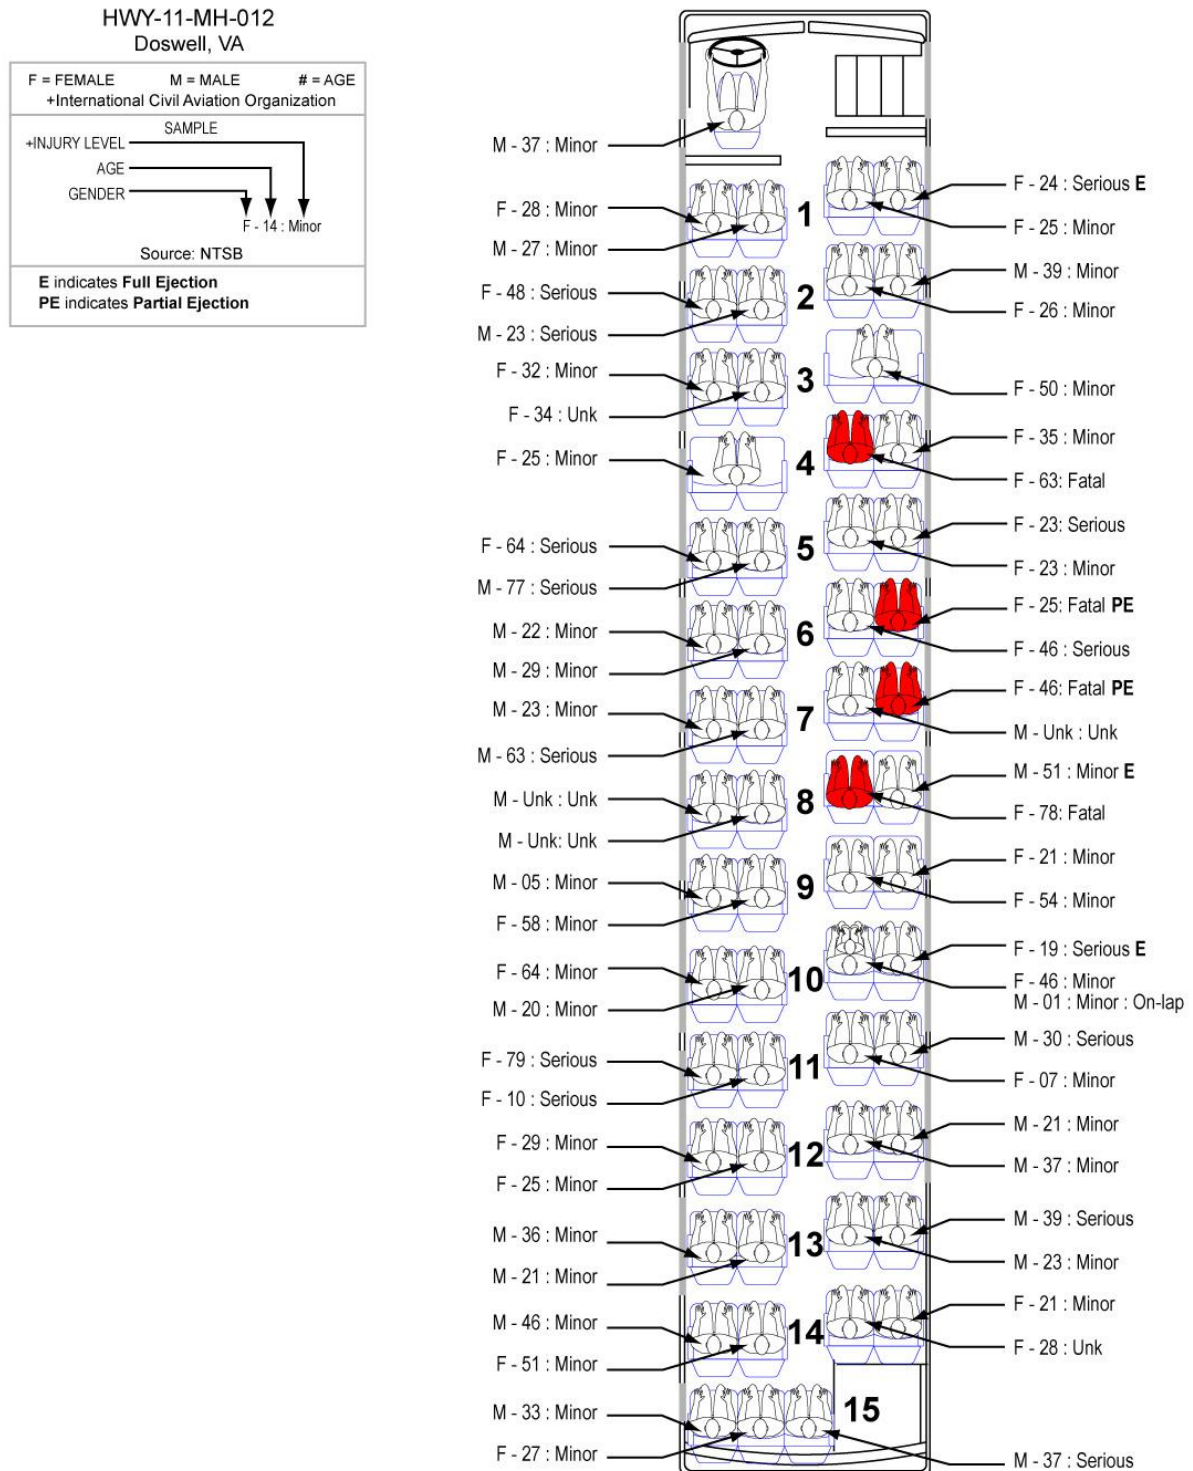
Through passenger interviews, investigators determined that three passengers were fully ejected.¹² Two other passengers were found partially ejected; they were fatalities. All five of these passengers were seated in window seats on the passenger side of the motorcoach.

Figure 4. Motorcoach occupant diagram, showing seating location, injury, and ejection information.

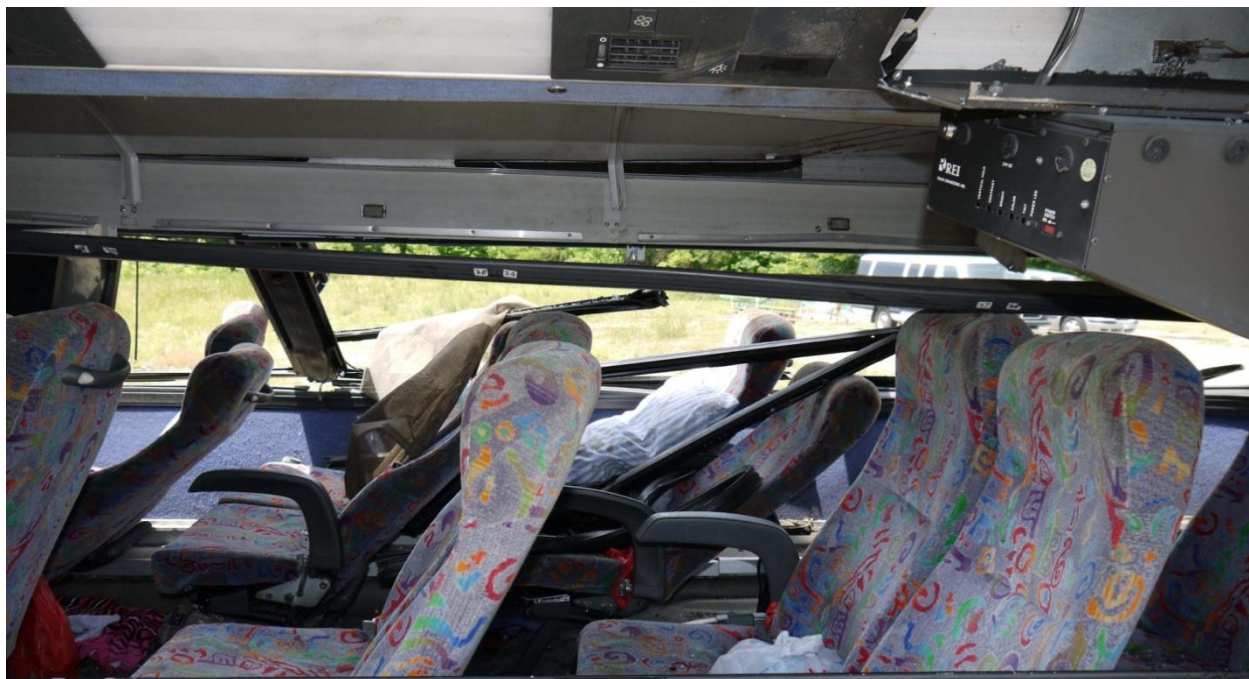
The roof of the accident bus was deformed laterally toward the driver side of the vehicle and displaced vertically toward the tops of the seatbacks. In the center of the bus, in the area of maximum roof crush, the interior luggage rack and bus roof were resting on top of the seats. Due to the roof crush, the bottom panel of the overhead luggage rack on the passenger side fractured away from the roof mountings and rested on top of the seatbacks, angling from row 3 on the passenger side to row 10 on the driver side.

Figure 5. Passenger seats in rows 6 to 8 of the motorcoach after the vehicle was righted following the accident, showing the extent of the roof crush. (Note: The maximum roof crush, or roof deformation, was greater than seen here. It is common for a vehicle structure to “spring back” somewhat after an impact.)

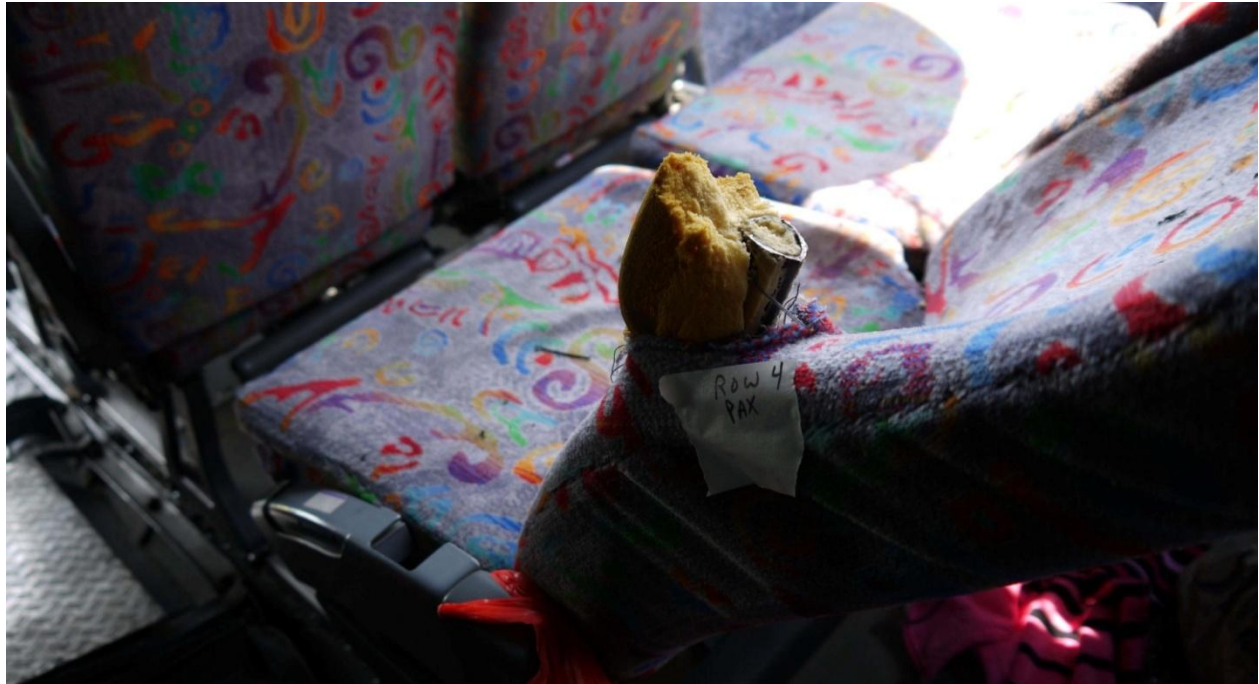
Figure 6. Damage to the aisle seat in row 4 on the passenger side of the motorcoach, showing that the collapse of the roof was so forceful it broke the seat structure.

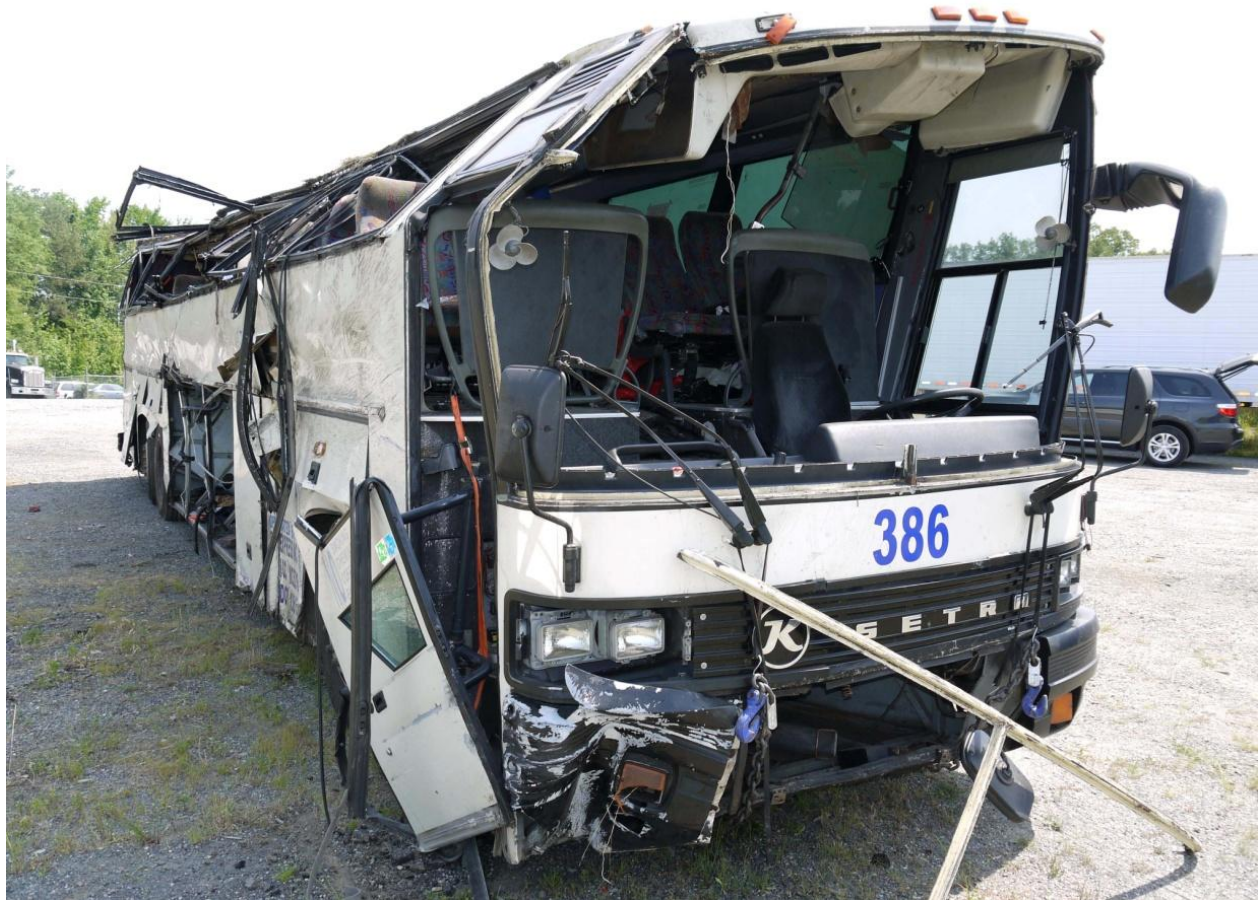
The accident bus was damaged over the extent of its front and passenger side; it also had significant roof deformation as a result of the rollover. The vehicle's initial impact with the three-strand cable barrier resulted in damage to the front end and passenger side. The direct contact damage extended from the vehicle's passenger-side front bumper corner to and along its passenger side. The approximate maximum crush to the bumper was 15.5 inches aft. Two deep parallel gouges, spaced 3 inches apart and measuring 129 inches long, were located on the passenger side of the bus, oriented at an angle of about 15 to 17 degrees counterclockwise from horizontal. Three external luggage bay compartment doors were detached from the passenger side of the bus. The boarding door located at the front passenger side of the bus retained only its bottom half; it also was only partially attached and hanging from the door frame. The rear and driver side of the bus had less damage, showing some body cracks and deformation induced from the damage to the side of the bus body. (See figure 7.)

Figure 7. Motorcoach postaccident, showing overall accident damage.

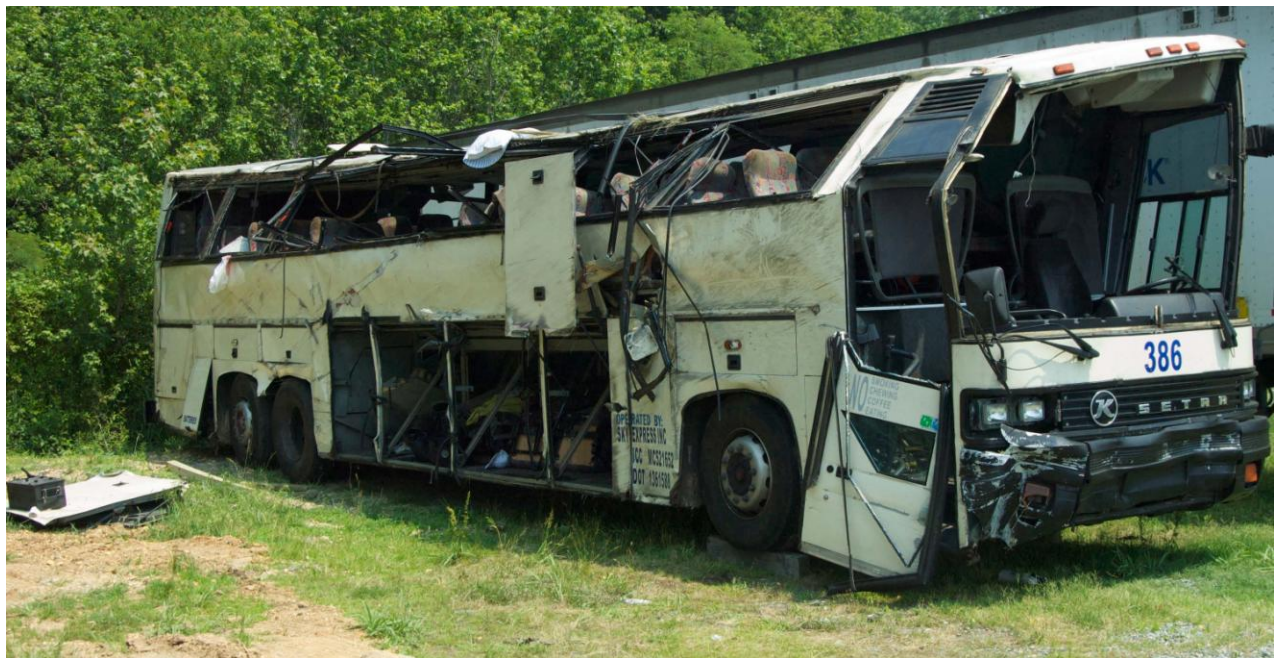
All windshield glazing, the upper boarding door glazing, and all passenger window glazing on the passenger side of the motorcoach were missing.¹³ The glazing from three of the seven passenger windows on the driver side of the vehicle was also missing. The driver's side window glazing was intact, and the window was found partially open at the time of initial postaccident inspection. (See figures 8 and 9 for additional damage information.)

Figure 9. Damage to the passenger side of the motorcoach.
