UAV-aided bridge inspection protocol through machine learning with improved visibility images

Euiseok Jeong^{a,2}, Junwon Seo^{b,1,*}, James P. Wacker^c

ABSTRACT

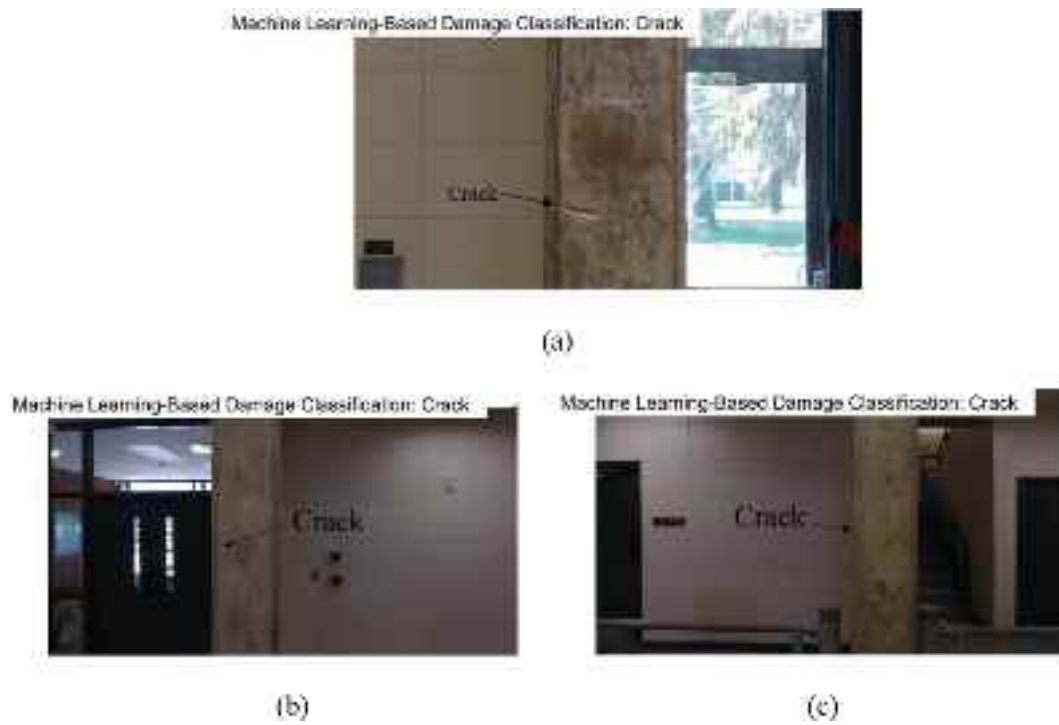
Fig. 4. Damage classification using CNN-based machine learning: (a) column A; (b) column B; and (c) column C.

In the first indoor inspection, UAVs captured 24,867 images of columns A through C in Animal Science Arena to identify any damage as displayed in Fig. 3. The images of the columns were examined in detail and a total of three noticeable cracks were visually observed on columns A through C. The damage classification using CNN-based machine learning coupled with the Residual Networks having 50 layers through MATLAB, 2020 was made as shown in Fig. 4 for three cracks on each of the columns.

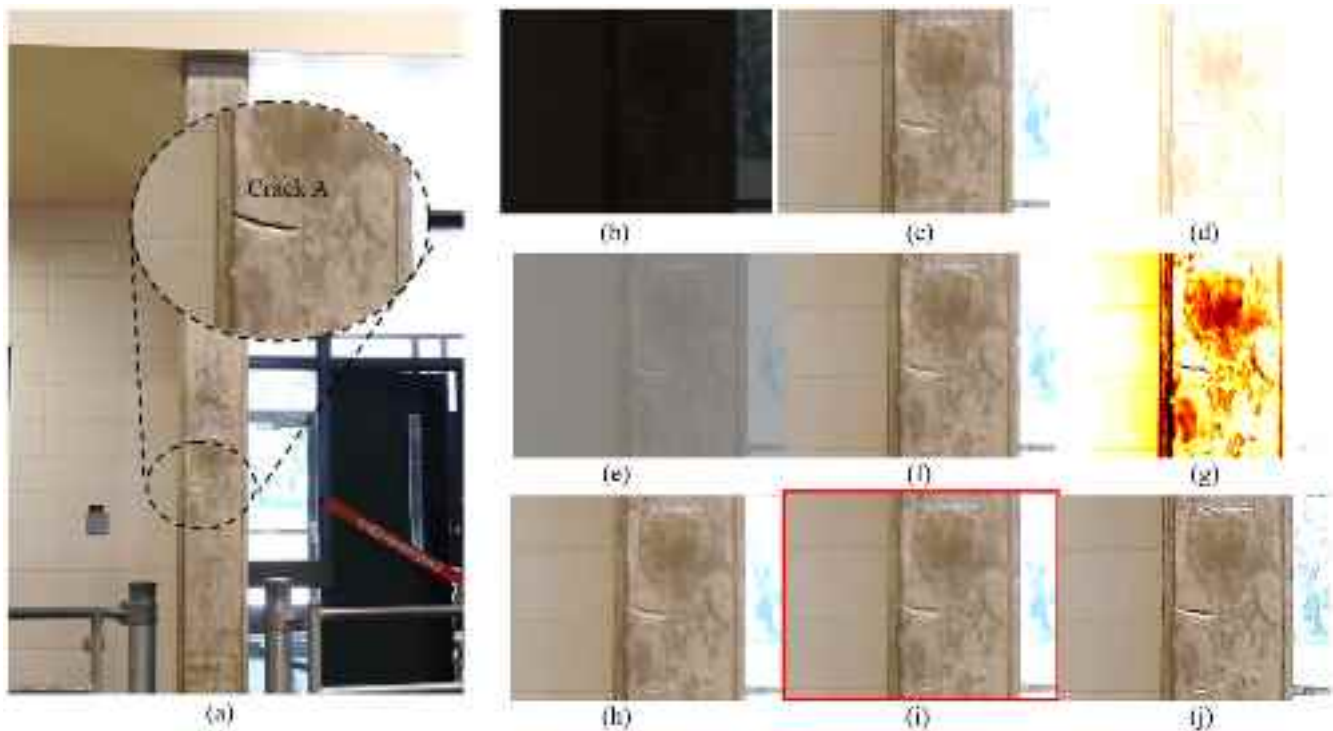
Fig. 6. Variation of images adjusted with brightness, contrast, and sharpness: (a) unfiltered crack image on column A; (b) filtered image with brightness -75% ; (c) filtered image with brightness 30% (optimization for brightness); (d) filtered image with brightness 70% ; (e) Fig. 6c adjusted with contrast -75% ; (f) Fig. 6c adjusted with contrast 0% (optimization for brightness and contrast); (g) Fig. 6c adjusted with contrast 90% ; (h) Fig. 6f adjusted with sharpness -25% ; (i) Fig. 6f adjusted with sharpness 40% (optimization for all image properties); and (j) Fig. 6f adjusted sharpness 90% .

The trial-and-error evaluation with brightness, contrast, and sharpness adjustment can be done with the unfiltered UAV images to identify the improved visibility image called “an optimized image” as shown in Fig. 6. Fig. 6a shows the unfiltered UAV image of crack on column A. Image properties (i.e., brightness, contrast, and sharpness) can be adjusted from -100% to 100% with its initial value being 0% . For instance, when the brightness of the UAV image was adjusted between -100% to -80% , the crack was not identified due to darkness under the brightness of -75% as shown in Fig. 6b. The crack was also not observed when the brightness of the UAV image was adjusted between 90% and 100% due to overexposure. The crack (refer to Fig. 6c) was observed clearly when the brightness was adjusted between 30% and 50% , whereas the error of damage quantification was found to be 0.53% deemed as the least value when the UAV image was adjusted with 40% brightness (green circle) as displayed in Fig. 5a. With the improved visibility image adjusted with brightness, contrast adjustment was also conducted as depicted in Fig. 5b. The UAV image with 0% contrast showed the lowest percentage error (green circle) against direct measurement and was considered the contrast-based improved visibility image (see Fig. 6f). The sharpness of Fig. 6f was further adjusted to obtain the optimized image as shown in Fig. 5c. The UAV image adjusted with 40% sharpness showed the optimized image through this procedure as displayed in Fig. 6i.

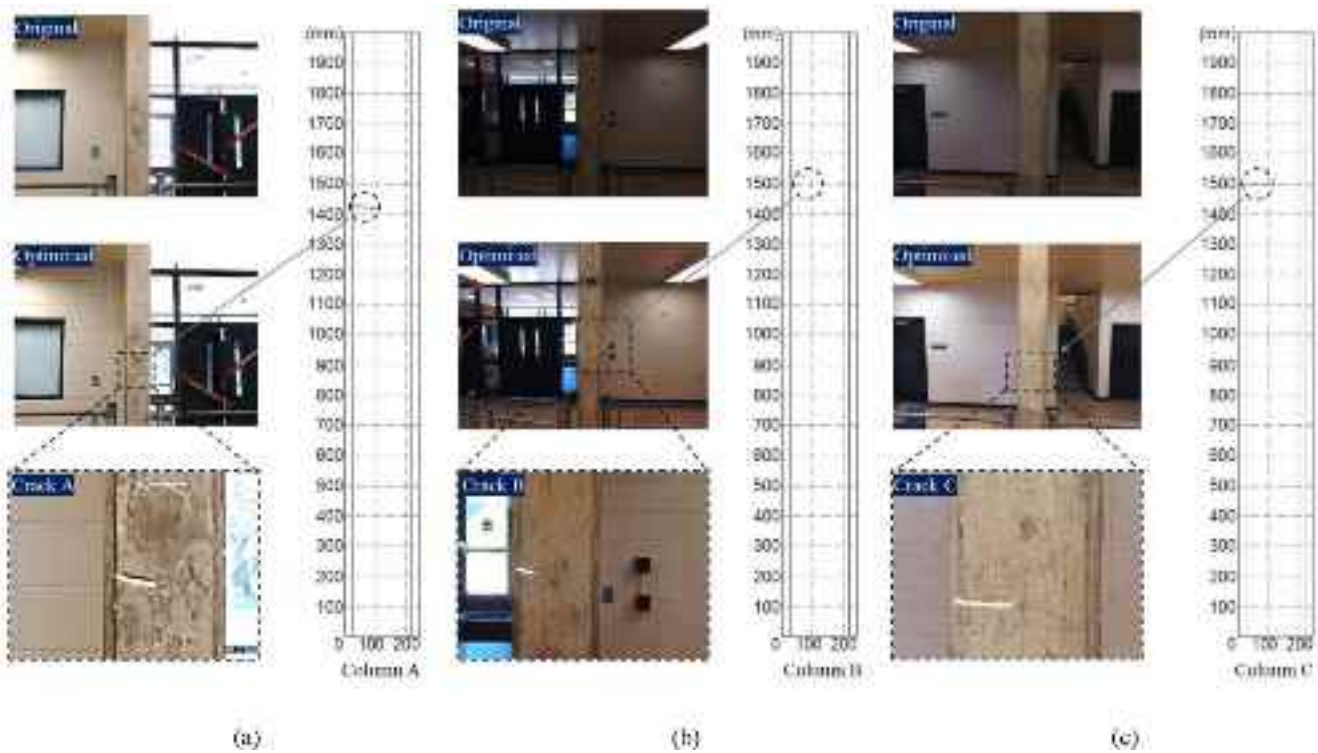
Fig. 7. Visual damage maps: (a) column A; (b) column B; and (c) column C.

Fig. 7a, b, and c show the unfiltered UAV inspection images, the optimized images, and corresponding damage maps for columns A, B, and C cracks, respectively. The unfiltered UAV inspection images are shown in Fig. 7a through 7c at the top left for each. After the image visibility improvement technique with the adjustment of image properties was applied to all the images to each of the columns, the following optimized inspection images were obtained: 1) column A crack image with the brightness of 30% , contrast of 0% , and sharpness of 40% ; 2) column B crack image with the brightness of 40% , contrast of 20% , and sharpness of 40% ; and 3) column C crack image with the brightness of 30% , contrast of 10% , and sharpness of 20% . To better observe damage, the magnified images for each crack are provided as well in these

figures. From the damage quantification with the optimized images, an average error of 2.56% of image analysis-based measurement was calculated against the direct measurement of the crack length of column A, B, and C cracks.

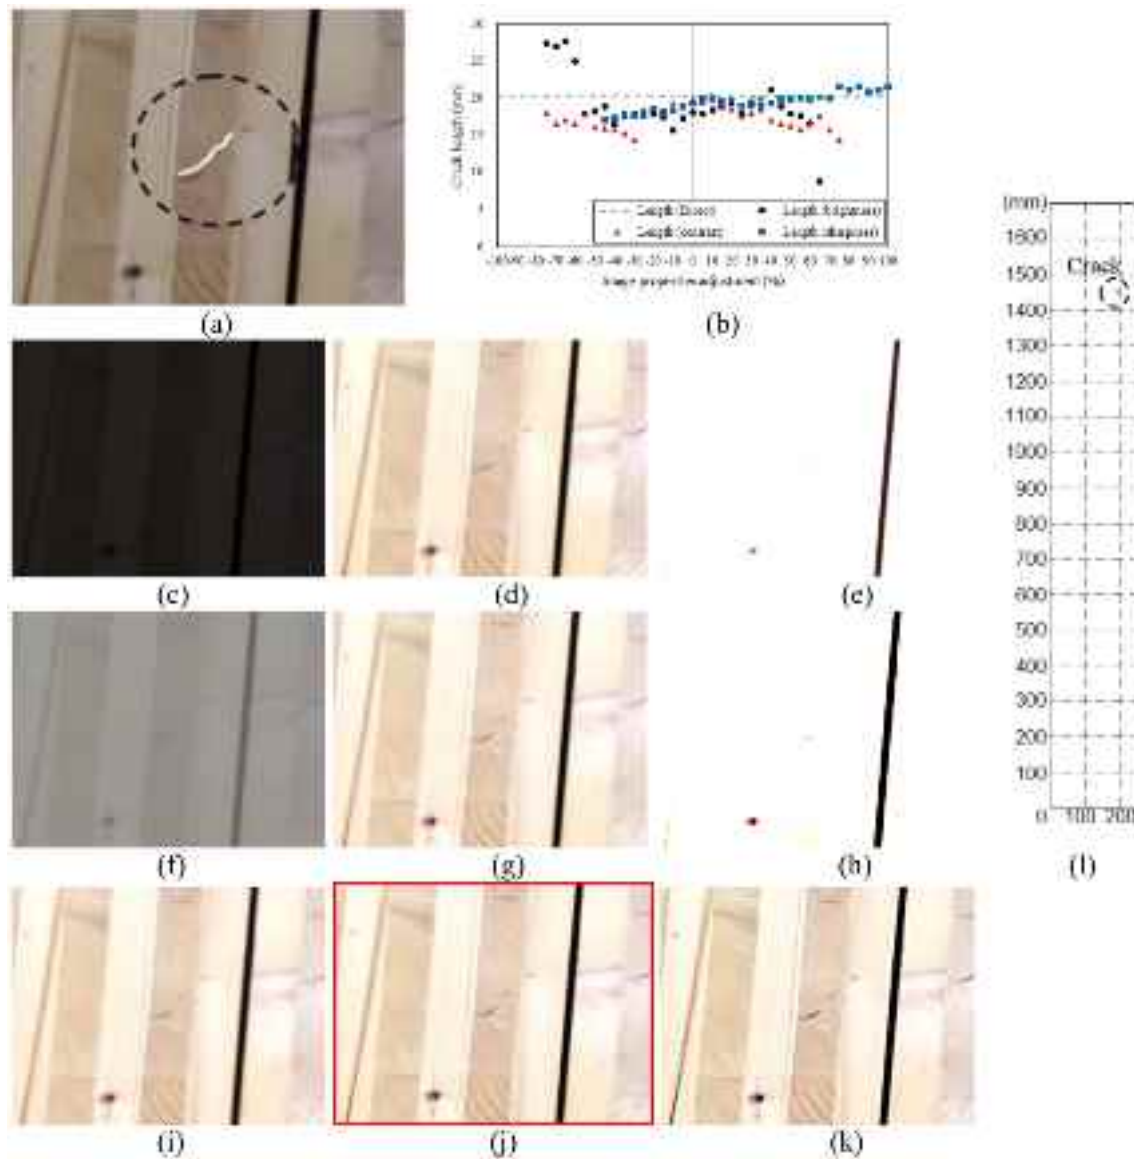
Fig. 9. Variation of images adjusted with brightness, contrast, and sharpness: (a) unfiltered crack image on CLT beam; (b) variation in crack size corresponding to brightness, contrast, and sharpness; (c) filtered image with brightness -75% ; (d) filtered image with brightness 35% (optimization for brightness); (e) filtered image with brightness 65% ; (f) Fig. 9c adjusted with contrast -80% ; (g) Fig. 9c adjusted with contrast 10% (optimization for brightness and contrast); (h) Fig. 9c adjusted with contrast 80% ; (i) Fig. 9f adjusted with sharpness -50% ; (j) Fig. 9f adjusted with sharpness 65% (optimization for all image properties); (k) Fig. 9f adjusted with sharpness 100% ; and (l) visual damage map for CLT beam.

Again, Fig. 9c through 9k show the images according to the adjustment of brightness, contrast, and sharpness. The effect of brightness in the image is observed in Fig. 9c through 9e, and Fig. 9d shows the optimized image adjusted with the brightness of 35% . The crack was not observed in Fig. 9d and f due to darkness and over-illumination, respectively. With Fig. 9d, contrast adjustment was performed as displayed in Fig. 9f through 9h. During the contrast adjustment, the contrast of 10% (see Fig. 9f) exhibited the lowest error against direct measurement as shown in Fig. 9b, whereas the crack was not observed visually in Fig. 9f and h due to inappropriate contrast adjustment. Finally, with Fig. 9g, the optimized image was obtained by adjusting the sharpness to 65% as shown in Fig. 9j. As Fig. 9i adjusted with the sharpness of -50% has unclear crack edges, this figure is improper for this image visibility improvement technique. On the other hand, Fig. 9k that was adjusted with the sharpness of 100% shows the crack clearly, but other edges are not clear due to over contrast. Using the optimized

image, the damage quantification that was performed revealed an average error of 5.47% against direct measurement, and a corresponding damage map was created as shown in Fig. 9l.

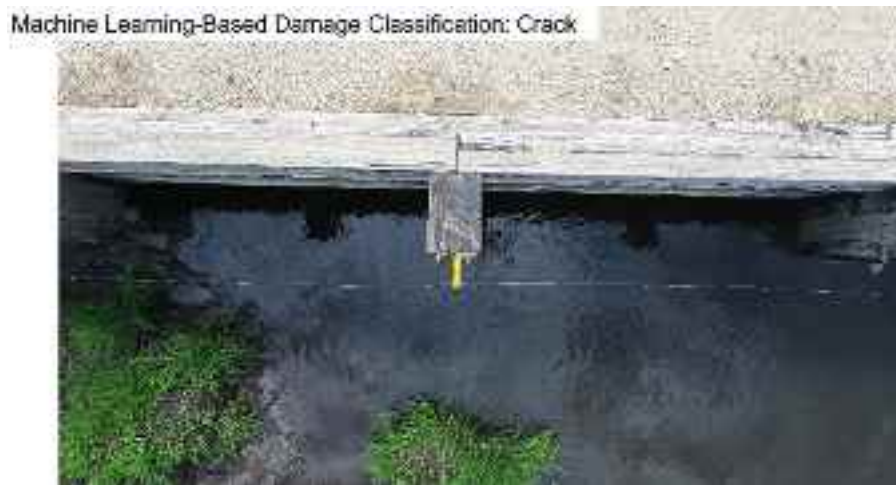
Fig. 12. Representative damage image showing damage classification result.

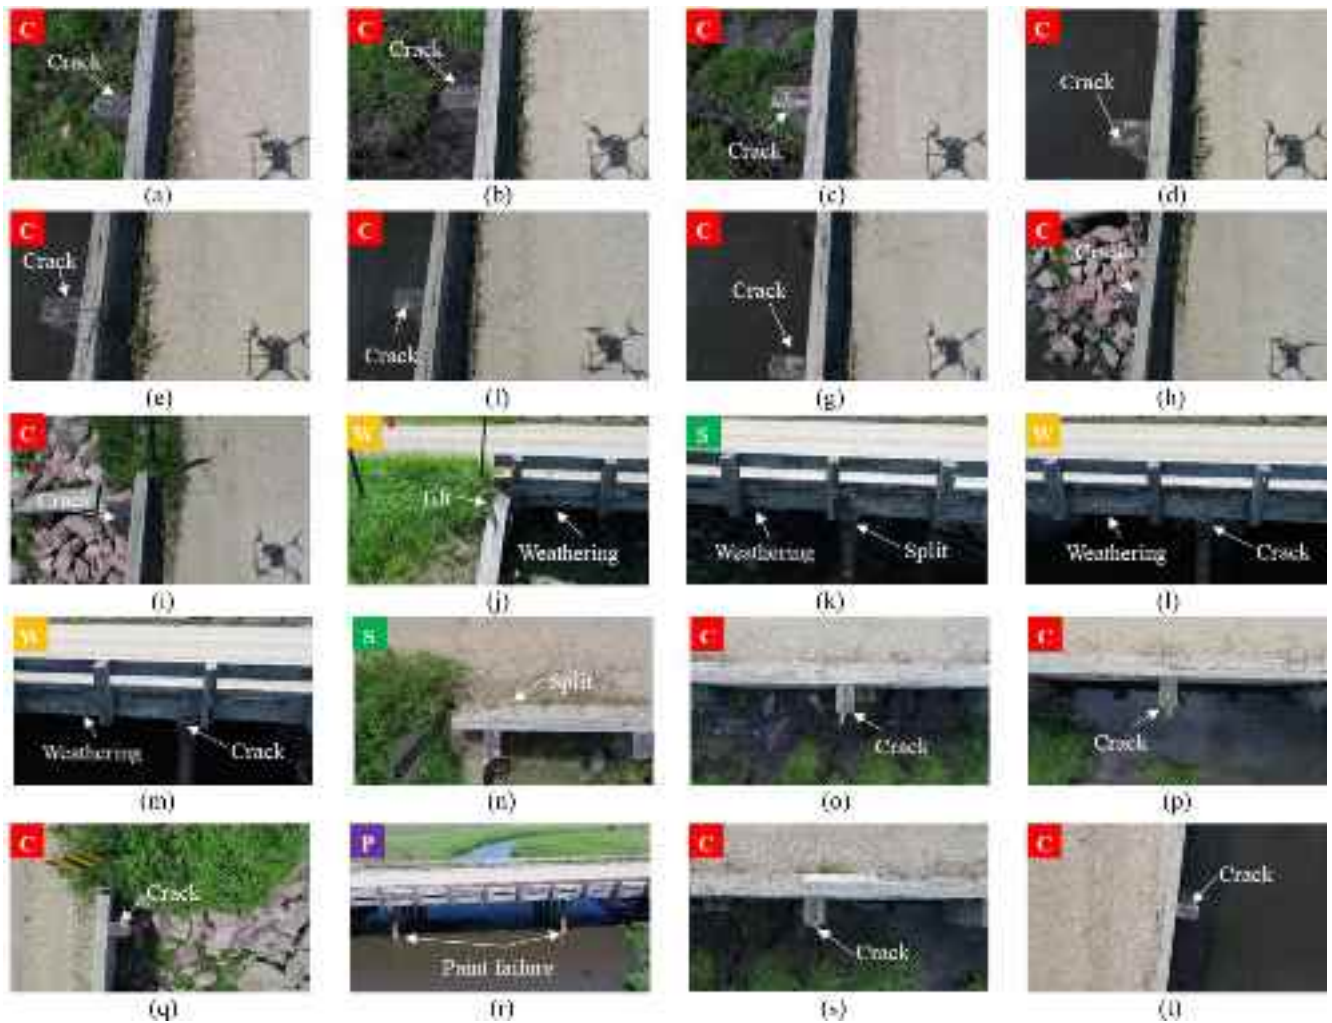
Fig. 13. Classified damage using UAV images: (a) crack on the railing on SS1; (b) crack on the railing on SS1; (c) crack on the railing on SS3; (d) crack on the railing on SS3; (e) crack on the railing on SS5; (f) crack on the railing on SS5; (g) crack on the railing on SS5; (h) crack on the railing on SS7; (i) crack on the railing on SS7; (j) tilt and weathering on NS1; (k) weathering and split on NS3; (l) weathering and crack on NS5; (m) weathering and crack on NS7; (n) split on NS1; (o) crack on the railing on NS1; (p) crack on the railing on NS1; (q) crack on the railing on NS7; (r) paint failure on NS; (s) crack on the railing on NS5; and (t) crack on the railing on NS5.

(see Fig. 13a through 13i, 13o, 13p, 13q, 13s, and 13t), weathering (refer to Fig. 13j, 13l, and 13m), split (see Fig. 13k and 13n), and paint failure (refer to Fig. 13r) were initially classified. Note, a small box (top-left) in each figure indicates the results of CNN-based damage classification. “C” with red box indicates crack, “W” with the orange box represents weathering, “S” with green box indicates split, and “P” with purple box shows paint failure.

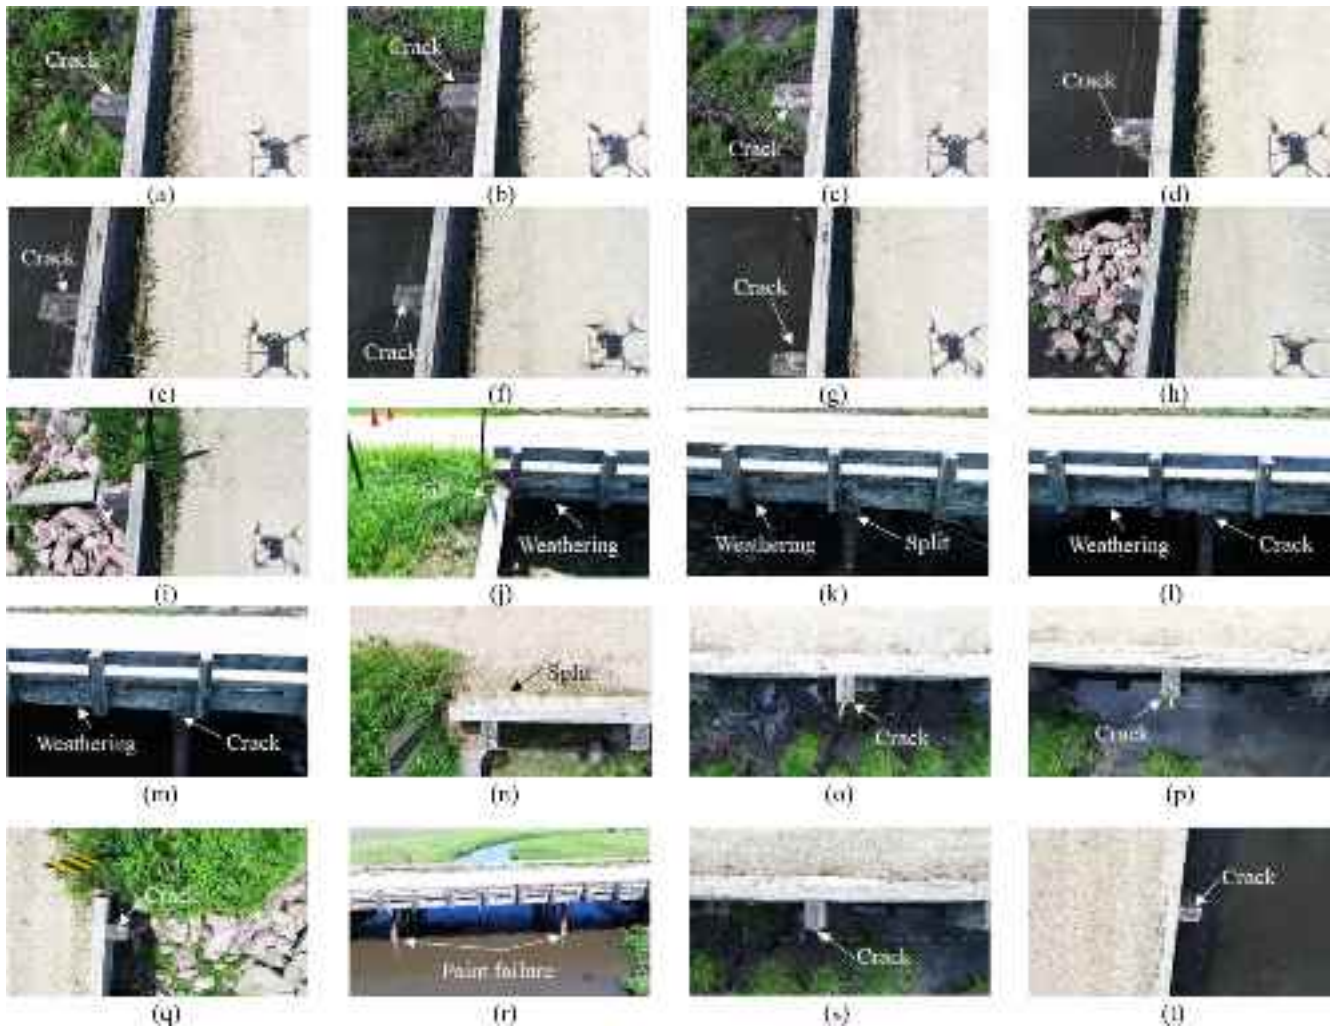
Fig. 14. Optimized UAV inspection images adjusted with the brightness of 20%, contrast of 20%, and sharpness of 30%: (a) crack on the railing on SS1; (b) crack on the railing on SS1; (c) crack on the railing on SS3; (d) crack on the railing on SS3; (e) crack on the railing on SS5; (f) crack on the railing on SS5; (g) crack on the railing on SS5; (h) crack on the railing on SS7; (i) crack on the railing on SS7; (j) tilt and weathering on NS1; (k) weathering and split on NS3; (l) weathering and crack on NS5; (m) weathering and crack on NS7; (n) split on NS1; (o) crack on the railing on SS1; (p) crack on the railing on NS1; (q) crack on the railing on NS7; (r) paint failure on NS; (s) crack on the railing on NS5; and (t) crack on the railing on NS5.

Upon the completion of CNN-based damage classification, various types of damage including crack (see Fig. 13a through 13i, 13l, 13m, 13o, 13p, 13q, 13s, and 13t), split (see Fig. 13k and 13n), tilt (see Fig. 13j), and paint failure (see Fig. 13r), and weathering timbers (refer to Fig. 13j through 13m) were further investigated manually from each of the UAV images to ensure that the CNN-based damage classification was able to identify individual damage types correctly. It is important to note that because the applied CNN algorithm was only capable of showing one damage classification result, another damage classification was not provided in the inspection images having more than one damage (i.e., Fig. 13j through 13m). With the UAV images in Fig. 13, image properties’ adjustment with the brightness of 20%, contrast of 20%, and sharpness of 30% was performed as shown in Fig. 14. Through this algorithm, the visibility of the inspection images was improved as in the process with indoor UAV inspection images. For instance, weathering in

darkness (Fig. 13j through 13 m) can be observed undoubtedly as depicted in Fig. 14j through 14 m.

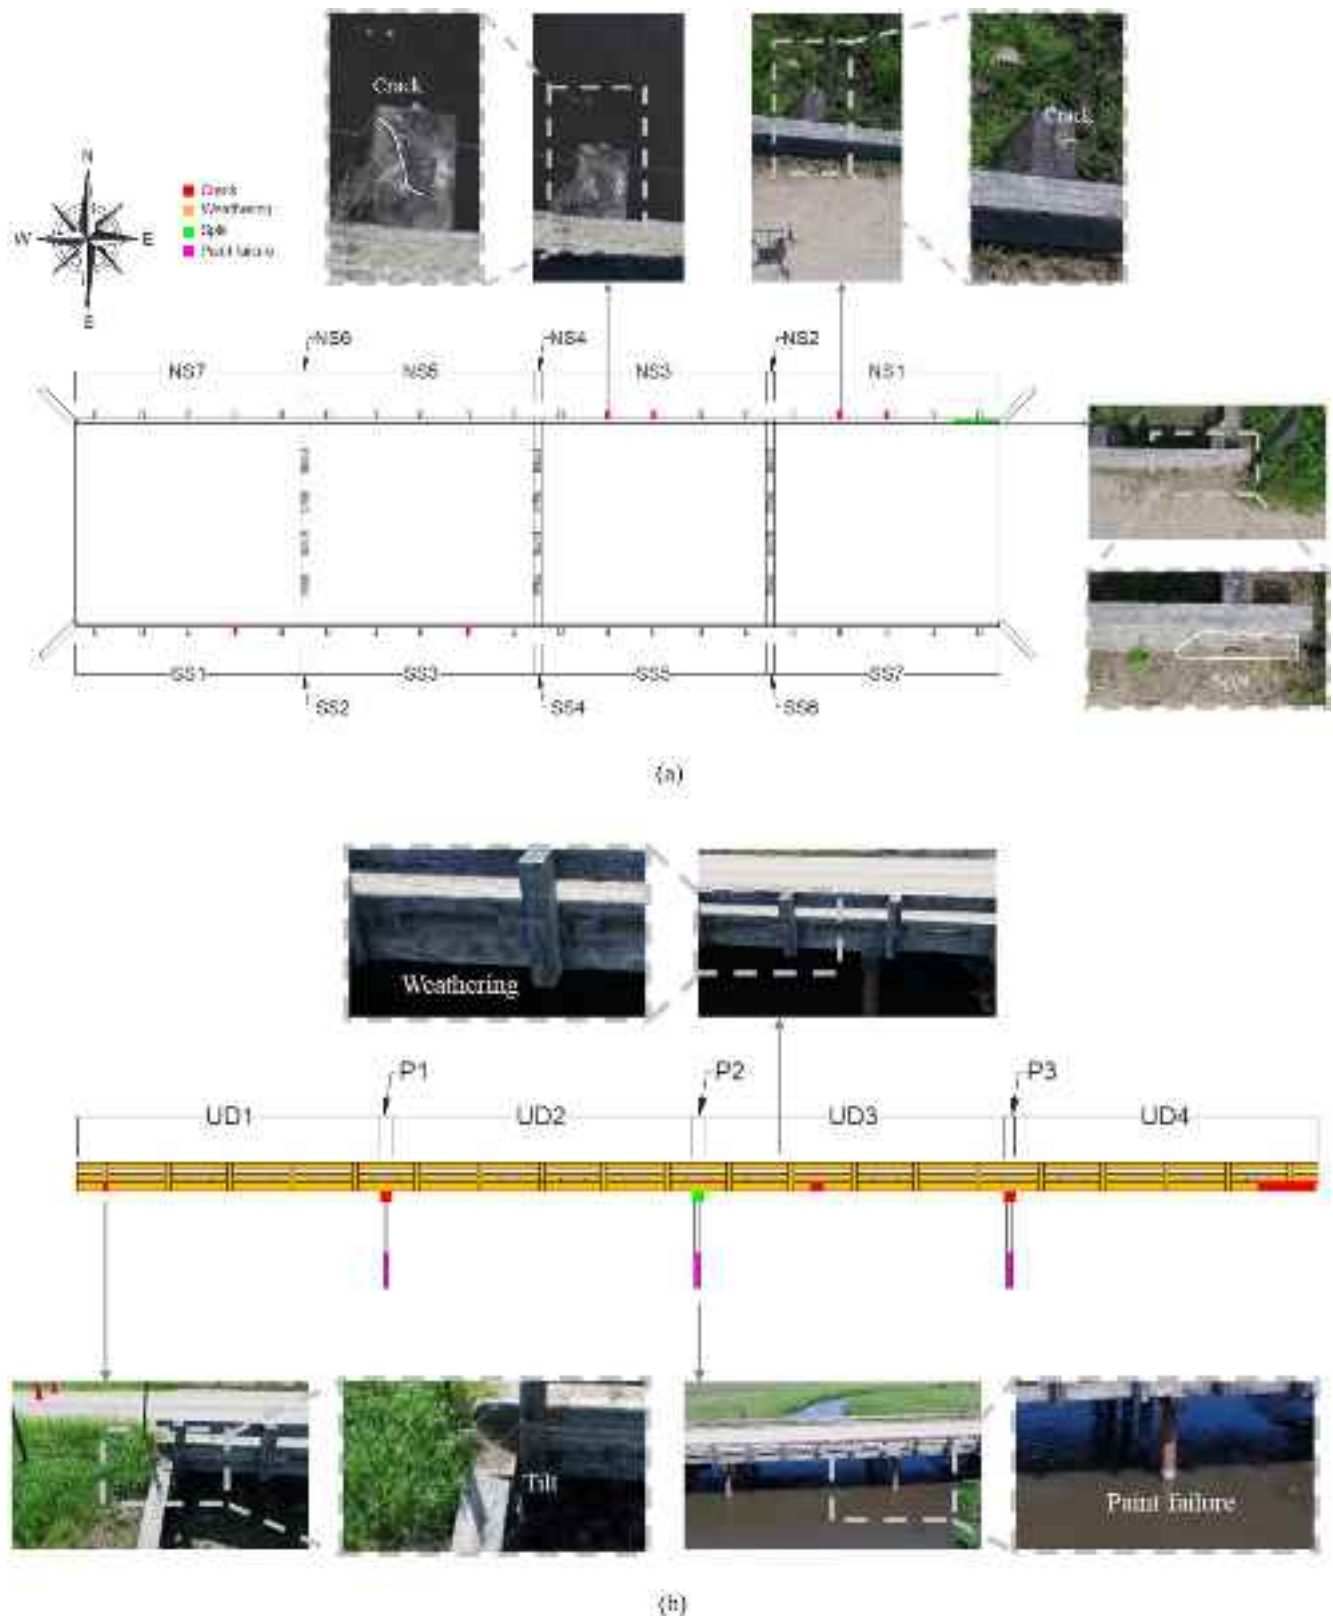
A damage map of the inspected bridge showing all the identified damage and corresponding optimized UAV inspection images is provided as shown in Fig. 16. The UAV images in this figure show different types of damage, including crack, split, weathering, tilt, and, paint peeling off. Note, the optimized images were obtained by performing the image visibility improvement process with the unfiltered UAV images with adjustment of image properties as stated before. The detailed damage descriptions provided from the inspection report completed by the bridge inspector, who are responsible for identifying any defects on the bridge, the quantified damage through the UAV-aided inspection protocol, and the direct measurements for accessible damage are also summarized in Table 2. It is worthwhile to note that the bridge inspectors did not quantify most of the damage. For example, the cracks on the railing posts were described as "all posts have moderate checks present" in the inspection report (Pipestone County, 2018). However, all the damage presented in the inspection report (Pipestone County, 2018) was identified and quantified using the proposed protocol with the inspection images obtained by the UAVs. Based on the comparison with the inspection report, overall, the proposed protocol with UAVs was able to appropriately identify all the damage presented in the report and quantify them through the image analysis. Also, the average error of UAV image analysis-based measurement compared to the direct measurement performed during the inspection showed 9.12%.

Fig. 16. Damage map for the studied bridge with representative optimized inspection images: (a) plan view and (b) elevation view.
