## **Security Assessment Report**

**CP-XR-DE21-S -4G Router**  
**Firmware version 1.031.022**

## 2.1 CP-XR-4G-01: UART Port Exposing Serial Logs

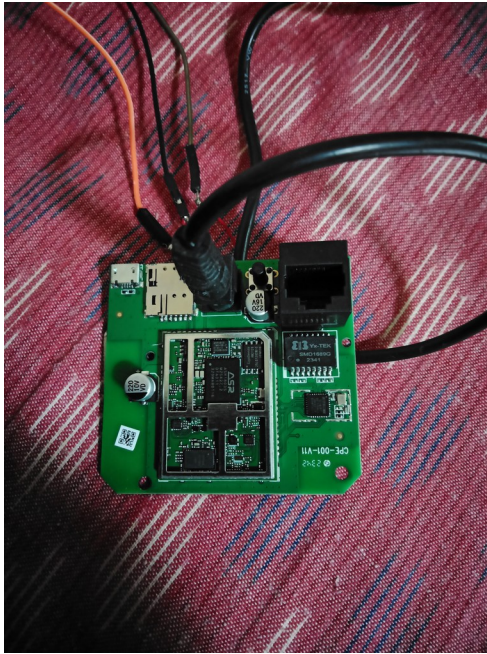
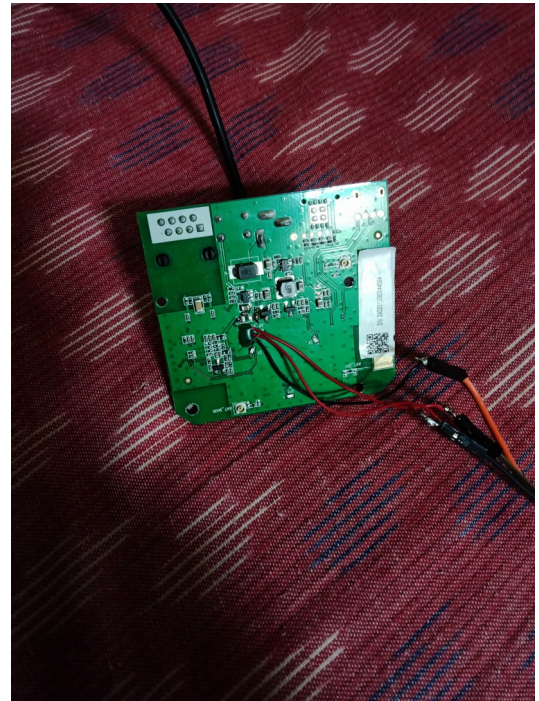
During the assessment it was identified that whenever logs from UART port are accessible that includes boot logs, hardware addresses, register dump,

1. Disassemble the CP-XR-DE21-S -4G Router and find UART pins viz 3.3 V, Gnd, TX and RX as shown in next image.

**Mitigations :** In the final production the UART logs can be disabled.

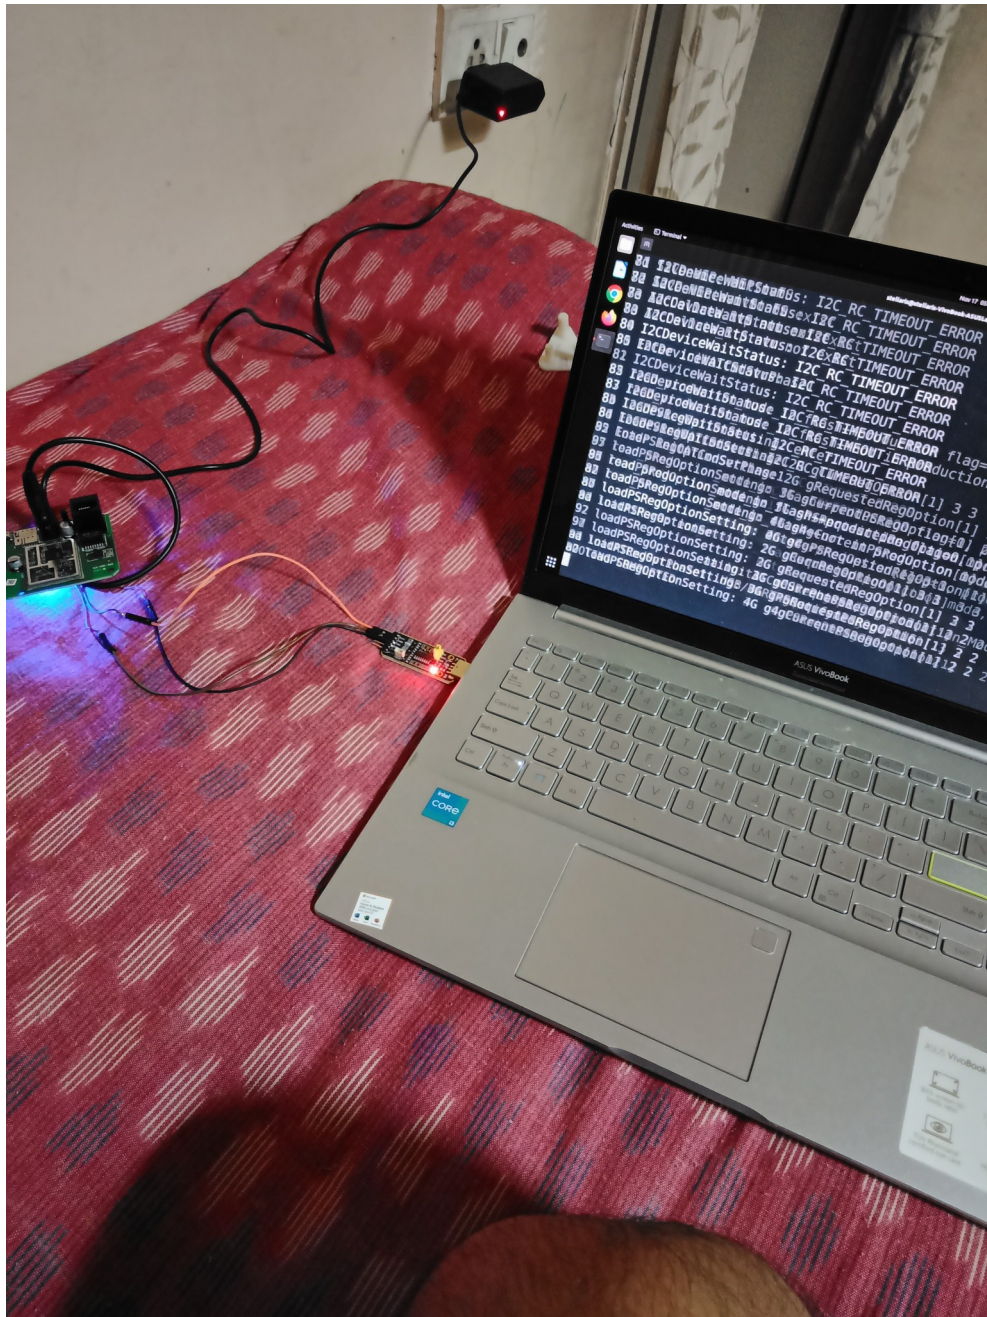
2. Solder the pins and connect to USB to UART Converter and connect to laptop as shown in image
