**16/03/2023**

**Qubo – A Hero Group Venture**

# **Security Assessment Report**

**Qubo Smart Plug 10 A**

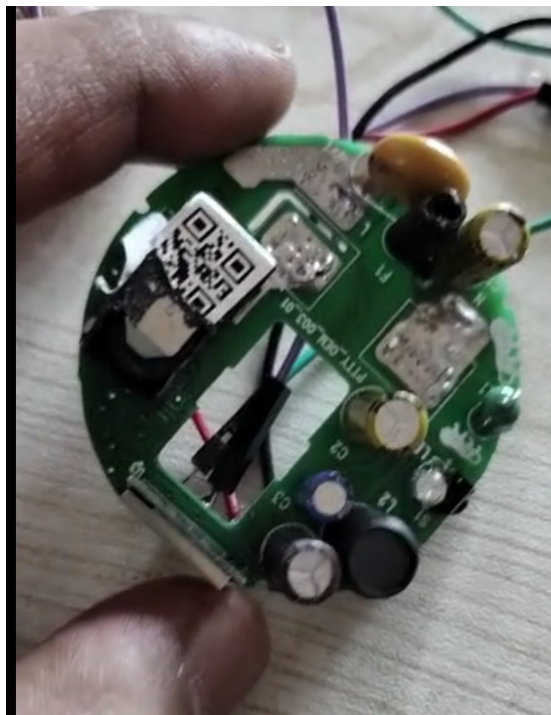
During the assessment it was identified that whenever logs from UART port are accessible that includes BLE service starting and sensor data string transmitted over UART shell.

1. Disassemble the Qubo Smart Plug 10 A

**Mitigations :** In the final production the UART logs can be disabled.

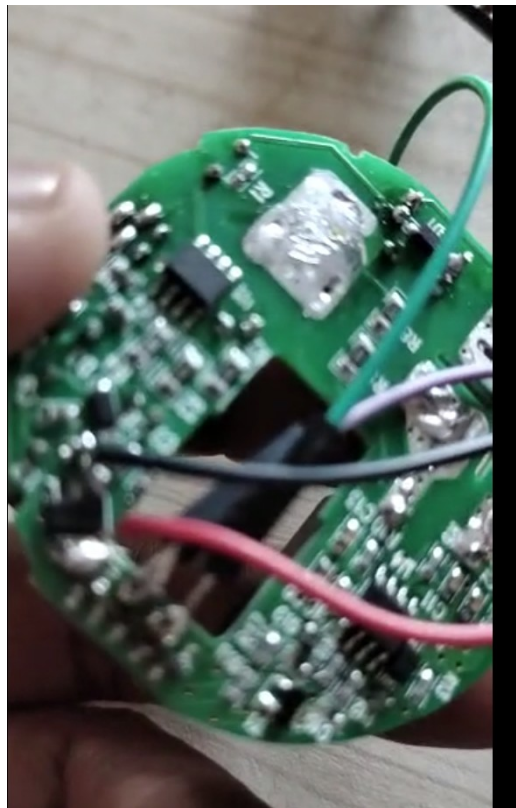
2. Read the datasheet of ESP8685-WROOM-03 module and identify Power and UART pins viz 3.3 V, Gnd, TX and RX

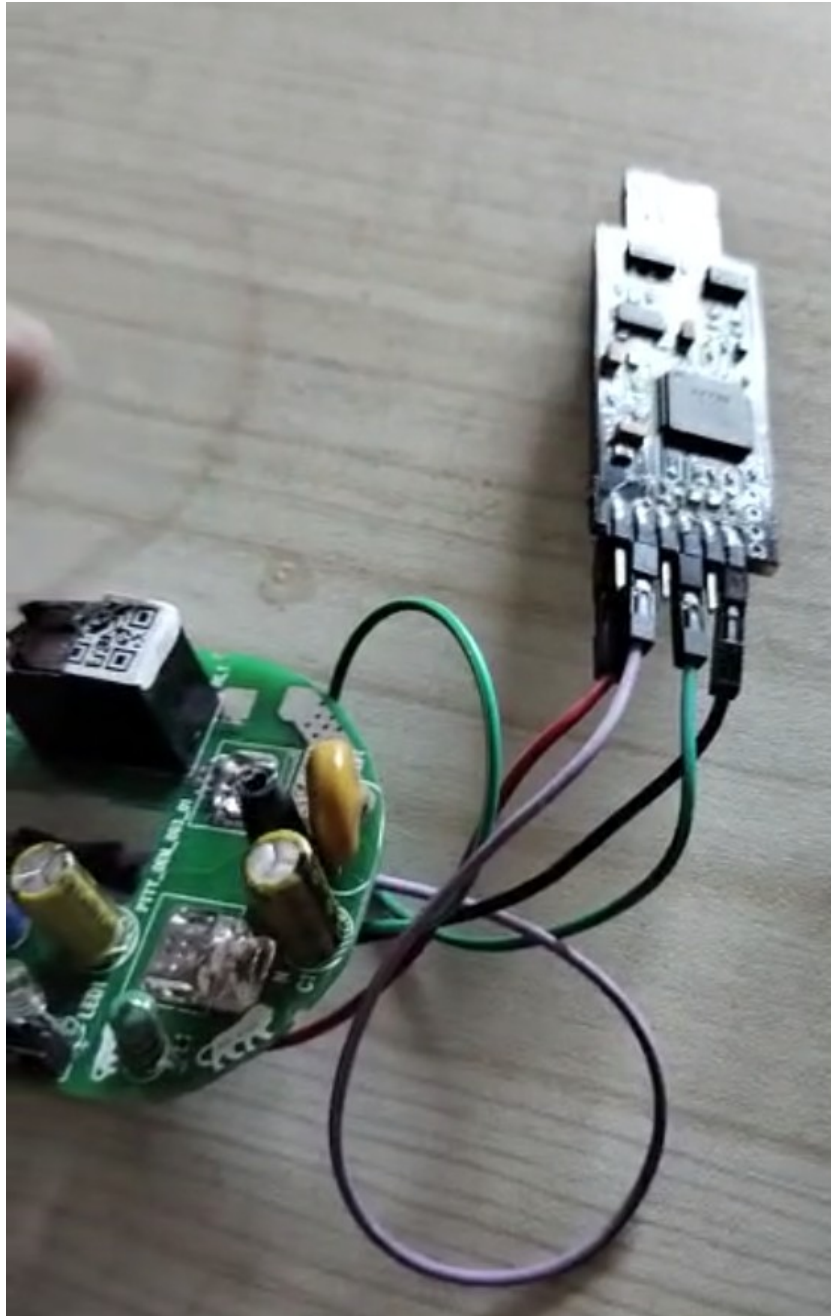
3. Connect the respective pin outs of ESP8685-WROOM-03 to any USB to UART converter shown in picture
