# ERR010385

# C55 E200Z4 BRANCH DISPLACEMENT ISSUE

## AMP APPLICATIONS ENGINEERING

10 AUGUST 2016  
REVISION 7

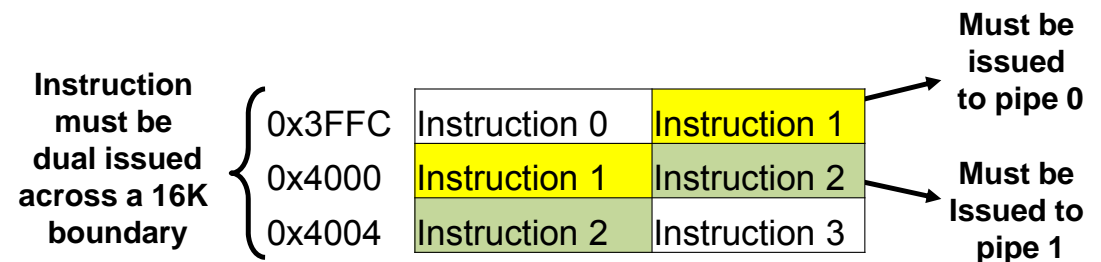
- An incorrect displacement calculation will occur on the instruction pipe 1 under the following conditions:
  - The PC is at 2 bytes before a 16K bytes boundary (address offset of 0x3FFE and multiples)
  - The instructions at offset 0x3FFE (and multiples) have to be as follows
    - Both instructions must be dual issued at the same time
    - Instruction in pipe 0 must be 32 bits;
    - Instruction in pipe 1 must be a relative branch with the 14 least significant bit displacement value of 0x3FFE
- The calculation is current address (0xXXXX\_{3,7,B,F}FFE) + the displacement + 4 (1 32-bit instruction)
  - The calculation could require 2 bits of overflow, but only 1-bit is implemented.

- Note: many instruction sequences, such as a branch that depends on the result of the preceding instruction, will not be dual issued.

- And both instructions are dual-issued
  - Under these conditions, the branch target address will be too small by 32Kbytes.
- Workaround:
  - After software is compiled and linked, code should be checked to ensure that there are no branch instructions located at address 0x2 of any 16K memory boundary with the lower 14 bits of the displacement equal to 0x3FFE if preceded a 32-bit instruction that crosses the 16K memory boundary. If this sequence occurs, add a NOP instruction or otherwise force a change to the instruction addresses to remove the condition.
