On the Out-of-Sync TDC Module on the HMS Chambers

Carlos Yero

August 28 2018

During the Fall-2017/Spring-2018 Hall C Commissioning Run Period, it was found that a particular TDC module in the HMS Drift Chambers Crate (ROC03) was shifting the tdc times of the corresponding groups of wires being fed into it. At that time, this did not seem to be a serious concern, as this could be fixed in software. There also seem to be no issues with the residuals per wire after calibration. After the end of the Spring Run, I decided to look at the residuals per wire for a defocused run in the HMS, and found certain groups of wire residuals to be significantly smeared compared to adjacent groups of wires. These were the same group of wires that exhibited the shift in time, which pointed to the same TDC module in ROC03, Slot 2. In this document I discuss the following:

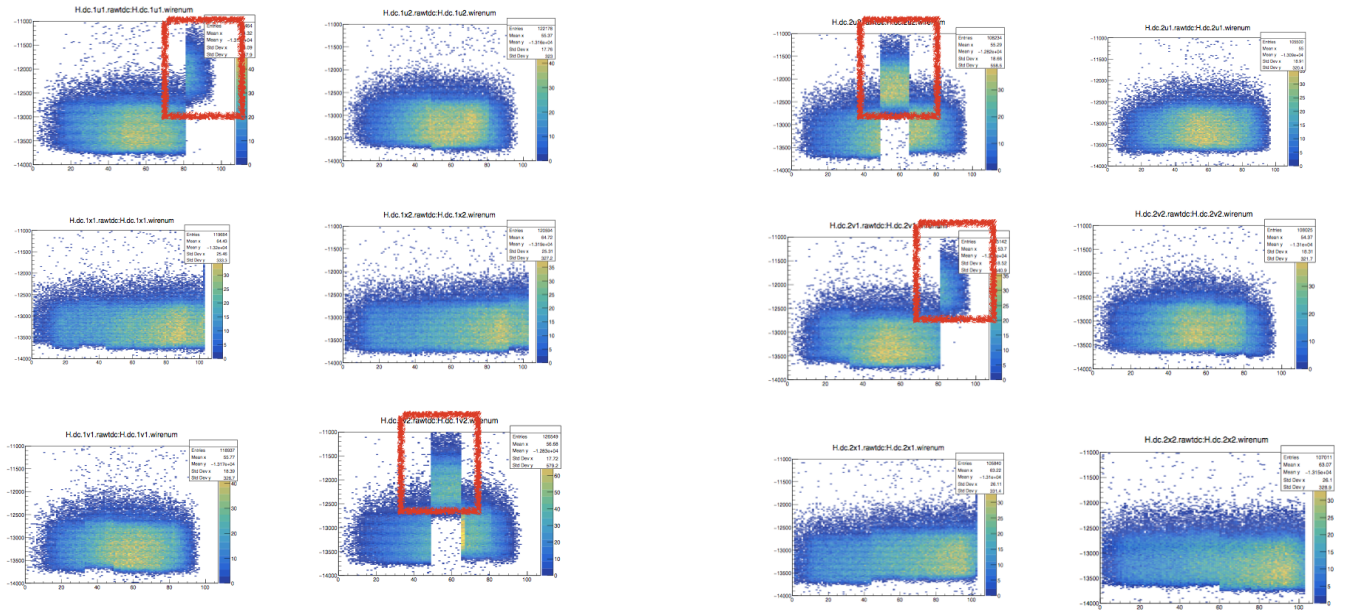
Figure 1: The Raw TDC vs. Wire Number Correlations for all 12 planes. An offset of ~ 1000 Channels (~ 100 ns) is observed in wire groups of four distinct planes.

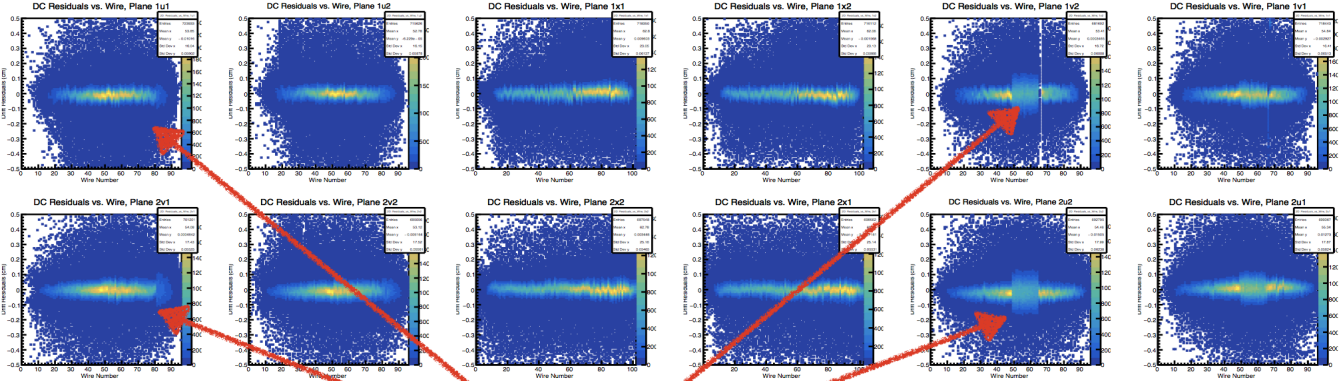
**Observed Bad Residuals
Corresponding to group of
Wires. ALL in TDC Slot 2**

**HMS Hut Crate, TDC SLOT2
Plane 1u1 (81-96)
Plane 1v2 (49-64)
Plane 2v1 (81-96)
Plane 2u2 (49-64)**

Figure 2: Correlation of Residuals vs. Wire Number for all 12 planes. Four wire groups stand out from the rest, with a noticeable smearing. The adjacent planes are affected by this smearing as well, even though they are NOT part of the problematic TDC.

The group of wires that were affected by the TDC synchronization issue cannot be restored to normal, so their residuals will remain significantly smeared out. Fortunately, two of the groups are located at the edge of each chamber, so they have minimal impact. The other two groups, even though they are near the center of the chamber, they are in different chambers, so tracking is NOT severely affected. The group of wires in adjacent planes are affected (See Figure 3) by

this smearing, since they depend heavily on their adjacent partners (U,V planes) for the (x,y) coordinate determination from tracking. To minimize this effect, the Hall C source code *hcana* was modified to read in the sigma parameters on a per-wire basis, if a certain flag was set. Originally, the sigma parameters were read on a per-plane basis, and were assigned a value of 0.02 by default. If the sigma-per-wire flag is set, then the sigma parameter values will be read on a wire-by-wire basis, and the wire groups associated with the Out-of-Sync TDC are assigned a sigma of 0.06, so that during the track-fitting algorithm, if a track passes through one of these groups, they will have a smaller contribution (or weight) on the entire fit. The results are shown in Figure

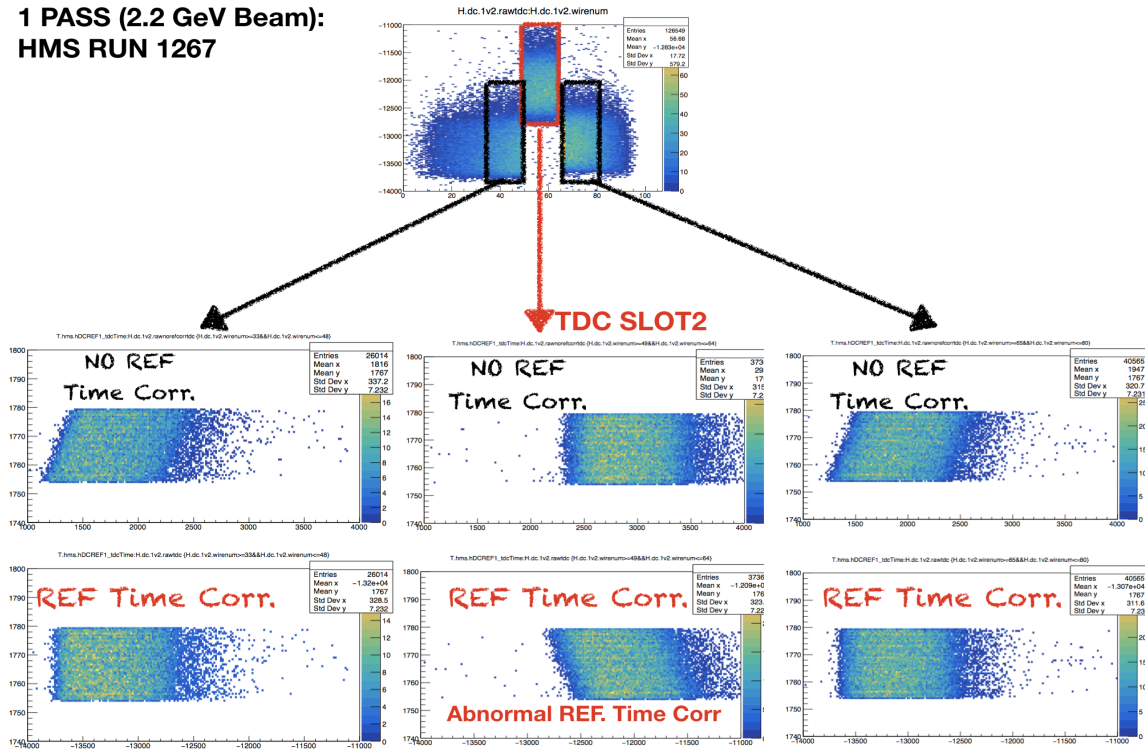
Figure 3: Correlation between the HMS DC reference time and the raw TDC times. The DC 1, V'-Plane raw TDC vs. Wire Number is shown. Adjacent wirgroups which are NOT in TDC Slot 2 are compared to the TDC Slot 2 wire group before and after applying the reference time correction to the TDC time.

The figure above is determinant in this study, as it shows the correlation of the reference time with the raw TDC time before and after applying the reference time correction. As expected from a normal TDC, when tdc times are reference time subtracted, the correlation disappears. However, in TDC Slot 2, the reference time and raw tdc time appear to be correlated, which is an indication that its copy of the reference time is Out-of-Sync with the rest of the modules.

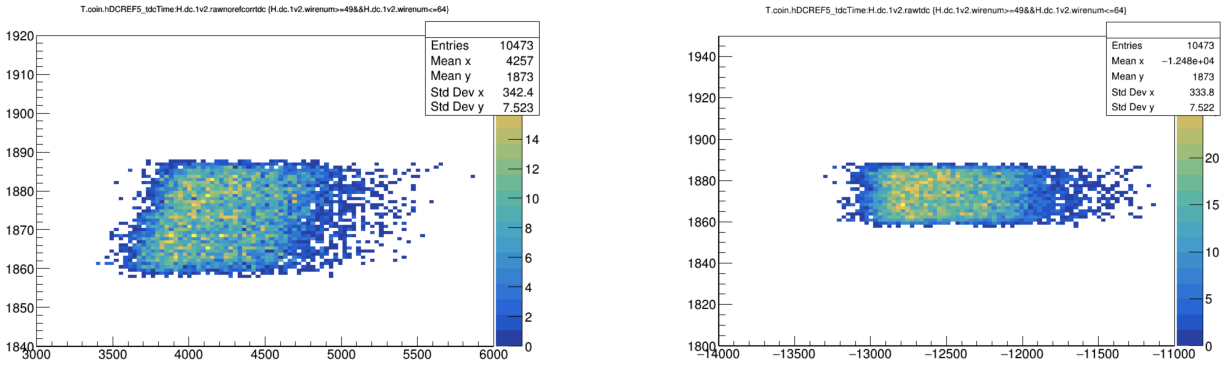
(a) TDC Slot 2 Reference Time vs. Raw Uncorrected TDC Time for wire group 1V2 (49-64)

(b) TDC Slot 2 Reference Time vs. Raw Corrected TDC Time for wire group 1V2 (49-64)

Figure 4: Results of HMS singles (DAQ in Coincidence Mode) cosmic run 4437 to verify that adding the new reference time to TDC Slot 2 fixes the problem. The subfigures above show the correlation between the newly added reference time and raw TDC Time from a group of wires in TDC Slot 2. As shown in subfigure (b), the correlation between the new reference time and raw TDC time is NOT present when the raw time is reference time corrected.

As a temporary solution, it was decided that a copy of the reference time should be fed independently to the bad TDC module. This way, the TDC can synchronize with its own reference time, as opposed to receiving an alternate copy from the trigger interface (TI) module. This modification was done on hardware on July 30, 2018. See Log Enrty <https://logbooks.jlab.org/entry/3583094>.

A modification in software map was also necessary, as the TDC Slot 2 needed to point to the new reference time. This change affects the data replay from the Spring 2018 Commissioning Run Period since during that time, TDC Slot 2 was pointing to a different reference time in the software. Therefore, if you have the most up-to-date copy of the hallc replay analyzer, to replay data from the previous run period, make sure to load the correct map into the replay script being used. See Figure 5
