Side Blinker Lamp body crack

Implementation

Dust cloud formation

AC Pulley shaft and bearing failure in Bus

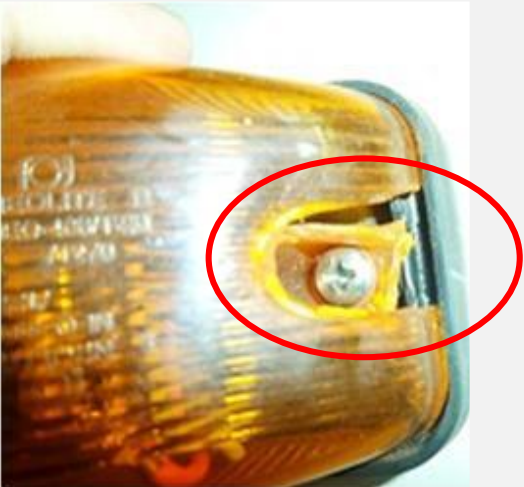
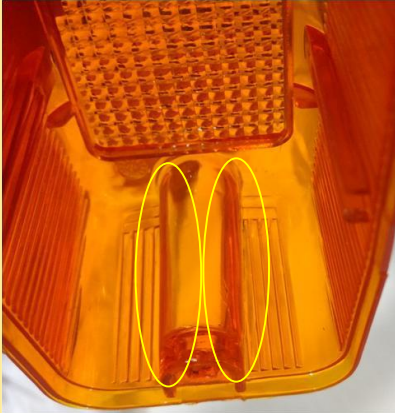
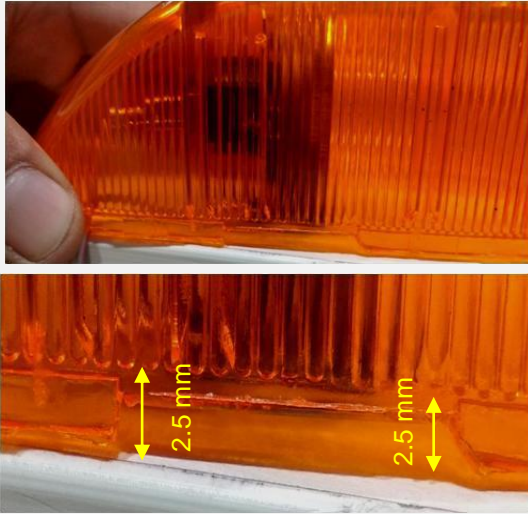
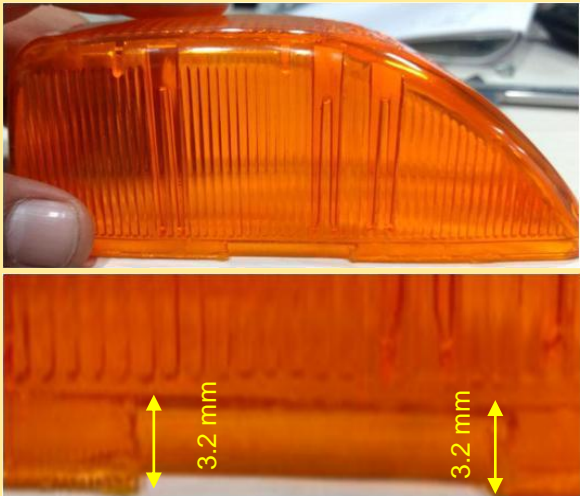
Defect Description	Side Blinker Lamp body crack near mounting screw.
Corrective action taken	<ul style="list-style-type: none">• Lens slot depth increased from 2.5 to 3.2 mm as per drawing to avoid the stress on lens after fitment on vehicle.• Radius provided inside the mounting lug to improve strength.
VIN cut-off	MBKMC5BE9JN020447
Cut-off date	Feb 2018
Vehicle models applicable	All CLA Trucks (Domestic)
Aggregate Sl. nr./ Batch code	X
DMN Nr.	X
Technical Information(s)	X

<p>Radius provided</p>

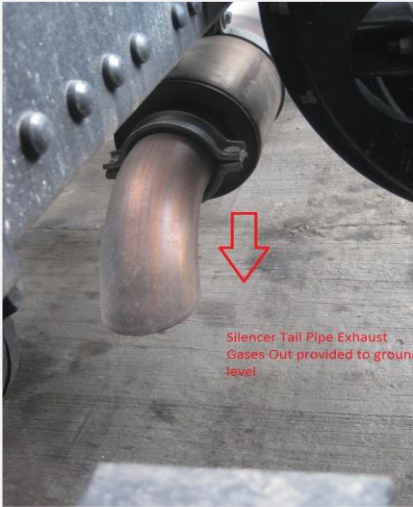
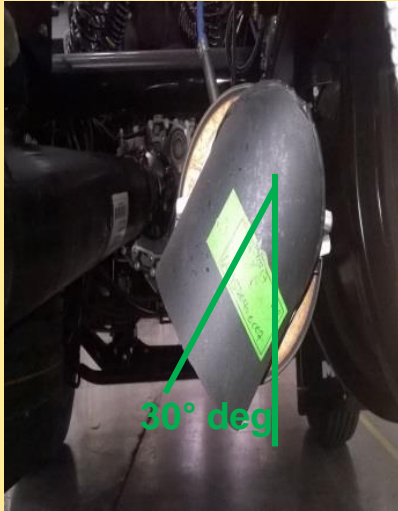
Defect Description	Dust cloud formation due to inappropriate Tail pipe orientation in BS IV haulage vehicles.
Corrective action taken	Changed orientation of tail pipe towards vehicle center line by 30 Deg.
VIN cut-off	MBKMC5AL3JN020377
Cut-off date	Jan 2018
Vehicle models applicable	All CLA BS IV Haulage Vehicles
Aggregate Sl. nr./ Batch code	X
DMN Nr.	15126
Technical Information(s)	X

<p>Silencer Tail Pipe Exhaust Gases Out provided to ground level</p>

<p>30° deg</p>

Identification criteria for new part(s)/ assy.	X
Service Document(s)	In case of any customer complaint of dust cloud formation, change orientation of tail pipe towards vehicle center line by 30°.
Retro-fitment in Plant & BSR	X
Retro-fitment in Field	X
Warranty labour rate	X
MAN Defect Codes	X

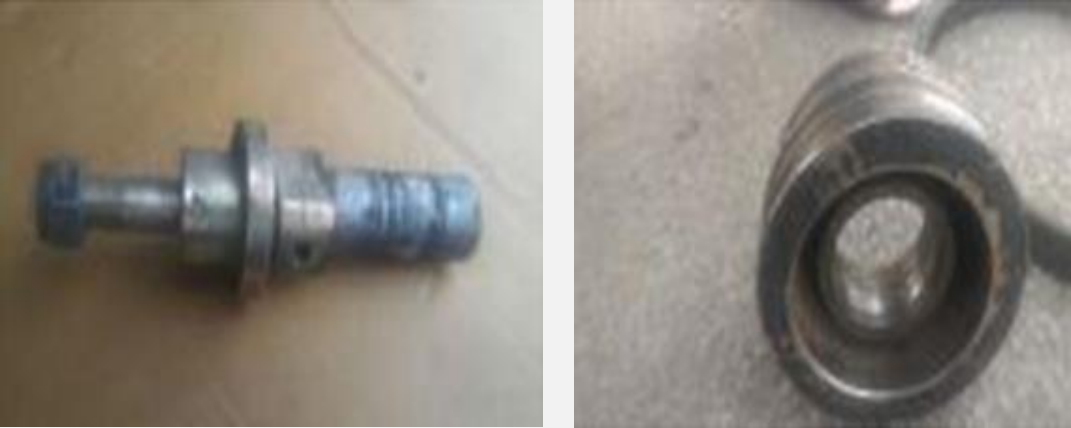
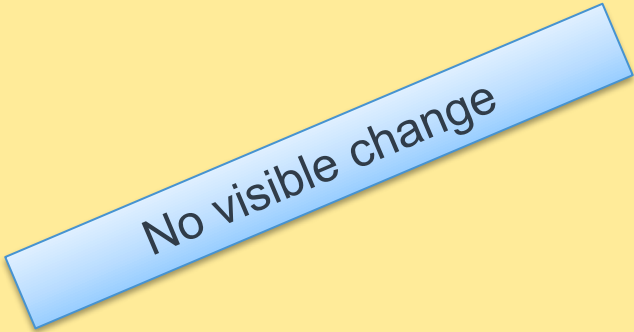
Defect Description	AC Pulley shaft and bearing failure
Corrective action taken	Fitment process is improved by ensuring proper alignment of shaft with AC pulley & bearing while press fitting with the help of newly developed fixture.
VIN cut-off	MBKMF5AA8JN000213
Cut-off date	Jan 2018
Vehicle models applicable	CLA Buses
Aggregate Sl. nr./ Batch code	X
DMN Nr.	X
Technical Information(s)	X
