A Study of the Affected Layer and Stress Corrosion Crack of Ultra-high-strength Steel (300M) for Aircraft Parts

Jinwoo Ahn^{*,**}, Taehwan Kim^{*,**, #}

^{*}Defense Agency for Technology and Quality,

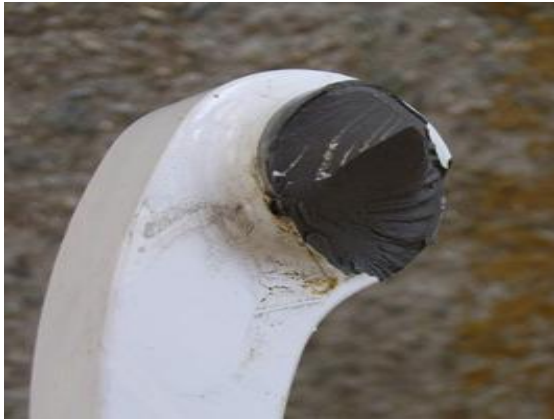
Fig. 2 Shapes of the fracture surface

The fractured is a part of the link assembly of the aircraft landing gear. The shape of original part is shown in Fig. 1. Fig. 2 show fracture surfaces. It can be seen that the fracture proceeded diagonally.

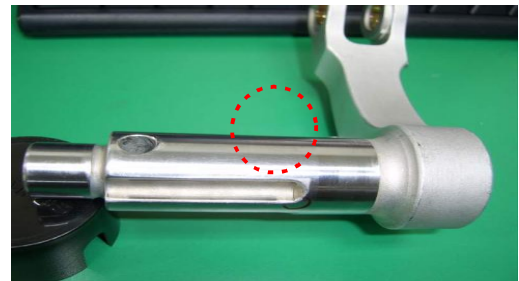
(a) Shape of the similar defected part

First, a visual inspection of the same type of aircraft was conducted to find the cause of the defect. As a result, the traces presumed to be similar defects are shown in Fig. 4. It is identified at the end of Groove. In particular, Ridge(Tool Mark) was identified on the curved surface of Groove as shown in Fig. 4(b) and (c). Fine cracks were observed around the ridge grooves.

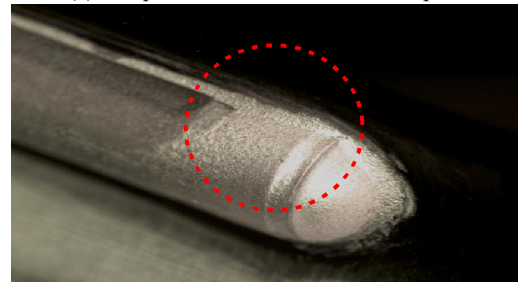
Fig. 4 Similar defect of other parts

(b) View of the defect on groove

(c) View of the defect on groove

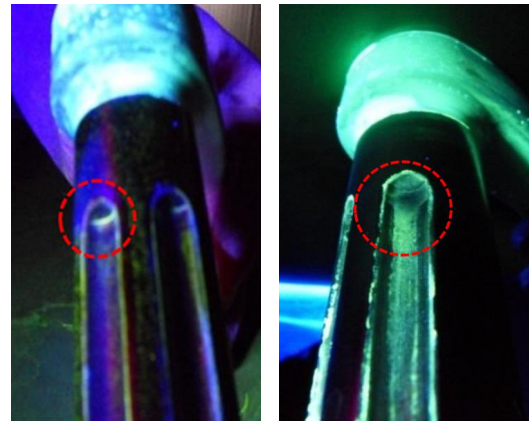
**(a) Result of MPI****(b) Result of FPI****Fig. 6 NDI for the defected part**

First, magnetic particle inspection(MPI) was performed on the total quantity of defected products for the purpose of surface defect detection. In general, it is possible to check Indication when there is crack or tool mark through MPI. As indicated by Fig. 6(a), in-depth analysis was required by fluorescence penetrate inspection(FPI). FPI was also performed for the total number of defected. Indication did not appear as shown in Fig. 6(b).

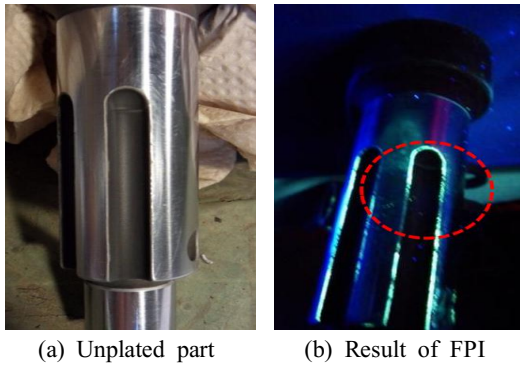
Fig. 7 NDI for the unplated part

Fig. 7(a) shows the part after plating peeling. As a result of performing FPI this part, there was no

indication as shown in Fig. 7(b). Through this, it was confirmed that the indication identified in the MPI was not a crack but a tool mark by machining.

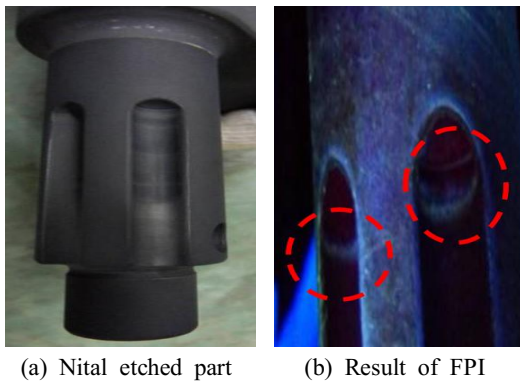
Fig. 8 Nital etched surface of defected part

As the tool mark due to the machining was confirmed, in order to check the surface affected layer due to frictional heat during machining, the defected part was subjected to grit blast and nital etching. Through this, the tool mark estimated by friction heat or burn is shown in Fig. 8(a).

As a result of FPI for this part, an abnormal indication that was generated by burn during machining was confirmed in the tool mark on the notch in Fig. 8(b).

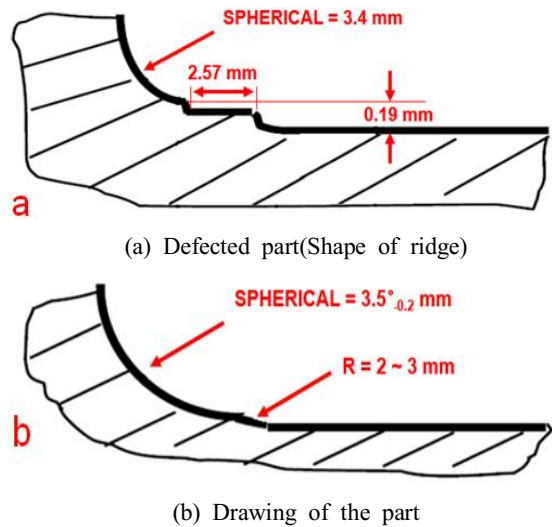
Fig. 9 Compare parts and drawing dimensions

curves. As a result of the measurement, a stepped ridge confirmed at the tool mark located at the end of the groove. Fig. 9(a) shows defect(ridge), Fig. 9(b) shows the drawing of Groove.

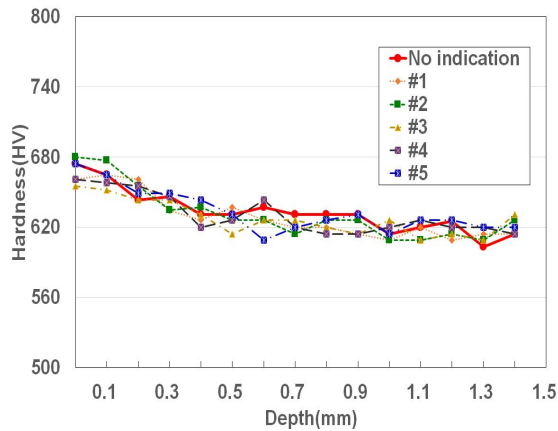
Fig. 11 Microhardness distribution of Indication #1~#5 and No Indication

In Fig. 11, which is the result of measuring the micro hardness, it was confirmed that there was no significant difference between the hardness value of the tool mark and the no indication.

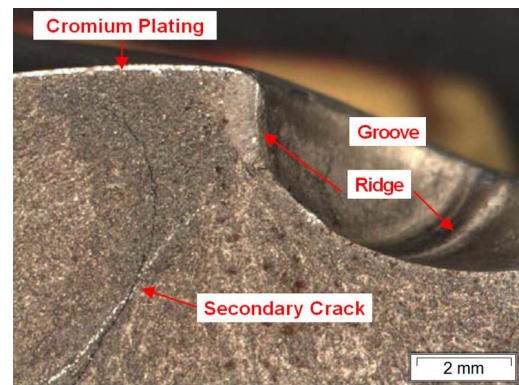
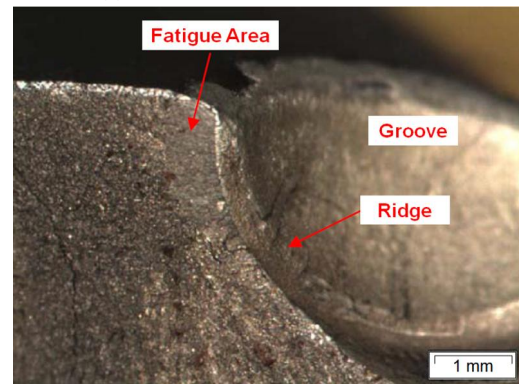
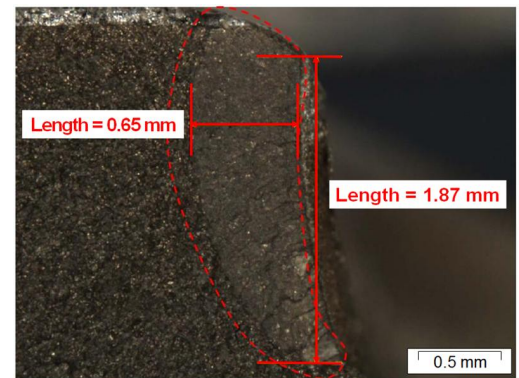
Fig. 12 View of the fracture surface

In Fig. 12(a), which enlarges the fracture surface, it can be confirmed that it is similar to the crack caused by fatigue, and the secondary crack is identified. In Fig. 12(b) and (c), It shows the fatigue fracture in more detail. On the fracture surface, it was confirmed that fatigue progressed to 1.87mm width and 0.65mm depth from the ridge edge of the groove(tool mark) and then to failure.

(b) Initiation of fatigue(x17)

(c) Shape of fatigue area(x40)

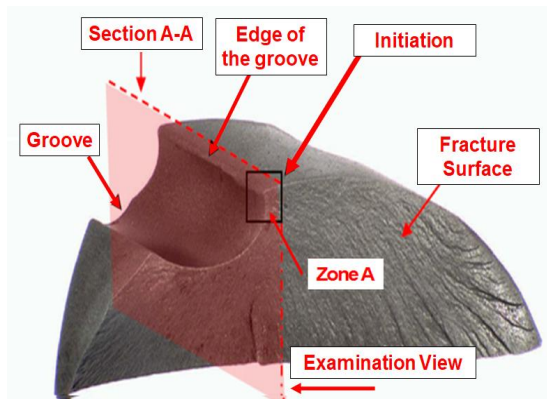
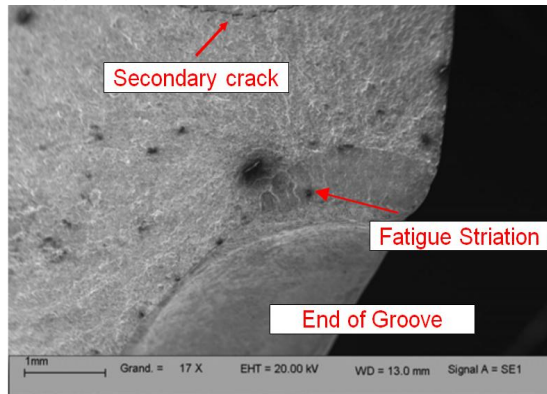
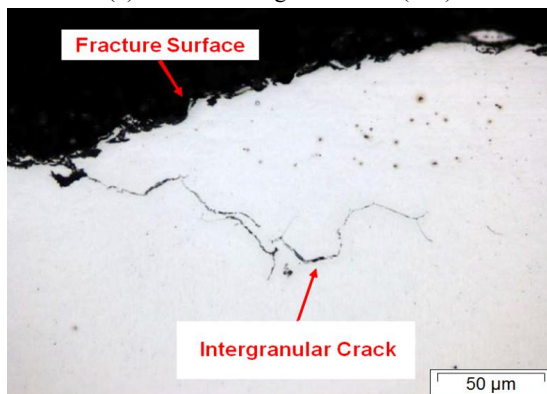
Fig. 13 Analysis of fracture surface

As a result of analyzing the fracture surface as shown in Fig. 13(a) using the scanning electron microscope(SEM), fatigue striation were found in Fig. 13(b). In Fig. 13(c), microsections showed branching with intergranular progressed from the end of the fracture surface. Such observed branching is

consistent with stress corrosion cracking initiated from the end of the fatigue propagation.

Based on these results, it is estimated that fatigue and initial cracking occurred due to stress concentration

(b) View of fatigue striation(x17)

(c) View of Intergranular crack(x500)

in the notch generated in the ridge of the tool mark. Thereafter, stress corrosion cracking proceeded to the cracked part, which promotes final failure.
