# **RESTORATION OF THE HISTORICAL ARCHBISHOP'S PALACE IN CAGLIARI (ITALY).**

G. Concu and F. Mistretta  
Department of Structural Engineering  
University of Cagliari, Italy  
Piazza D'Armi 2  
09123 Cagliari, ITALY  
[fmistret@unica.it](mailto:fmistret@unica.it)

## **ABSTRACT**

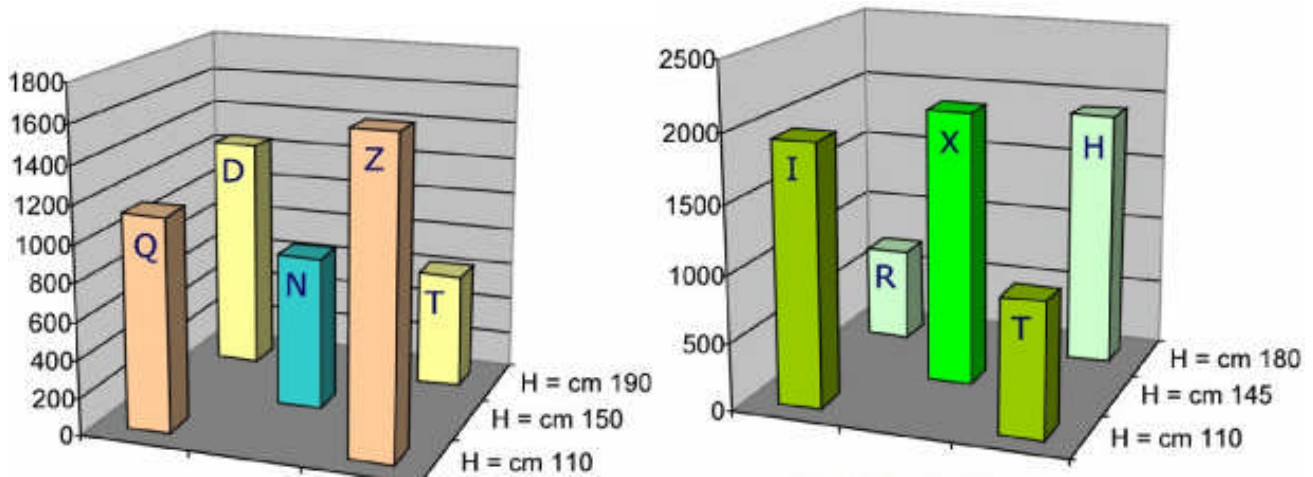
Fig. 5 Histogram of V(m/s). Area 4 (left) and area 5 (right). H is the height from the floor.

- in the most of the tested areas V average value ranged between 900m/s and 1400m/s;
- areas 2, 3 and 12 showed V average value lower than 700m/s;
- area 1 showed a V average value higher than 2000m/s;
- V values scattering was extremely high in all the tested areas;
- the acquisition of the transmitted sonic signal in area 11 was impossible to perform.

Thus, results highlighted the highly irregular distribution of the velocity, that is symptomatic of a high level of non-homogeneity. As expected, the higher V values were measured in the large stones, while the decreasing of the values could indicate an internal detachment between the stones, or the presence of cracks and damages. The areas where V is lower than 700m/s should be looked at in special concern, because the de-cohesion degree could be serious. Additional surveys have been carried out on area 11 in order to ascertain which defects disturb the signal transmission and establish the real inner condition of the masonry.

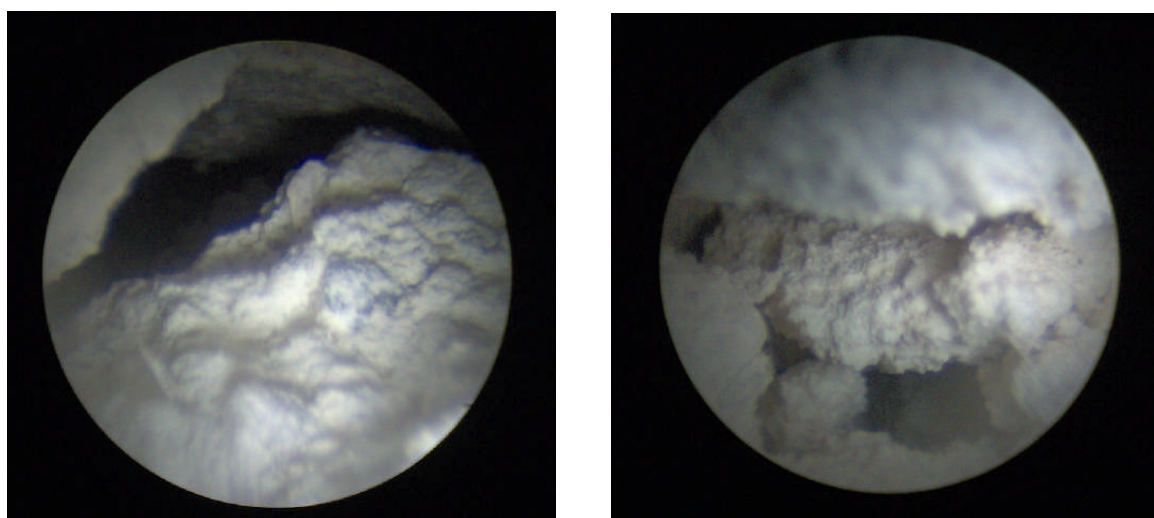
Some pictures acquired during the survey are shown in Fig. 6. It can be noticed that the inner masonry has several discontinuities, cavities and lack of material.

Fig. 6. Pictures acquired during the endoscopy

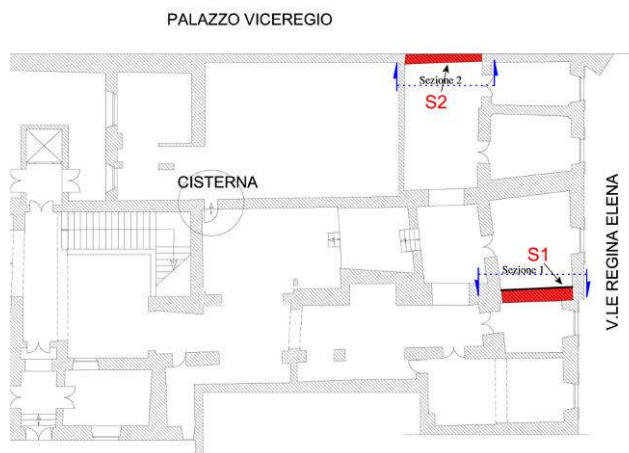
Figure 8 Cracks monitored. Ground floor

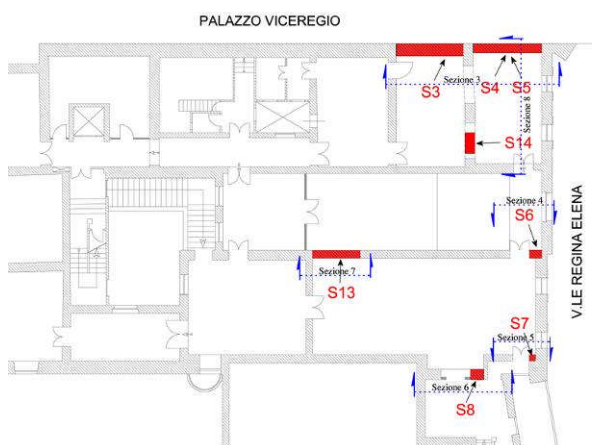
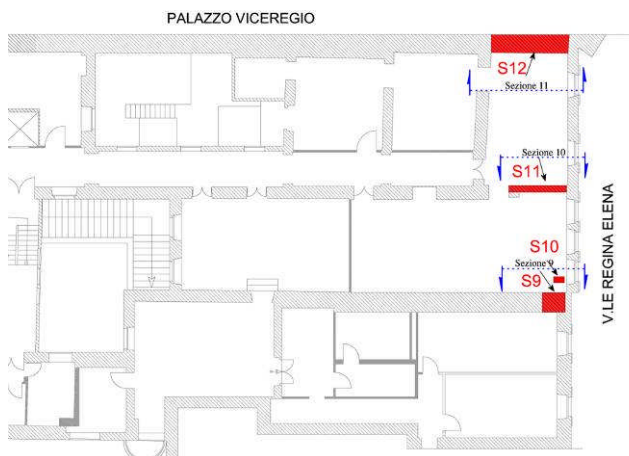
Fig. 9-10 Cracks monitored. First floor (left) - Second floor (right)

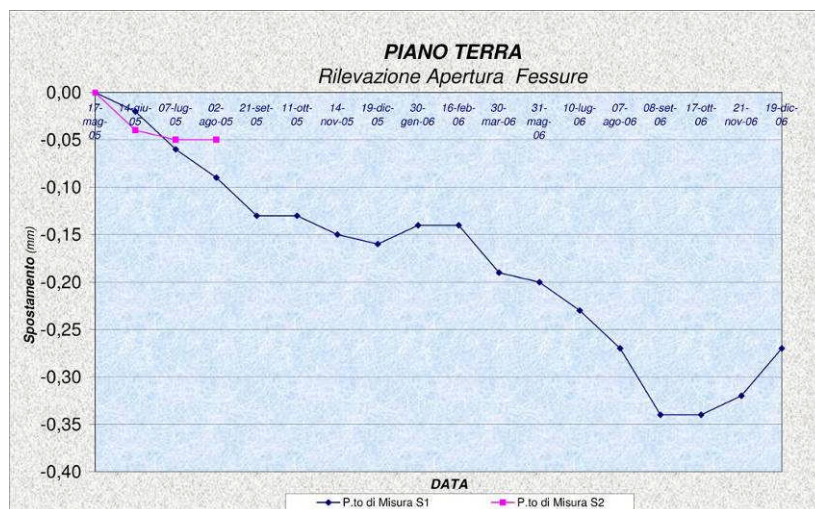
- displacements of cracks S3, S4, S5, S8, S13 at the 1<sup>st</sup> floor and S12 at the 2<sup>nd</sup> floor were quite moderate, and their sinusoidal trend seemed to depend on the temperature changes;
- crack S1 at the ground floor, S6, S7, S14 at the 1<sup>st</sup> floor and S9, S10 at the 2<sup>nd</sup> floor showed most important displacements;
- displacements trend of cracks S6, S7 and S14 was sinusoidal with slowly time-increasing amplitude;
- displacements trend of cracks S1, S9 and S10 wasn't sinusoidal.

Thus, monitoring results highlighted that a slow but steady displacement of the Archbishop's side where cracks S1, S6, S7, S14, S9, S10 are located was ongoing.

Fig. 11 Crack's displacements trend. Ground floor.

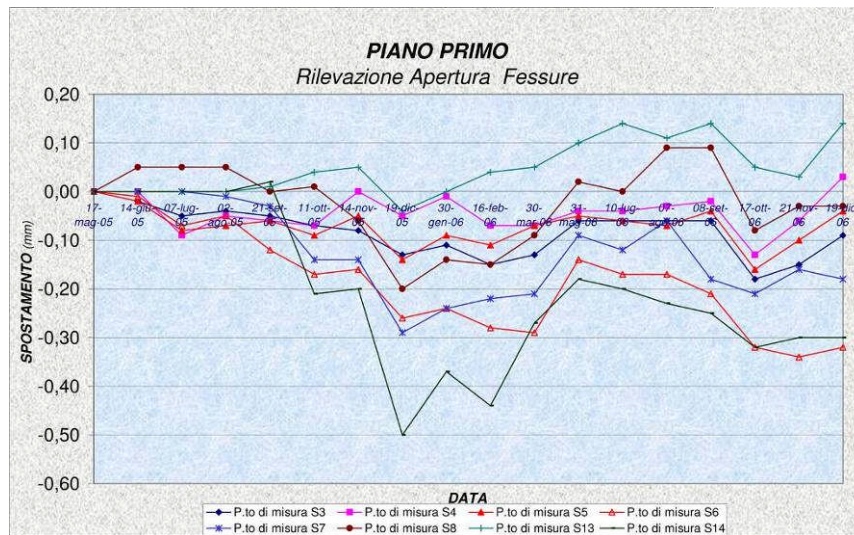
Fig. 12 Crack's displacements trend. First floor.

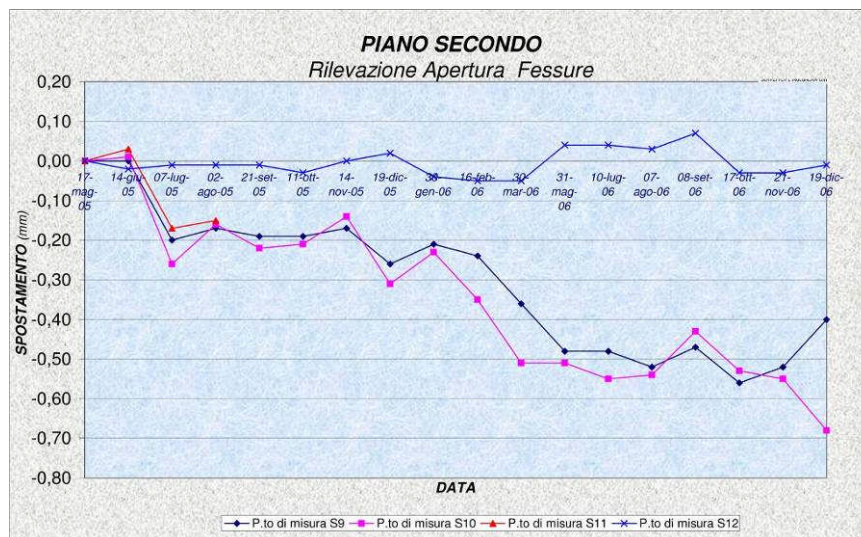
Fig. 13 Crack's displacements trend. Second floor.

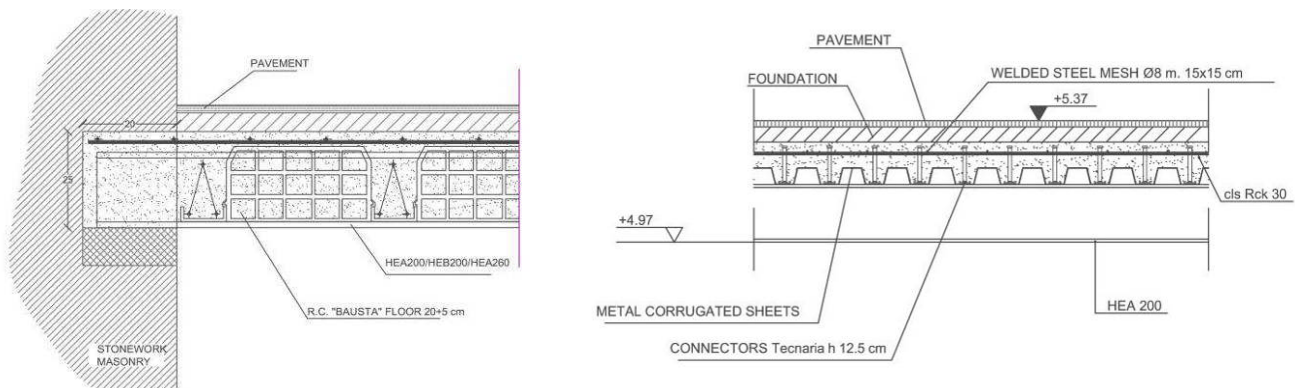
Fig. 16 Composite steel-concrete structure: original design (left) ad solution applied (right).

The design of the new floors had originally provided for a composite steel-concrete structure made of double T-shaped steel beams with a overlying concrete cast, keeping up a interposed precast joists and hollow tiles mix. Given the difficulty of handling the materials caused by the hard operating conditions (old town centre), the contractor proposed to replace the designed floors with a different system providing the same static performance and better performance in terms of installing and safety working (Fig. 19-20). The system provided the use of a corrugated steel sheet 1.2mm thick resting on the double T-shaped steel beams extrados instead of the precast joists and hollow tiles mix floor; a concrete layer overlaid the structure (Fig. 16-21-22).

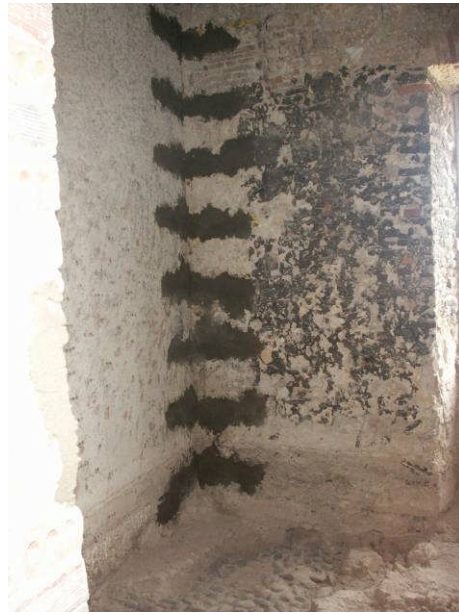
Fig. 18 Inserted tie bars.

Along the joints between perpendicular walls, for the entire wall's height, and in correspondence of the floors, tie bars have been inserted in order to upwind the building and prevent additional failures and lesions (Fig. 18).

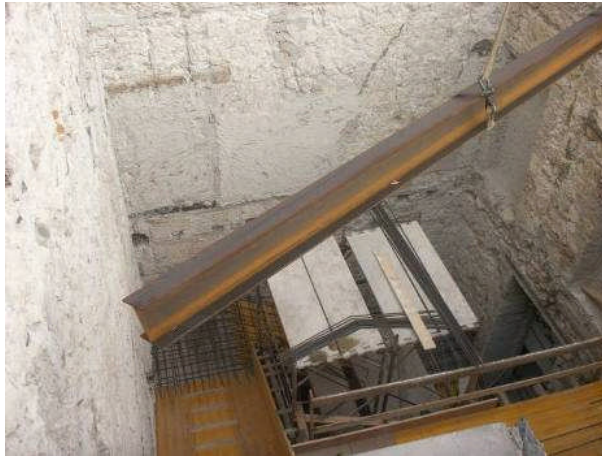
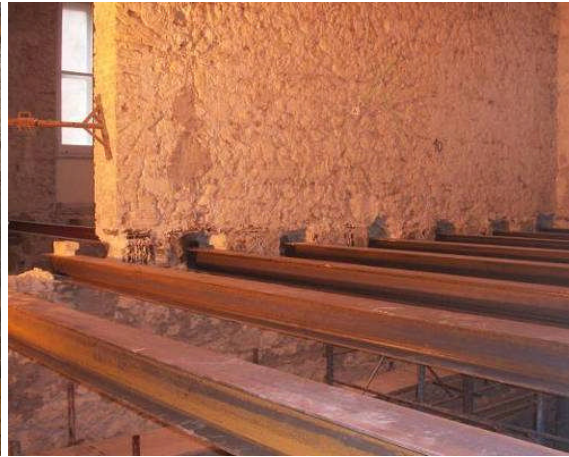
Fig. 19-20 Difficulties of steel beams set-up.

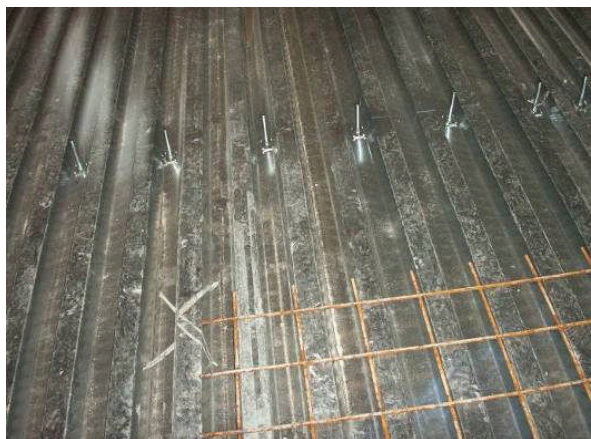
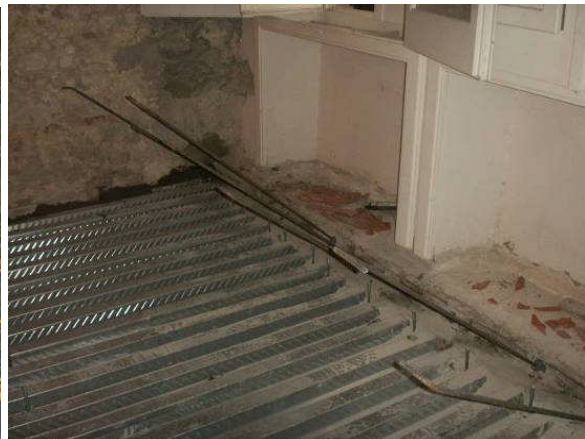
Fig. 21-22 Corrugated steel sheet set-up: connectors (left) - Inserted tie bars (right).

In order to guarantee the static unity of the load-bearing steel structure and the overlying concrete cast, it has been used a new system that consists of cold fastening the connectors using special nails. The connector consists of a headed stud inserted in a suitably shaped and stiffened base plate. Two cold-fastening nails, made of highly resistant material, passing through the plate, ensure the rigid fastening of the connector to the steel beam. The nails are punched in the means of a powder-actuated tool (Tecnaria 2008).

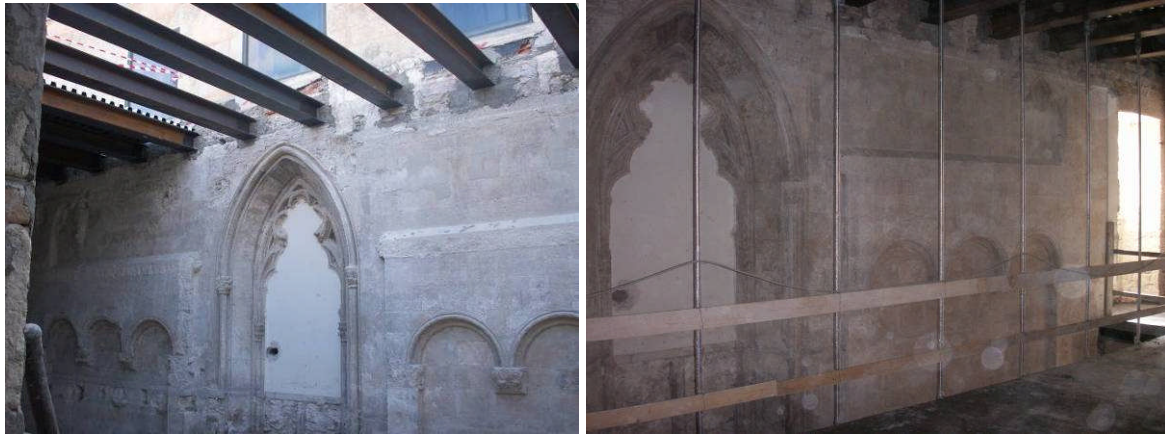
Fig. 23-24 The suspension floor in front of the Cathedral.

A particularly scenic floor suspended with stainless steel cables has been carried out in order to expose to view the beautiful palace's wall bordering the Cathedral (Fig. 23-24).
