Effects of Electrolyte Impurities in Chlorate Cells

Richard A. Kus
Senior Research Chemist
ELTECH Systems Corporation
Fairport Harbor, Ohio USA

16th Annual Chlorine/Chlorate Seminar

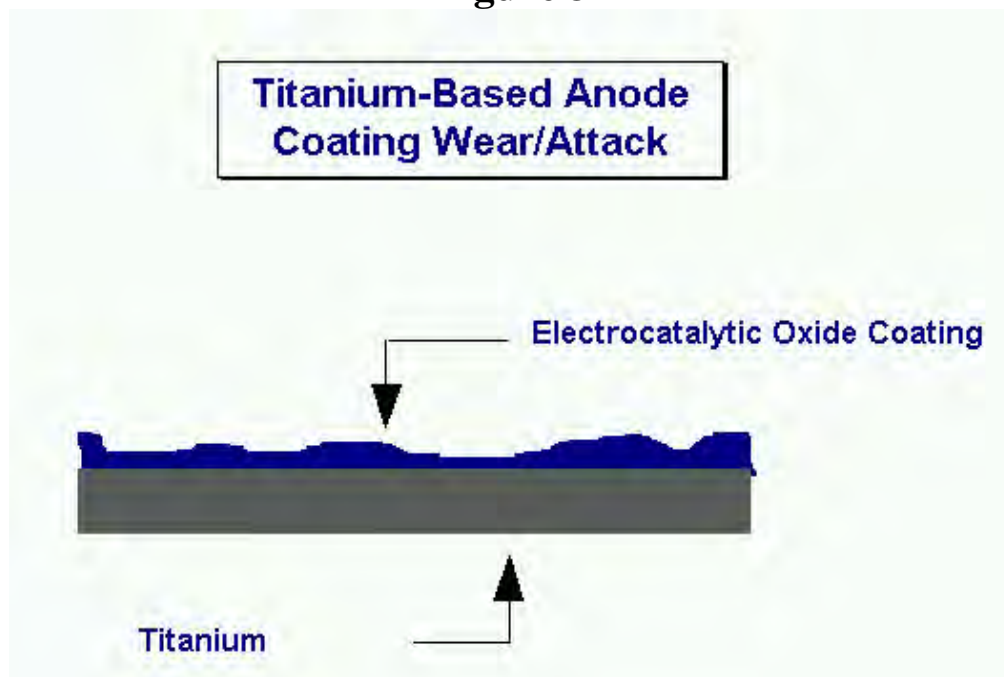
Figure 3

Examining a cross sectional view, there are four ways to interrupt the electrical circuit between the metal substrate and the electrolyte. The catalyst can be lost in service exposing the valve metal substrate which oxidizes and cannot accept electrons from solution without the presence of the catalyst (Figure 3). Secondly, the substrate can be chemically attacked at the coating interface, resulting in loss of adhesion of the coating (Figure 4). Thirdly, the interface between the catalyst and the substrate can become non-conductive preventing electron flow from the catalyst to the substrate (Figure 5). And finally, a foreign material can deposit on the surface of the catalyst effectively isolating the catalyst from the solution (Figure 6).

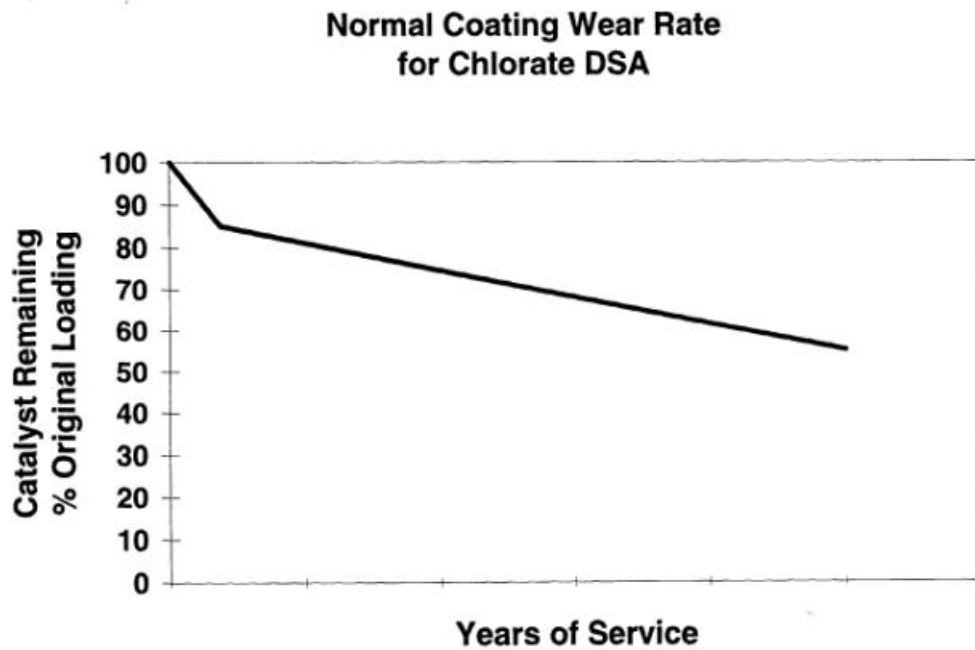
Figure 7

Brine impurities directly and indirectly affect the catalyst wear mechanism. Normal DSA performance is characterized in Figure 7. Typically a 10-15% initial loss of catalyst is observed over the first six months to a year of operation, followed by a gradual wear with time throughout the useful life of the coating. No change in voltage performance is expected until below 20% of original loadings are present. As wear continues, a gradual increase in operating voltage will be observed as wear exposes uncoated areas of the substrate. Current will shift to remaining active areas, locally increasing current density and observed operating voltage.

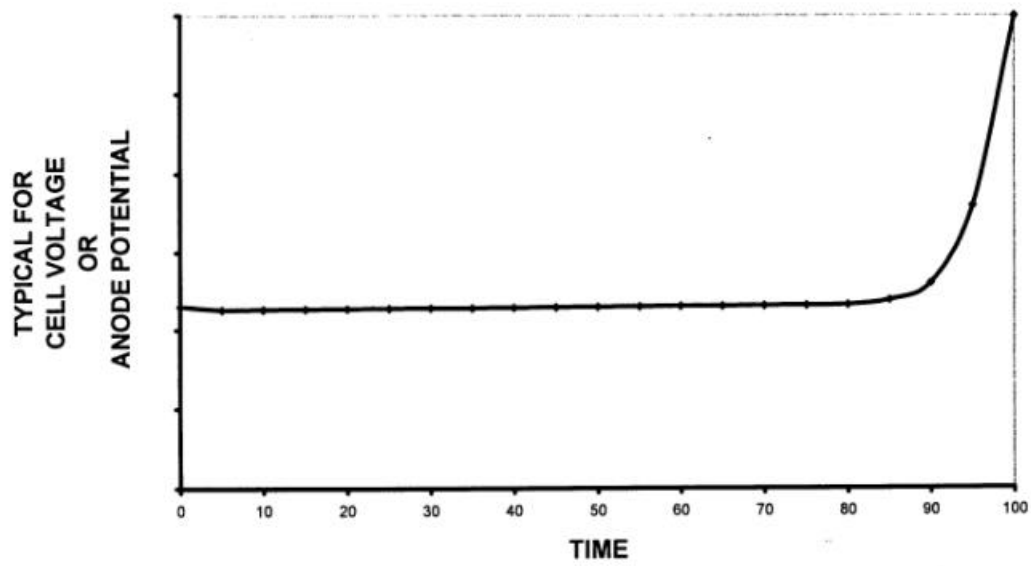
Figure 9
TYPICAL POTENTIAL TIME CURVE

A typical potential time curve for DSA anodes operated to passivation failure is similar for both chlorine and oxygen type anodes (Figure 9). The difference between the two is reflected in the time axis. For oxygen coatings at 3 kA/m^2 the time axis can be years. For chlorine coatings, producing only oxygen, the axis is measured in hours.

In both cases, the time to failure can be directly related to the amount of oxygen produced and the rate at which it is generated. Studies involving chlorine DSA coatings run to passivation failure under low NaCl conditions have resulted in a mathematical relationship between life, catalyst loading, and the rate of oxygen generation at the DSA surface.

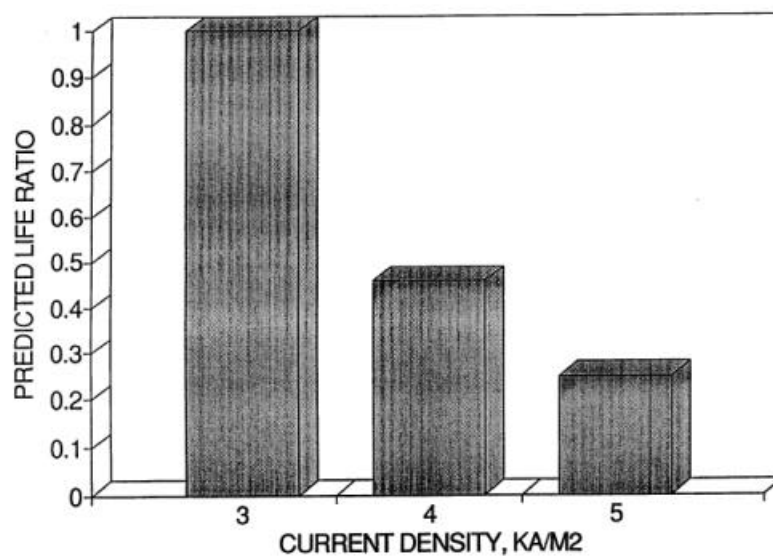
Figure 10
**IMPACT OF EXCEEDING DESIGN CONDITIONS
ON LIFE EXPECTANCY**

The exponential relationship between expected lifetime and the rate of oxygen production can result in rapid failure of a chlorine DSA when operation at conditions favoring increased oxygen production are encountered. If a catalyst loading is established for operation at a specified maximum rate of oxygen generation using 3 kA/m^2 but is operated at 4 or 5 kA/m^2 by design or through poor current distribution, the forecast life is significantly reduced as illustrated (Figure 10).

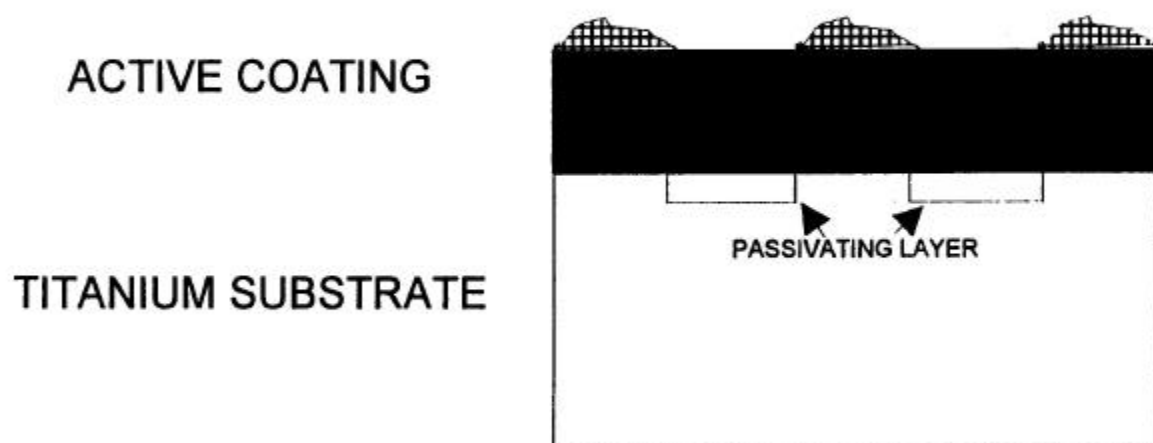
Figure 11

The most frequently encountered effect of brine impurities on DSA performance is the formation of blinding deposits. Both organic and inorganic deposits have been encountered over the years. The inorganic deposits can be the result of chemical precipitation reactions when solubility product limits are exceeded or may be electrochemically oxidized at the anode. The high surface area DSA catalyst effectively binds the deposit, blocking solution access to the surface. Failure to remove gross surface deposits can lead to an acceleration of the passivation mechanism (Figure 11).

In general, these deposits form by both electrochemical and electrophoretic processes. As they form, they alter the current distributions within the cell and can result in locally high current densities in non-blinded regions. The first indication of a problem is usually rising cell potentials. Inorganic deposits are normally visible on inspection. High single electrode potentials that return to normal on proper cleaning, rule out passivation. Coating loading and appearance are normal after cleaning.
