SIEMENS SOMATOM go.Up
SIEMENS SOMATOM go.Now

Safety Advisory Notice CT013/18/S

Re: SOMATOM go.Up and SOMATOM go.Now – Risk: Patient rescan might become necessary

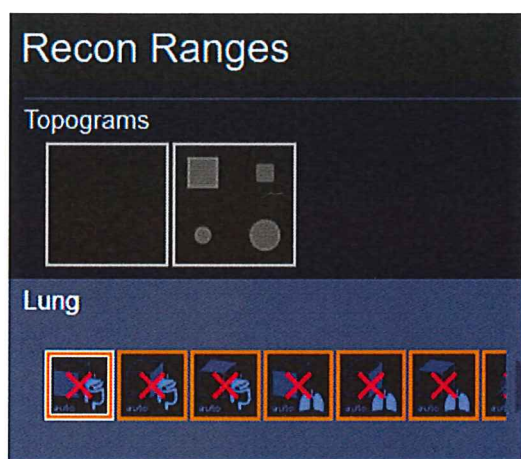
[Fig. 1]

Topic 1: We have observed sporadic software stability problems preventing the start of a reconstruction after the CT examination. If these problems occur, this is indicated by a red cross in the "Job Status" table (see example in Fig. 1 on page 2).

Screenshot example "Job status" – no reconstruction possible

Topic 1: If a reconstruction cannot be started after an examination, please reboot the system and repeat the aborted reconstruction. If the error persists, please contact your local Siemens Healthineers service support team. They can help you to decide whether a rescan is necessary or not.

The stability and image quality issues mentioned are solved by the software updates VA10A_SP2 and VA20A. The Osteo reconstruction issue is solved with the VA20A software update. The respective upgrade of your system is scheduled for the second half of this year 2018. You will be informed as soon as the update(s) are available for your system.

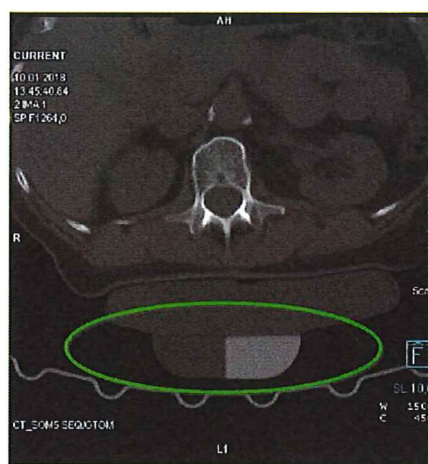
[Fig. 2]

A successful and complete Osteo reconstruction is visualized by full green bars in the column "Recon Progress" of the "Job Status" table and by images including the Osteo phantom in the tab card "CT View&Go" (for details please see Fig. 3 below). An example of a correct Osteo reconstruction is provided in Fig. 2. After checking the successful and complete Osteo reconstruction you may close the scan/recon tab card.

Example of a successful reconstruction for later use in syngo Osteo CT

- Topic 3: After an osteoporosis scan has been completed, the Osteo reconstruction needs to be started and completed directly after the scan. Therefore the images should be loaded and checked in "CT View&Go" *before* the scan/recon tab card is closed. Please do not close the scan/recon tab card before you have reconstructed and checked all Osteo images.

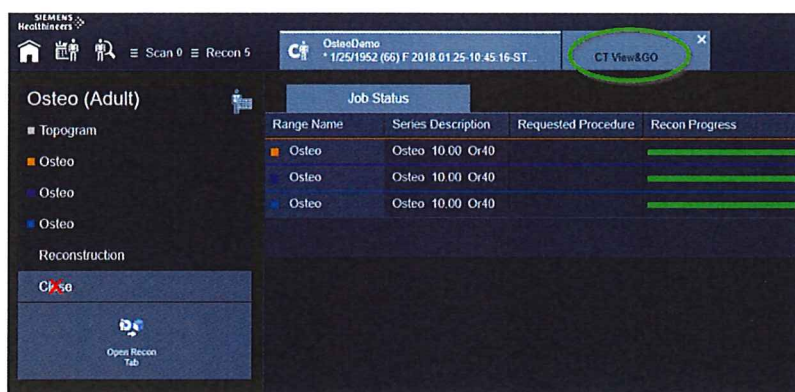
[Fig. 3]

GUI screenshot with Recon Progress bar
