URGENT FIELD SAFETY NOTICE

M320 Microscope System

FSCA Identifier: CAPA-2017-04-001-H

Replacement of mechanical parts in M320 parallelogram / swing arm

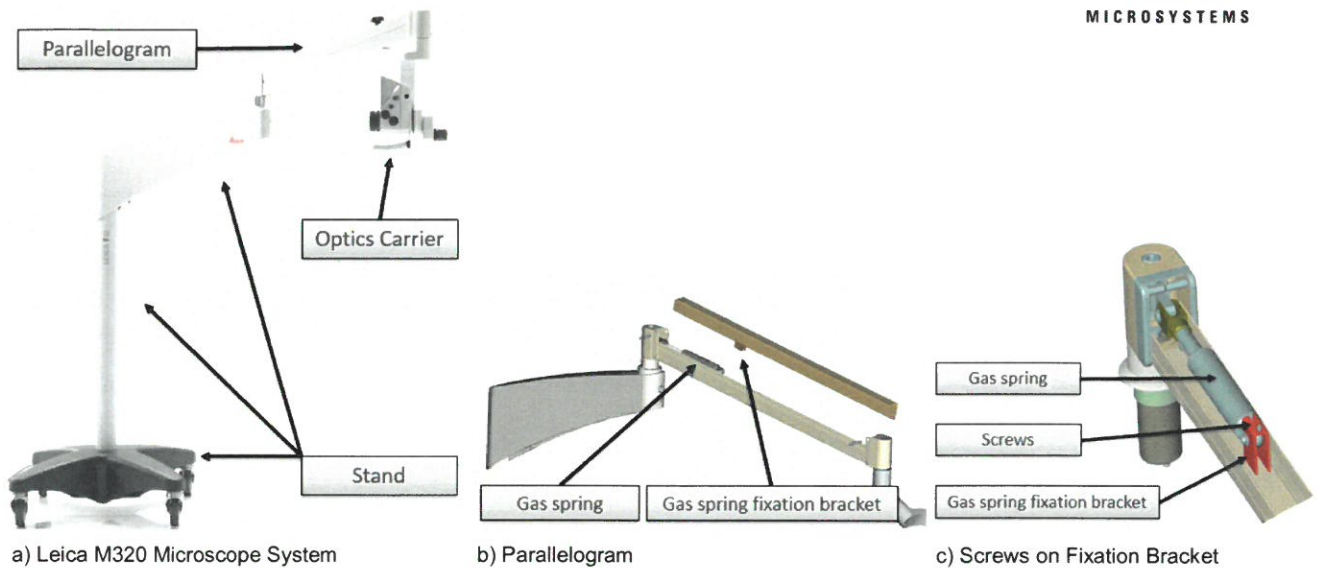
Recently three (3) complaints were reported involving mechanical part failures for the Leica M320 Microscope System. These specific systems had failures with the screws that hold the gas spring fixation bracket in place (see picture c below). Due to this failure, the gas spring, which is fixed to the upper part of the parallelogram, cannot hold up the weight of the optics carrier. This may potentially cause the M320 optics carrier to drop to the lower mechanical end stop (see pictures a and b below).

This failure was identical in all three (3) complaints and has been linked to an identified batch of screws, used in the manufacture of the gas spring fixation bracket. These screws have been determined to be non-conforming.

This defect does carry some potential injury risk. In the unlikely event that this observed defect were to occur, the M320 optics carrier may unintentionally drop into the surgical field, risking contact with the patient.

Leica Microsystems has chosen to initiate a field update to replace mechanical parts of the parallelogram for all M320 microscopes manufactured with screws from the nonconforming batch to ensure customer satisfaction and patient safety.

A Leica Microsystems representative will be contacting your facility to arrange the no-cost field update of your instrument. The field update will be scheduled to occur at your convenience within the next 12 months.
