FSN: 2018-IGTBST-005

DocID: DHF312811

URGENT - Field Safety Notice

Medical Device: OmniDiagnost-Eleva and OmniDiagnost-Classic**Tilt actuator base unit**

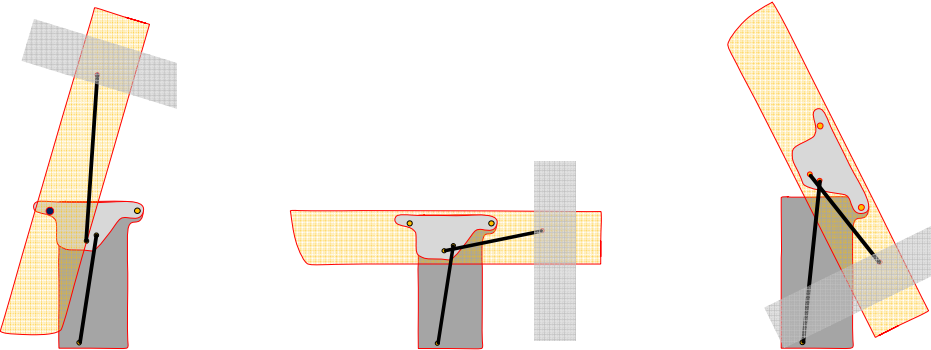
Philips has been reported instances in which the table of the OmniDiagnost system (OD-Eleva) suddenly started to rotate from 0 to 90 degree (table arm down) with high speed. The cause of this unexpected rotation movement is related to an issue with the fixation of the upper and lower tilt actuator.

System name:	System Code:	OmniDiagnost Eleva	708026	708027	708028	OmniDiagnost Classic	70859	708023	708024	708025
System name:	System Code:											
OmniDiagnost Eleva	708026											
	708027											
	708028											
OmniDiagnost Classic	70859											
	708023											
	708024											
	708025											
PROBLEM DESCRIPTION	<p>The fixation of the upper and lower tilt actuator, of the Omnidiagnost system might break off and the table will start to rotate from 0 to + 90 /- 90 degree with high speed. This rotating movement can not be stopped by the user.</p> <div style="text-align: center;">

</div> <p>Tilt towards - 90° Table horizontal Tilt towards + 90°</p>											
HAZARD INVOLVED	<p>If the fixation of the actuator breaks off and if the point of gravity of the table is beyond its rotation point, the table starts to rotate uncontrolled to its + / - 90 degree end point, potentially leading to the patient falling off the table.</p> <p>During procedures, the system is remotely operated from the control room. In case of an uncontrolled rotation, there is a risk of injury for the patient, user or bystander standing in the vicinity of the system (e.g. the tube may hit the legs of that person). This might lead to harm that necessitates medical intervention for the person involved.</p>											
HOW TO IDENTIFY AFFECTED PRODUCTS	<p>All units of the systems identified in the section "Affected Products" above are affected.</p>

ACTIONS PLANNED BY PHILIPS	<p>All possibly affected products in the field will be corrected by means of a field change order free of charge.</p> <p>A Philips representative will replace affected material on the upper and lower tilt actuator in the affected systems.</p> <p>You will be contacted by our local Philips representative to schedule this corrective action.</p> <p>This action will start effective July 2018.</p>
FURTHER INFORMATION AND SUPPORT	<p>If you need any further information or support concerning this issue, please contact your local Philips representative:</p> <p>0800 80 3000</p>
