980E Dump Body Bolster Corrosion

10/16/24

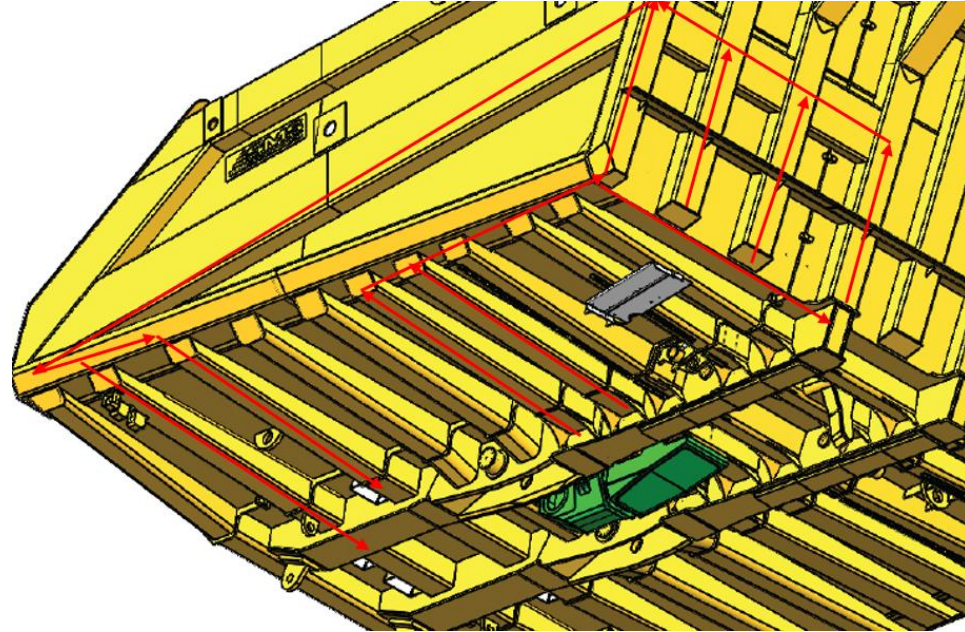
- Bed is angled at a decline so condensation pools in the corners of bolsters closest to the ground.
- Leading edge corner most susceptible to corrosion and damage.

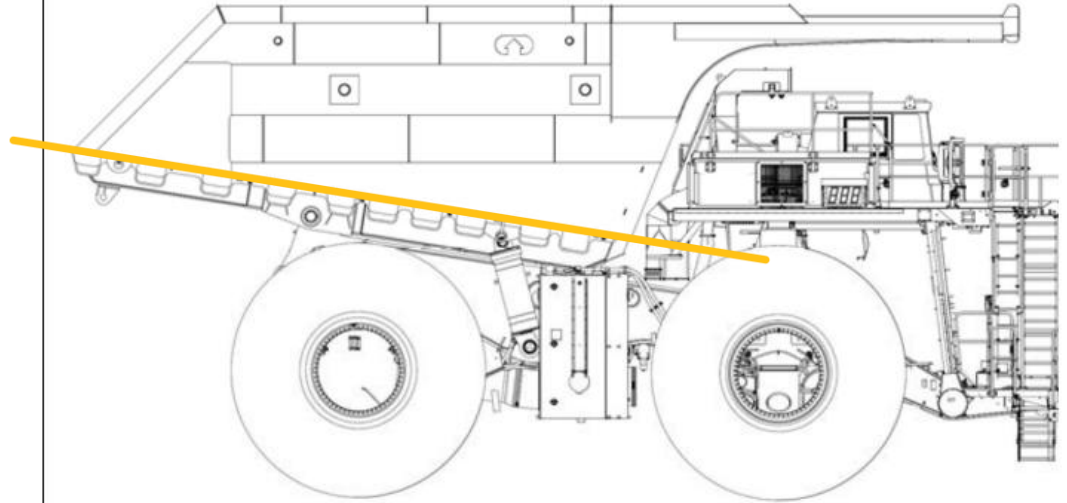
- Bed is angled at a decline so condensation pools in the corners of bolsters closest to the ground.
- Leading edge corner most susceptible to corrosion and damage.

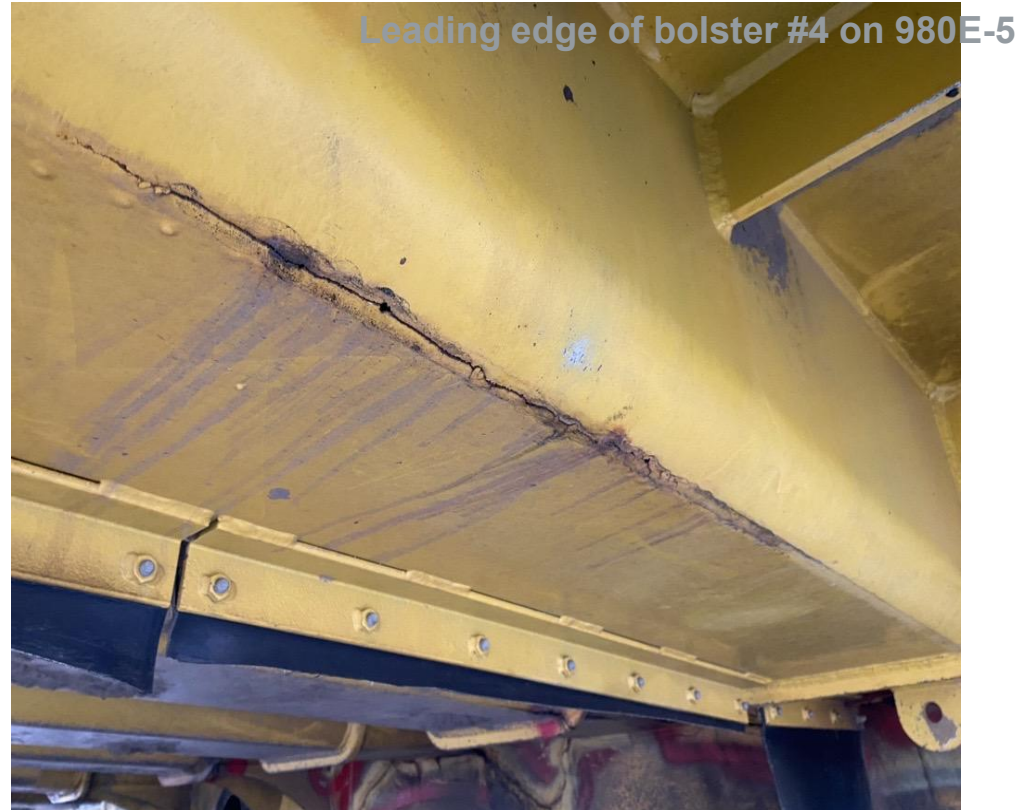
980E-5 Dump Body

- Corrosion is highest on bolsters where exhaust initially enters
- Also where exhaust is hottest
- Bolster 4 and 5 on 980E-5

Bottom panel on bolster
4 & 5 are darkest
indicating most corrosion

- Corrosion Mitigation: application of a thermal spray coating on **critical horizontal exhaust bolsters** most susceptible to corrosion.
- Use aluminum or Inconel based thermal spray coating
- Apply thermal spray coating to the inside of bolster 3,4 & 5 on 980E-4 due for rebuilds.
- Apply thermal spray coating to bolster 4 & 5 on 980E-5 dump bodies waiting to be in installed/assembled
- F347 is the -5 closest to a rebuild. Not economical to take -5 trucks out of operation to coat bolsters.
- Greatest results to be seen from coating first 3ft from the middle on bolsters 3,4,5 on 980E-4
- Contact Kymera International & SMS to discuss coating new bolsters before being welded to bed floor during rebuild.

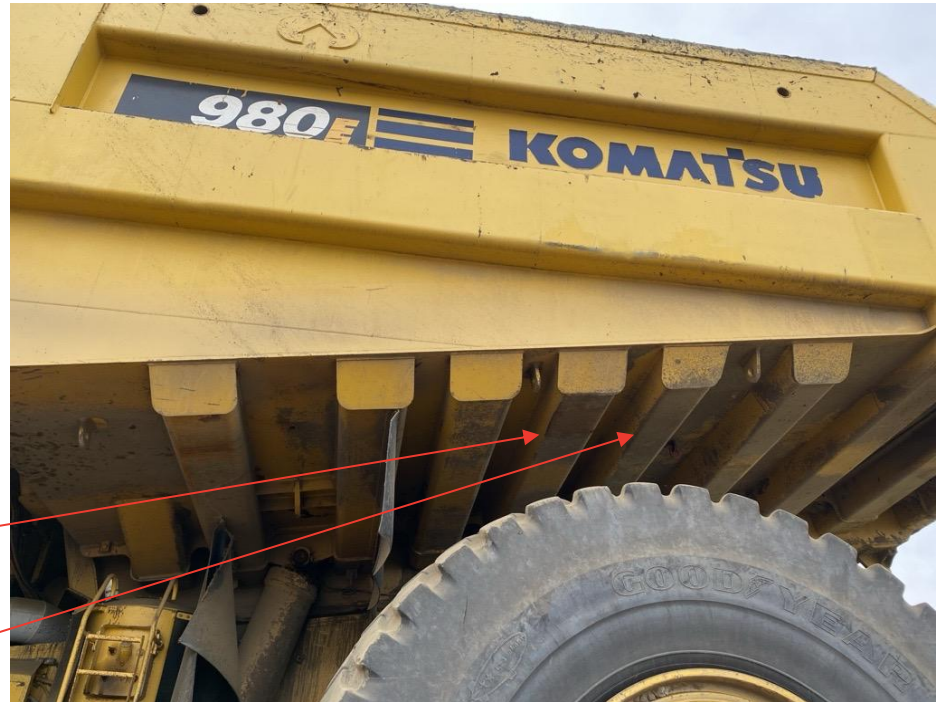
Leading edge
on bolster 4 &
5 showing the
most wear

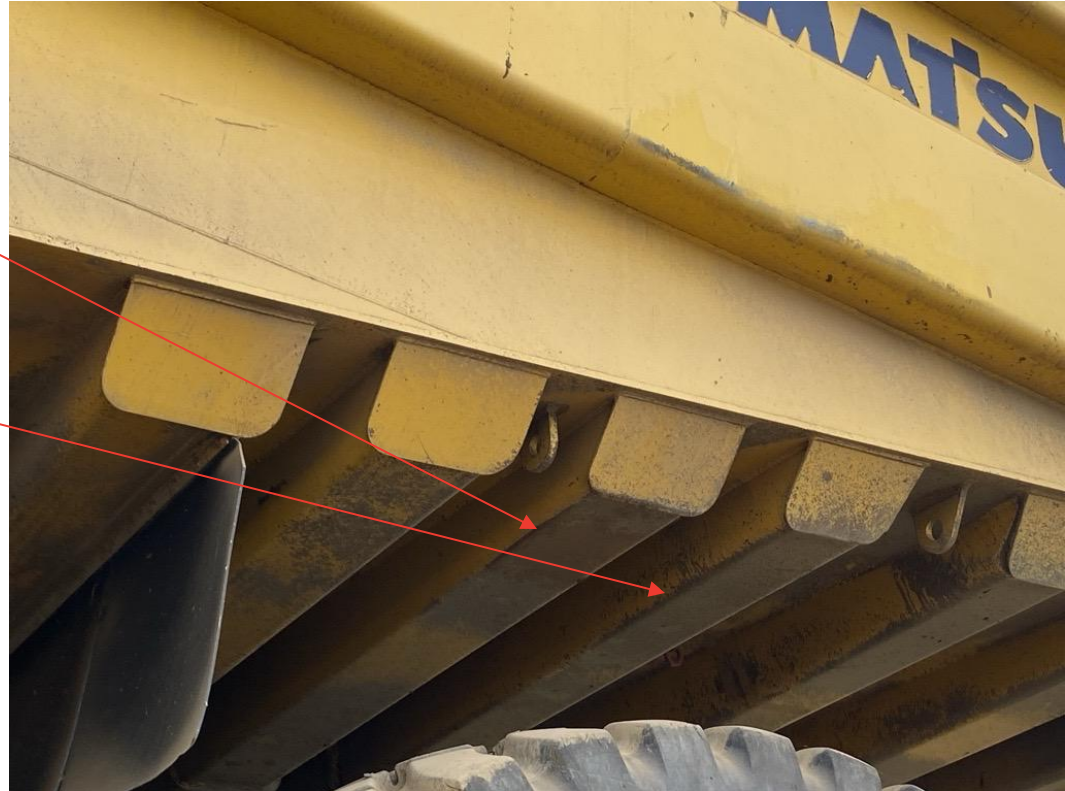
- Exhaust path through bolsters is different on the 980E-4 thus different areas of high corrosion.
- Exhaust enters through the front wall, matches where corrosion is highest.

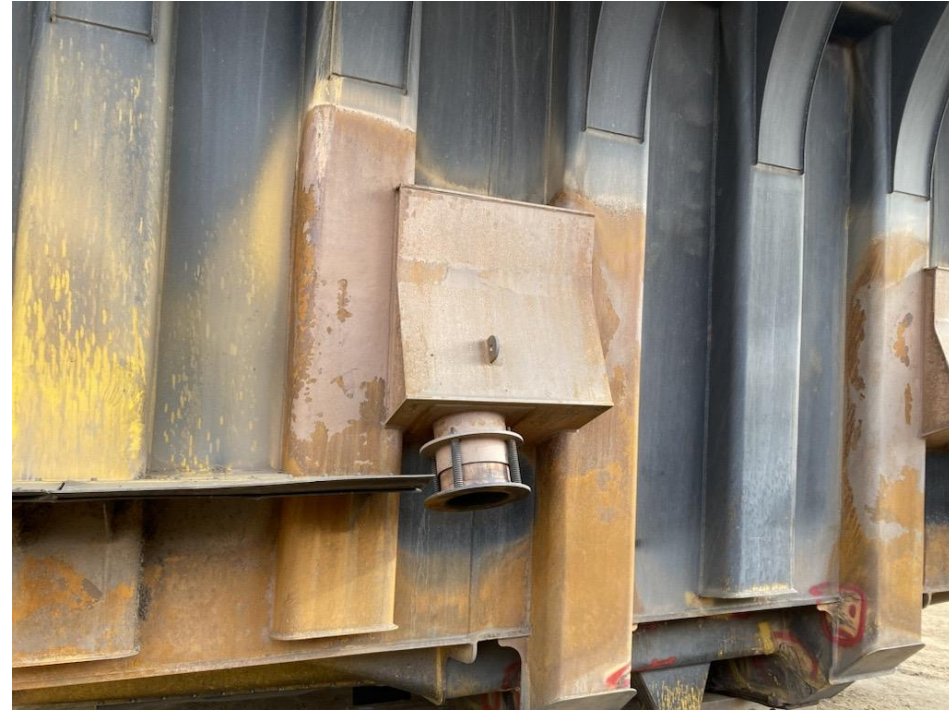
- Exhaust path through bolsters is different on the 980E-4 thus different areas of high corrosion.
- Exhaust enters through the front wall, matches where corrosion is highest.

Front wall experiences highest
concentration of highest
temperature

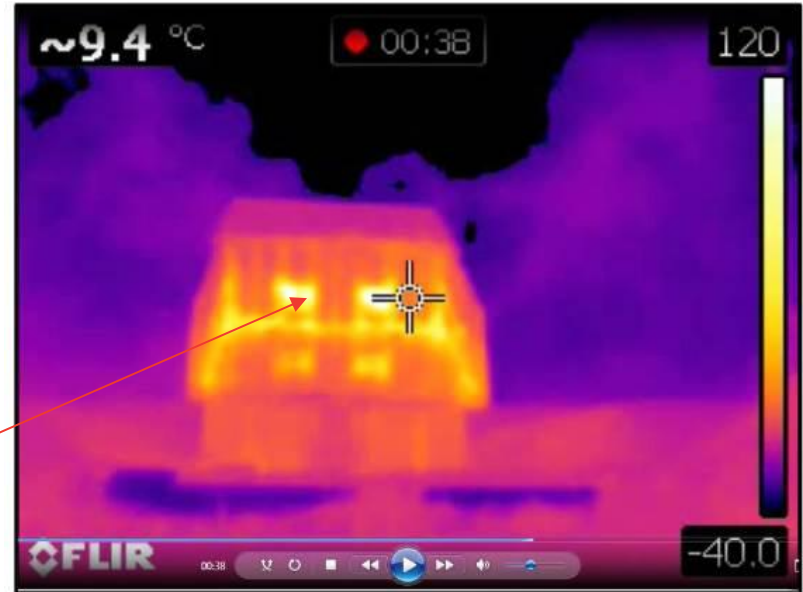
- Bolster corrosion of 980E-4 is fairly even
- No bolster showing more corrosion than the others
- Front wall takes the extent of damage from exhaust.

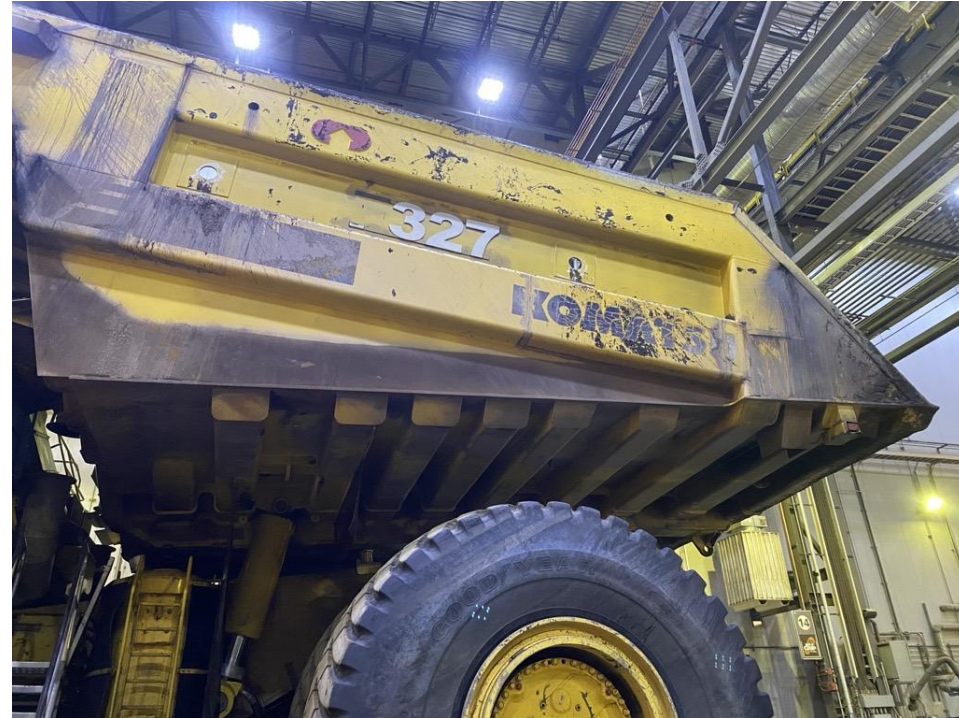
- Standard bolster thickness is $3/8"$ = 9.525mm
- Took readings on bolster #4 on F0325
- Average reading of 5.8mm, across 5 points
- Lowest Reading of 3.3mm
- Thinnest near middle of truck, thicker moving further away

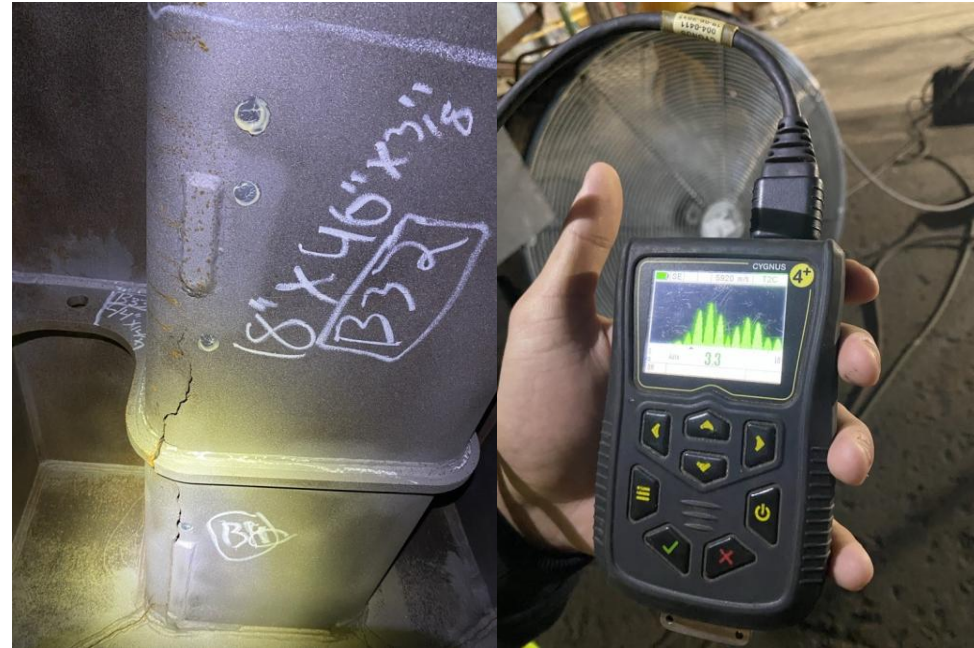
Crack on leading edge of Left Bolster #4 near frame

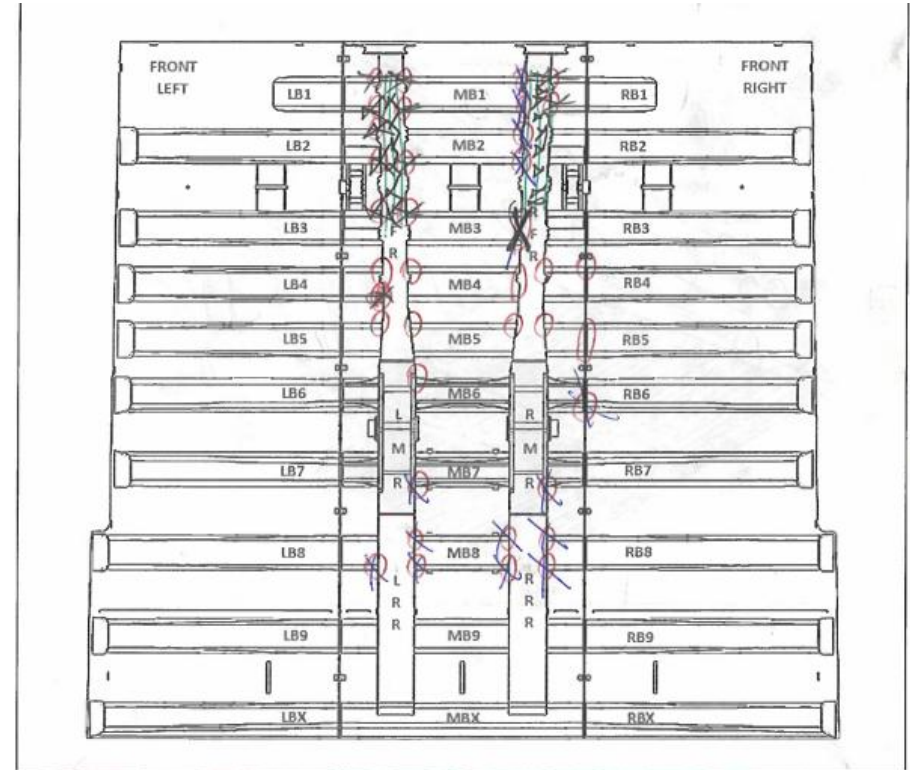
F347 Crack Map

- On 980E-4 Front Wall Bolsters see most corrosion due to exhaust heat – However they are not removed during rebuilds.
- Bolsters 3, 4, 5 subject to second most exhaust heat corrosion. Specifically first 3ft from the center of bed.
- Bolster 8 subject to greatest length of cracks – Suspected mechanical fatigue, not corrosion induced.
