| Overview | | | | Site |
|---|---|---|---|---|
| Inspect No: | 1139 | Page: | 1/1 | <div>AECOM - MIDLANDS HUB</div> <div>Drift Drive Crick Northamptonshire NN6 7GZ</div> |

| Client-ID | Make / Model | Serial No | ISI Equipment No |
|---|---|---|---|
| Roof Access Ladder | Ladders & Scaffolding All | Roof Access Ladder | 2001388 |

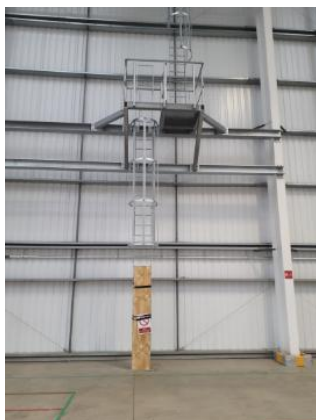
| Asset Photograph | |
|--|--|
| Capture photograph of Asset, including asset number | See Photo 1 |

| Asset Photograph | |
|--|--|
| Intolerable - Defects requiring immediate action | Missing horizontal rungs at first rest platform. Installation is not compliant with BS4211 |
