## Stellaris® LM3S9B92 RevB1 Errata

This document contains known errata at the time of publication for the Stellaris® LM3S9B92 microcontroller. The table below summarizes the errata and lists the affected revisions. See the data sheet for more details.

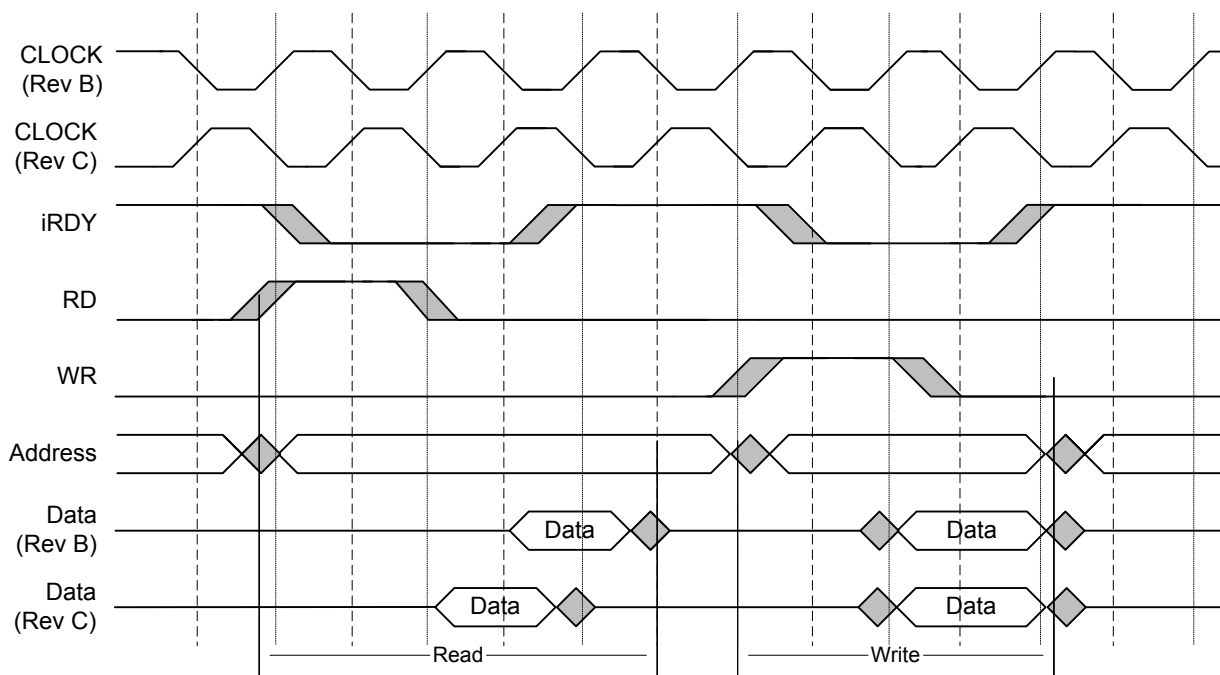
**Figure 1. Timing Differences Between Rev B and Rev C Devices**

The clock signal that is output on the EPIO31 signal in General-Purpose mode is inverted. Figure 1 on page 13 shows the timing differences between Rev B parts and Rev C parts.

Use the opposite edge for timing when designing with this interface. During read cycles, ensure that the data meets set up and hold times for the appropriate edge as shown in the diagram above.

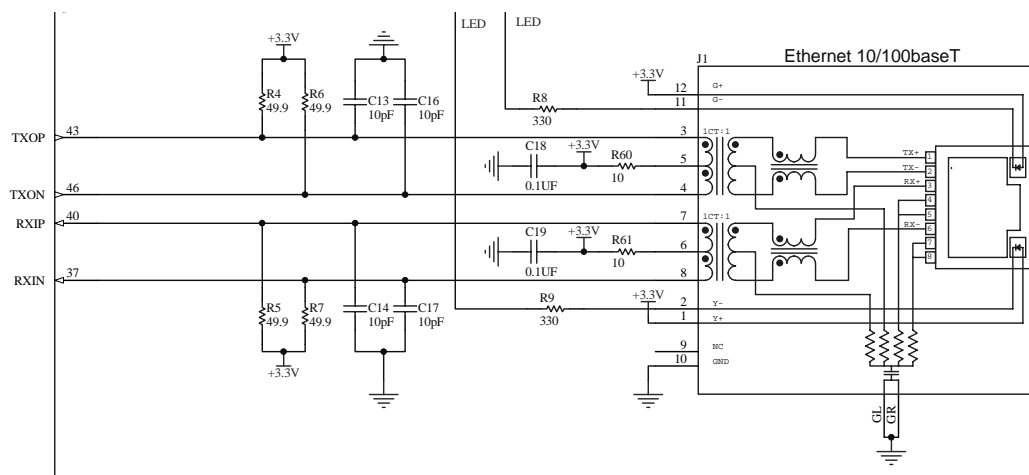
**Figure 2. Recommended Center-Tap Connections**

The microcontroller experiences some packet loss with Ethernet cables longer than 50 meters in normal operating conditions.

1. Add 10  $\Omega$  resistor to the center-tap of the transformer as shown in the figure. These resistors should be replaced by a direct connection for silicon that has this item fixed.
2. Continue using the recommended circuit, but limit cable lengths to 50 meters.
