Reservoir Inspection Report

Lisvane Reservoir

This document has been prepared in good faith based on data collected by Abyss Solutions Pty. Ltd. during the inspection of Lisvane Reservoir on January 21-22, 2019. The information contained herein, is to the best knowledge of Abyss Solutions Pty. Ltd. complete and accurate.

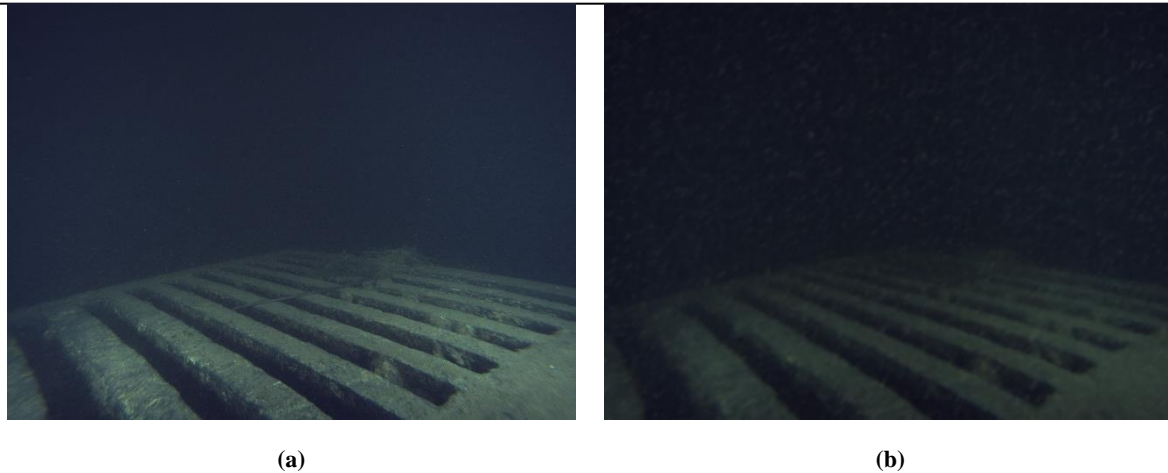
Figure 1 Comparison of the imagery obtained using Abyss Solutions' imaging system and subject to post-processing (a) with the ROV navigation camera imagery (b) of the Lisvane Reservoir scour outlet screen.

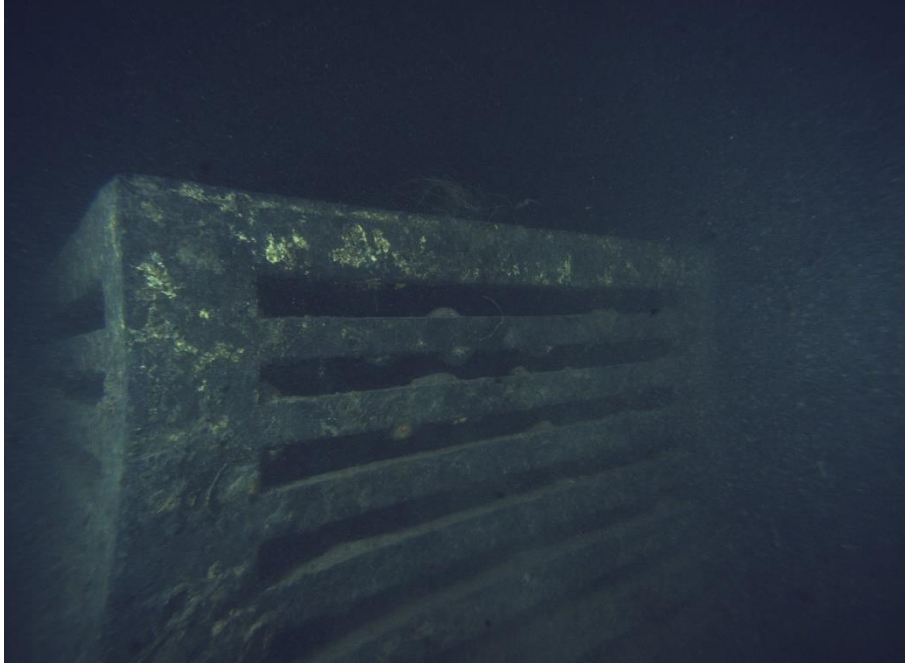
Figure 2 - North face of scour outlet screen appears to be intact, above the silt level and free of obstructions.

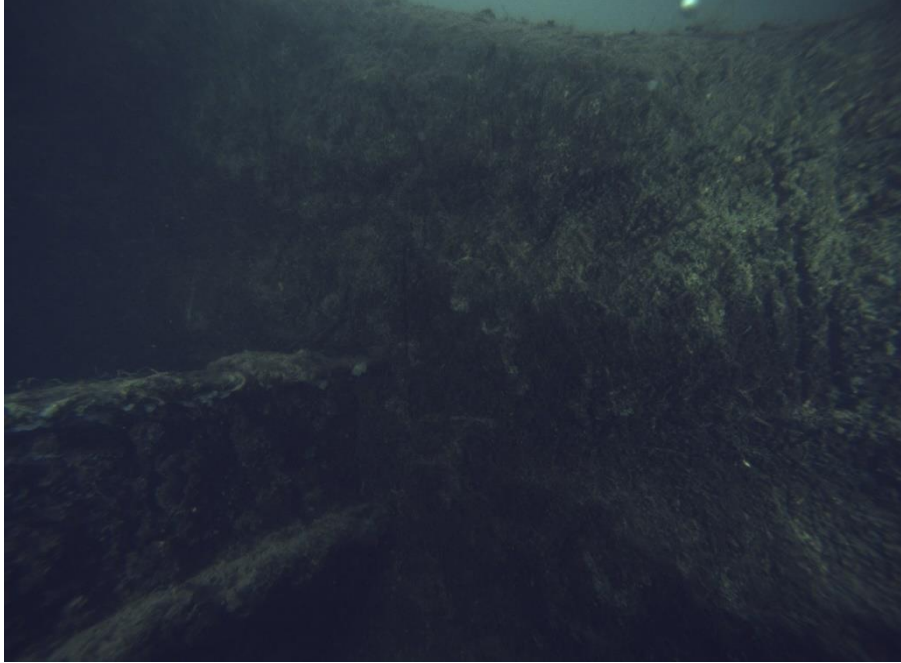
The concrete headwall was found to be intact with no signs of spalling or major concrete damage. The I-beam bracing was intact. Examination of the I-beam to headwall interface reveals that the I-beam was embedded within the concrete wall. The interface appears free of major spalling. The I-beam and headwall were covered in thick fouling.

Figure 9 - Close up of interface between I-beam and concrete headwall of inlet. The I-beam appears to be embedded within the concrete. The interface is free of major spalling.
