# Reservoir Inspection Report

*Lisvane Reservoir*

Welsh Water  
Pentwyn Road  
Nelson, Treharris  
Mid Glamorgan CF46 6LY

Abyss Solutions Pty. Ltd.  
Unit 35 11-21 Underwood Rd  
Homebush NSW 2140  
Australia

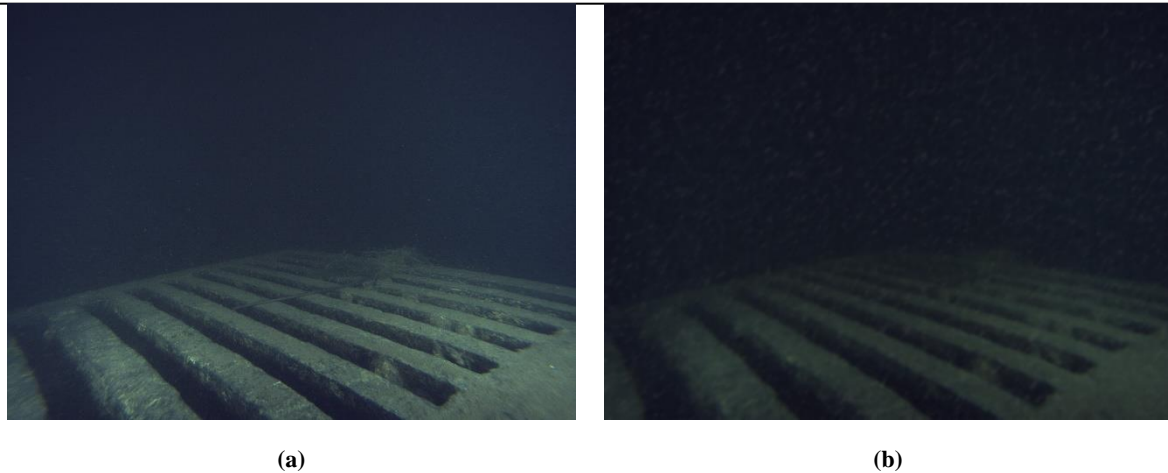
Figure 1 Comparison of the imagery obtained using Abyss Solutions' imaging system and subject to post-processing (a) with the ROV navigation camera imagery (b) of the Lisvane Reservoir scour outlet screen.

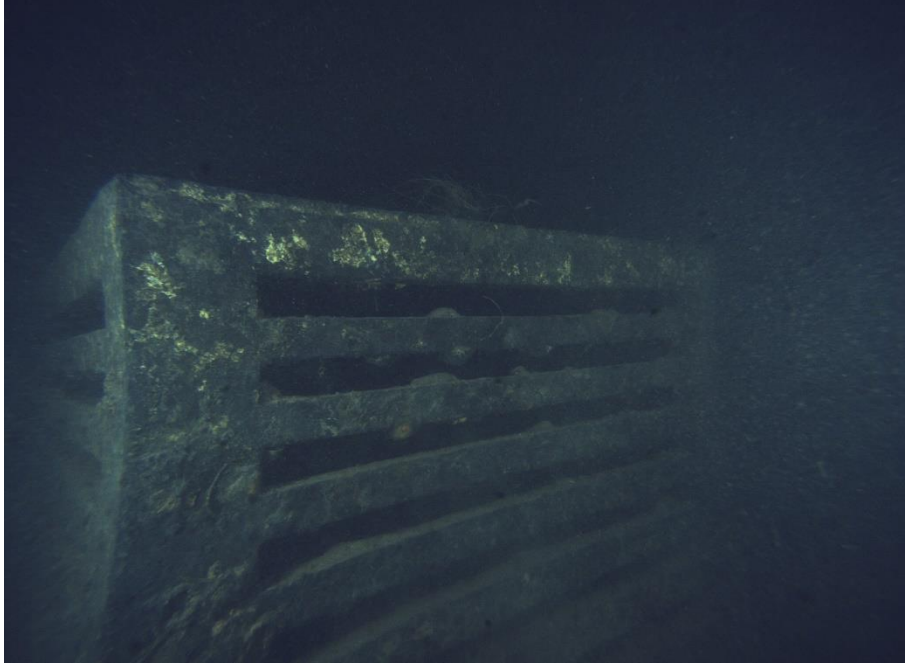
**Figure 2 - North face of scour outlet screen appears to be intact, above the silt level and free of obstructions.**

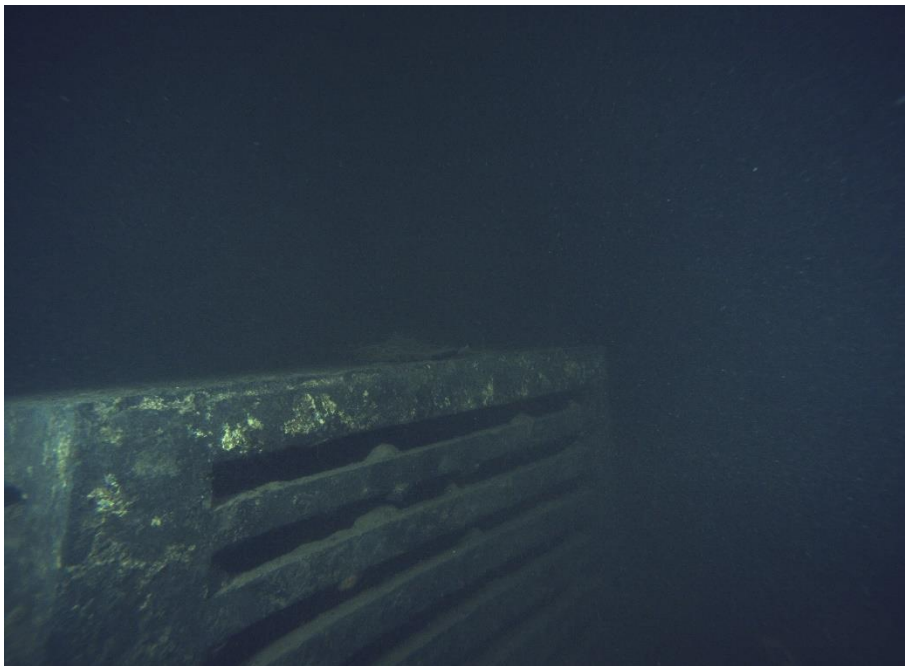
**Figure 3 - East face of scour outlet screen appears to be intact, above the silt level and free of obstructions.**

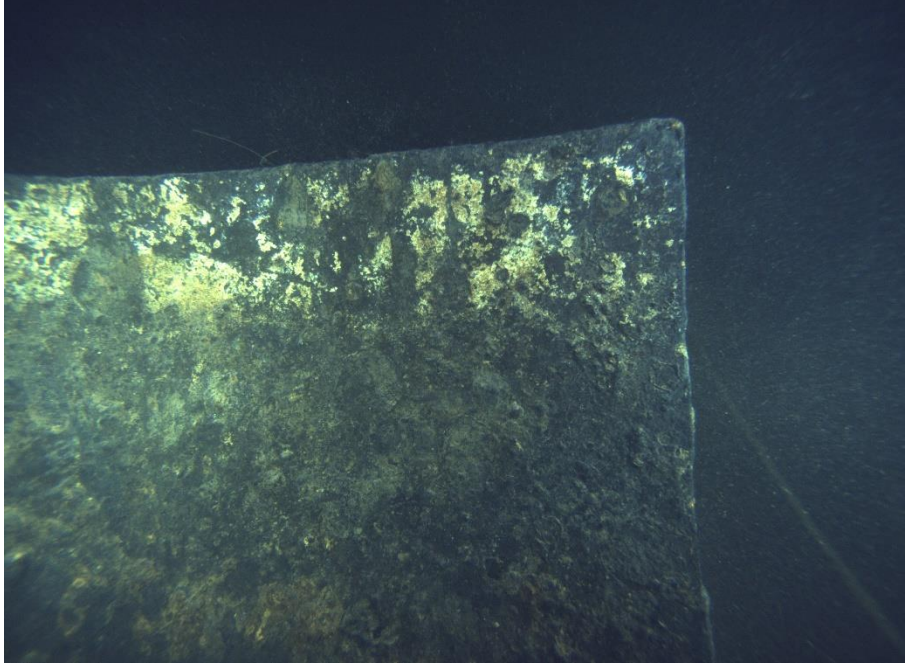
**Figure 4 - West face of scour outlet screen is completely solid and appears to be intact.**

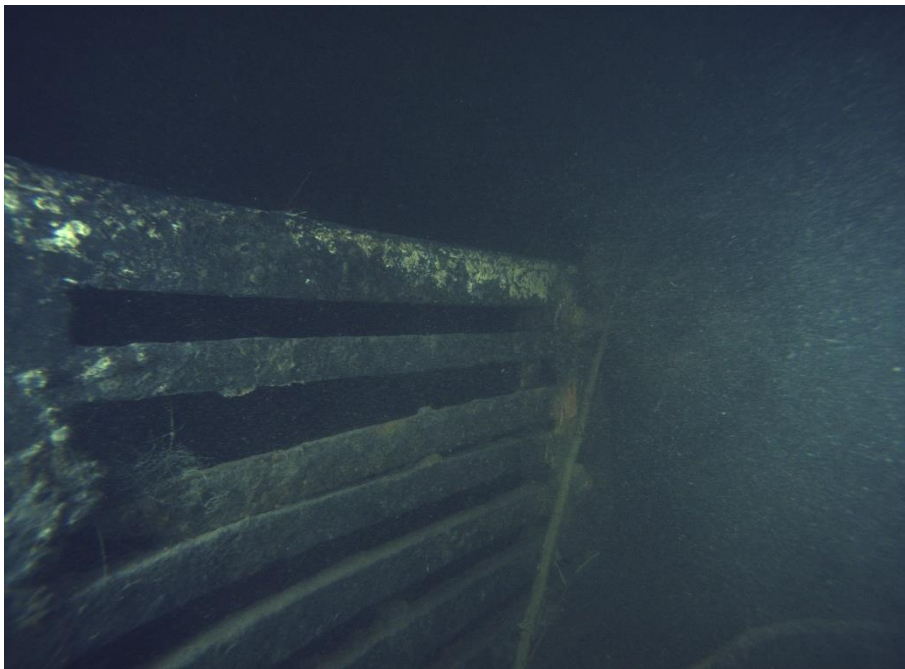
What is believed to be the original scour outlet of the dam was located at the north-east of the reservoir. A rectangular screen with 4 open sides and horizontal penetrations was found over the outlet. The screen was largely intact with the silt level below the bottom of the screen. A fractured bar was observed at the southern face of the screen. Debris was lodged against the southern and top faces. All other faces of the screen appear to be intact and free of obstructions.

The scour outlet was judged to be in adequate condition based on the moderate deficiencies (fractured bar & debris) identified. Nevertheless, the outlet appeared to be functioning as designed. Imagery of the outlet screen is presented in Figures 2-06. Inspection video footage of the outlet and a visual 3D model are presented in Figure 7 and Figure 8, respectively.

**Figure 5 - South face of scour outlet screen presents a fractured bar and debris lodge against it. The silt level appears to be below the screen.**

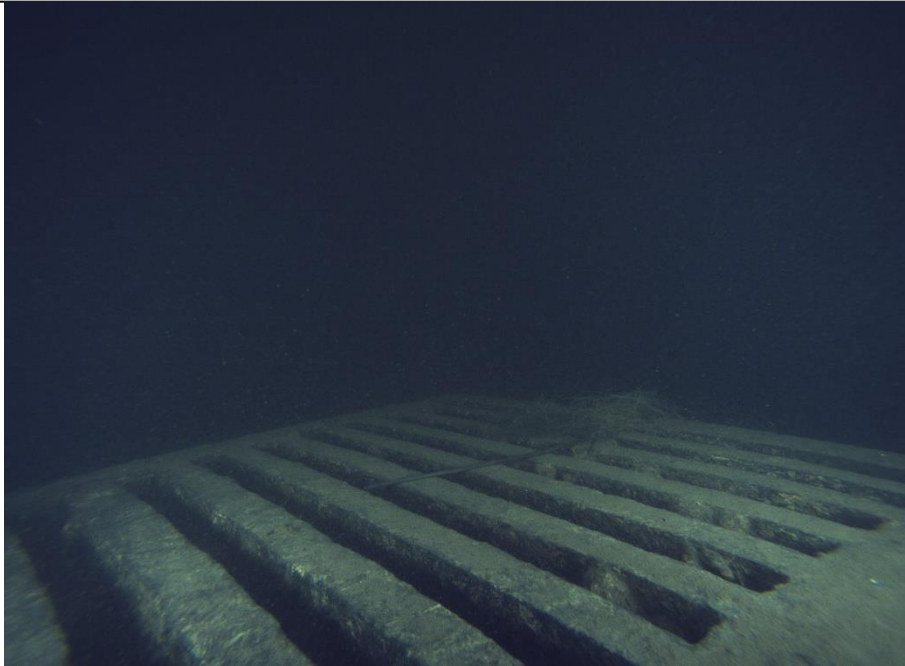
Figure 6 - Top face of scour outlet screen presents minor debris lodge against it. The silt level appears to be below the screen.

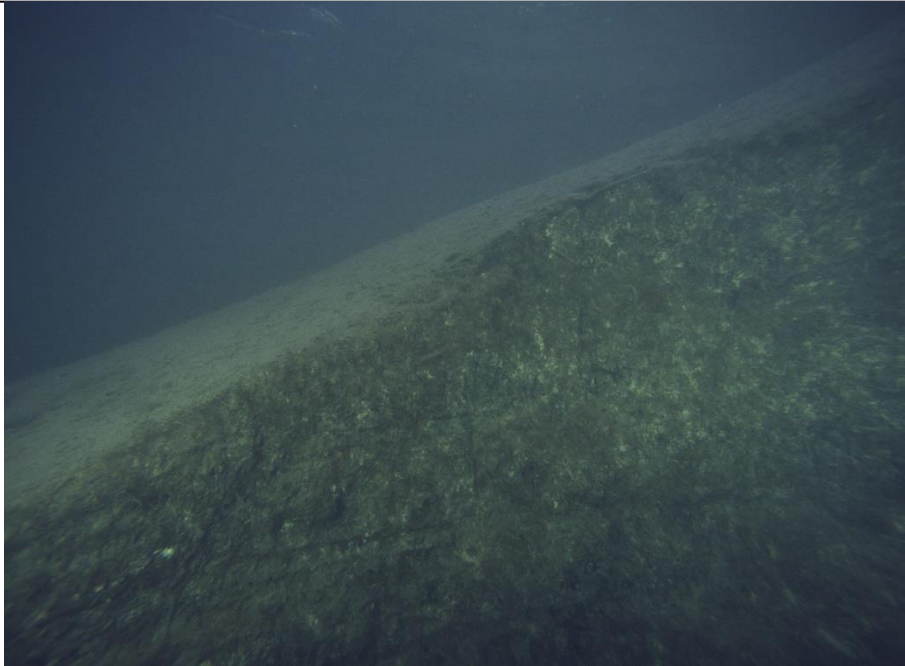
The concrete headwall was found to be intact with no signs of spalling or major concrete damage. The I-beam bracing was intact. Examination of the I-beam to headwall interface reveals that the I-beam was embedded within the concrete wall. The interface appears free of major spalling. The I-beam and headwall were covered in thick fouling.

**Figure 11 - Eastern end of inlet concrete headwall. The headwall appears intact with no signs of major spalling or concrete damage. The concrete is covered in thick fouling.**

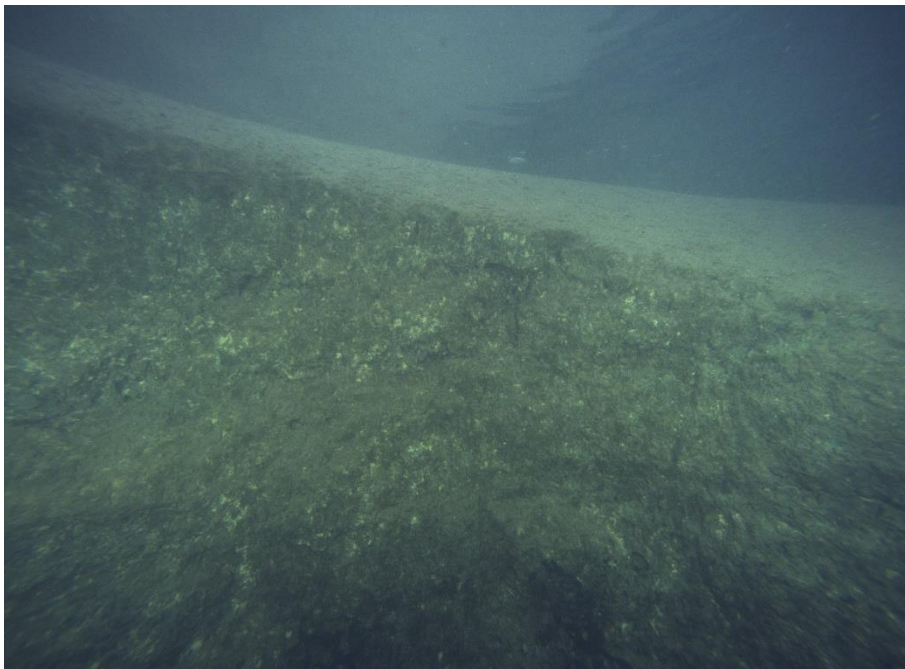
**Figure 12 - Western end of inlet concrete headwall. The headwall appears intact with no signs of major spalling or concrete damage. The concrete is covered in thick fouling.**

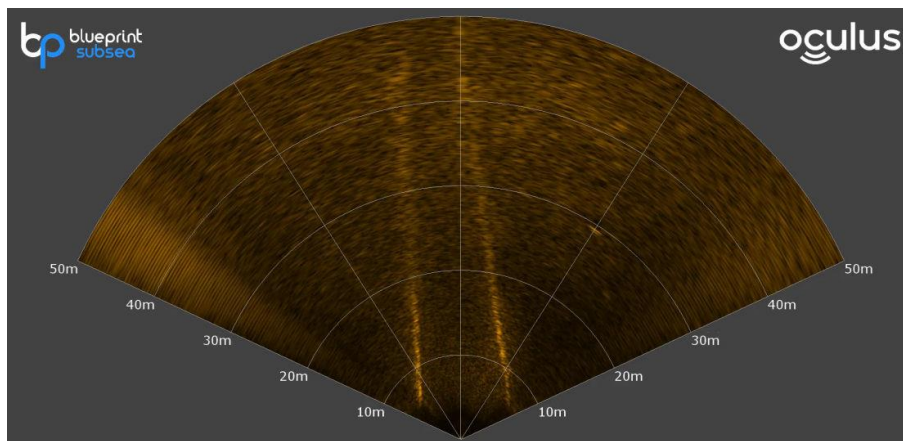
Figure 16 - Sonar image of embankment inlet channel.

What is believed to be a channel extending from the embankment inlet was identified at floor level using a sonar scan. The channel extended approximately 65m from the inlet and was found to be 2.4m deep. The channel gradually disappears into the reservoir floor at its end.

The channel appeared well defined in the sonar imagery indicating that it is largely intact and not completely silted. The channel was judged to be in good condition. A sonar image and video of the channel are presented in Figure 14 and Figure 15, respectively.

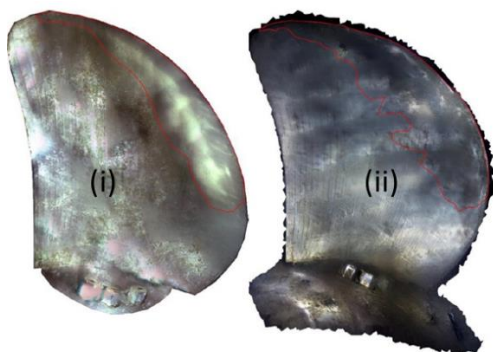
Blade	Fault	Increase in affected surface area
1/SIM003-2	Pitted surface	8.7%

Figure 18 - Pitting corrosion highlighted on 3D models of a propeller blade between successive inspections. The change in affected surface area is estimated between the (i) first and (ii) second inspections.
