Dam Inspection Report

Craig Goch Dam

Welsh Water
Pentwyn Road
Nelson, Treharris
Mid Glamorgan CF46 6LY

Abyss Solutions Pty. Ltd.
Unit 35 11-21 Underwood Rd
Homebush NSW 2140
Australia

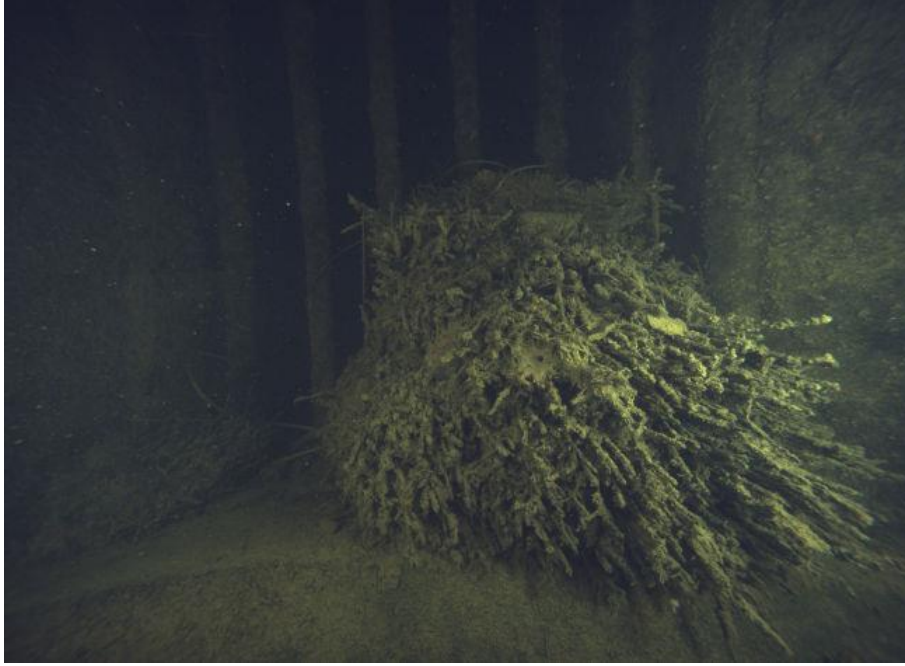
Figure 21 - Trash screen grate at 8m depth on the western wall of the outlet tower. The grate is heavily corroded with significant material loss. Material obstructing 10% of the grate was observed.

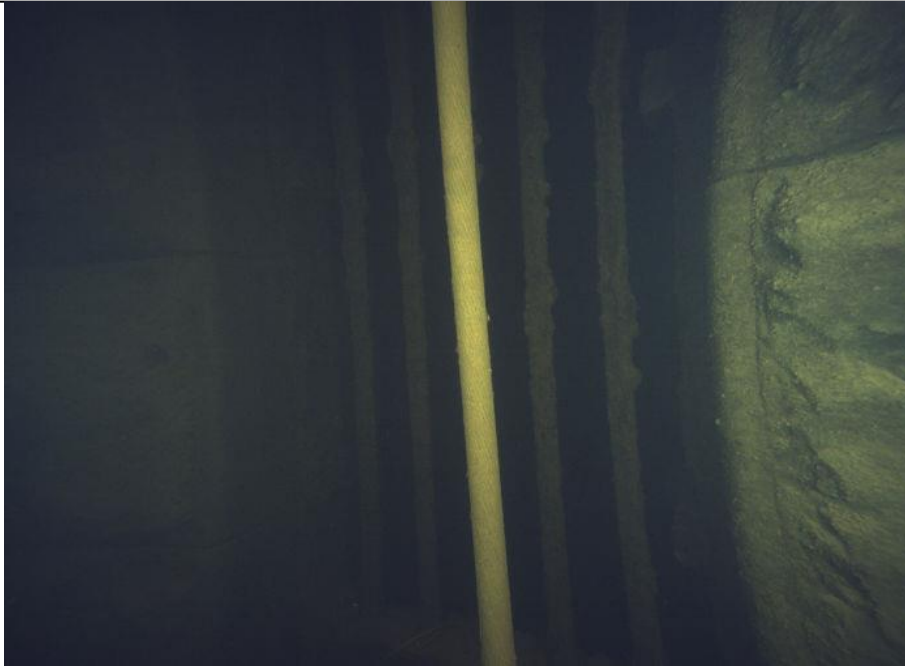
Figure 29 - Trash screen grate at 8m depth on the south eastern of the outlet tower. The grate is heavily corroded with significant material loss.

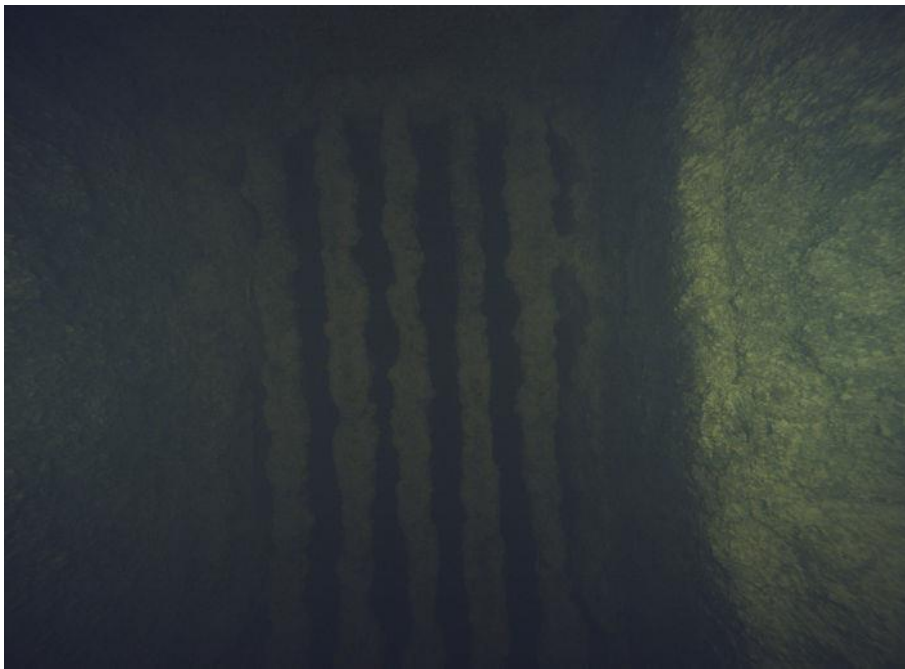
Figure 34 - Trash screen grate at 10m depth on the eastern wall of the outlet tower. The grate is heavily corroded with significant material loss.

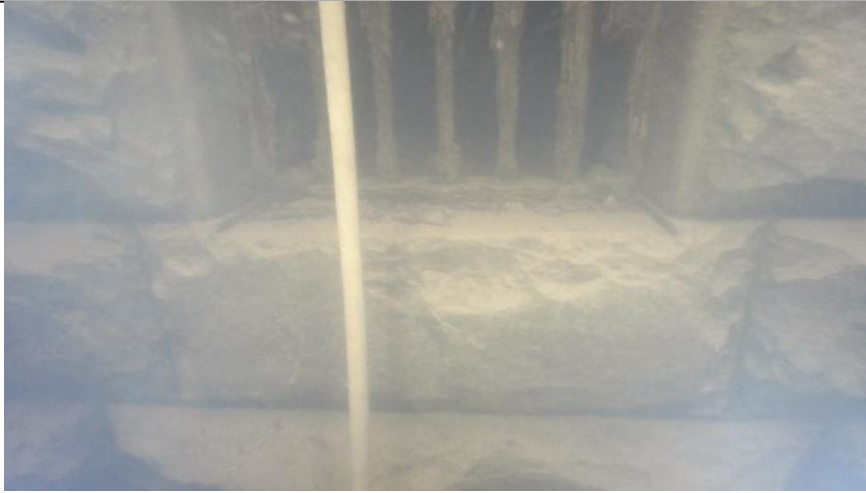
Figure 36 - Earthing cable at 5m depth. The cable appears intact.

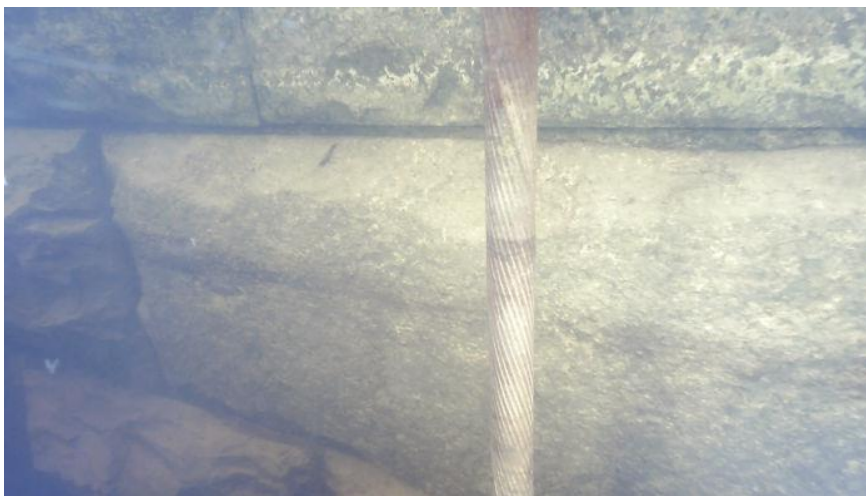
Figure 38 - Lightning cable at 5m depth. The cable appears intact.

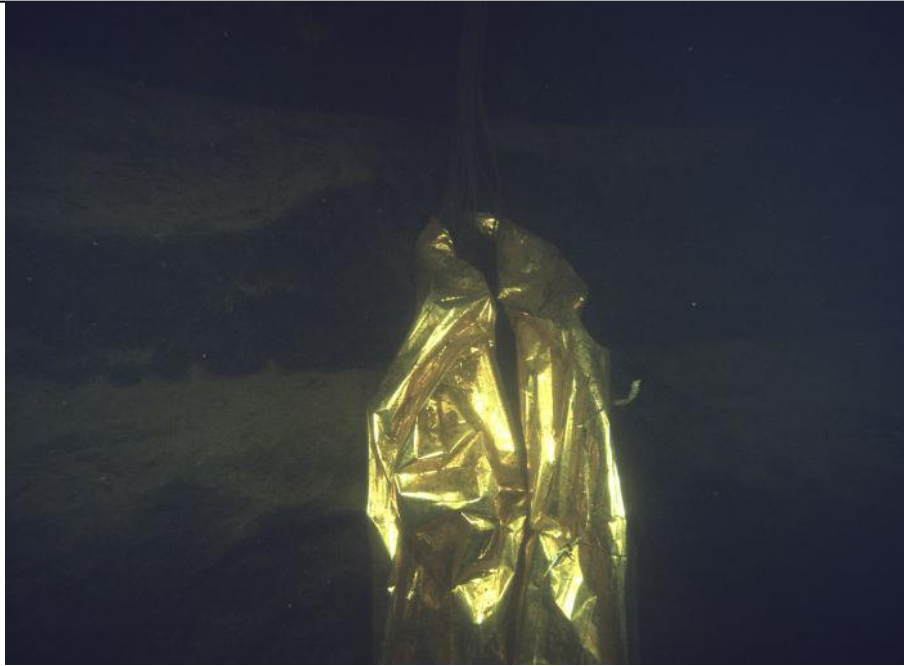
Figure 39 - Base of lightning cable at 8m depth. The cable termination device appears to be missing. A balloon appears to be caught on the end of the cable.

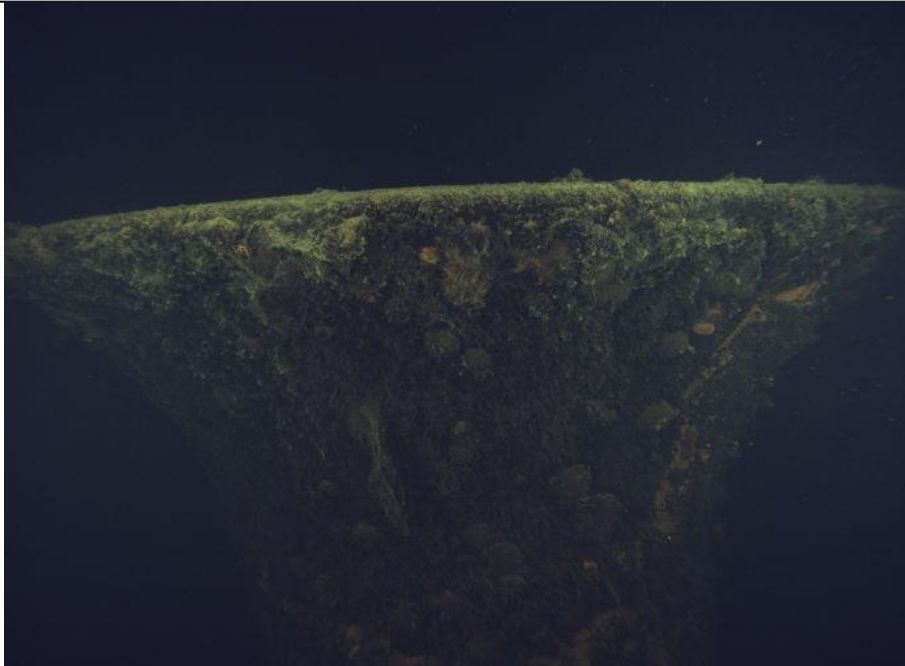
Figure 41 - Bellmouth at the end of the inlet pipe. The bellmouth appeared intact and free of obstructions.

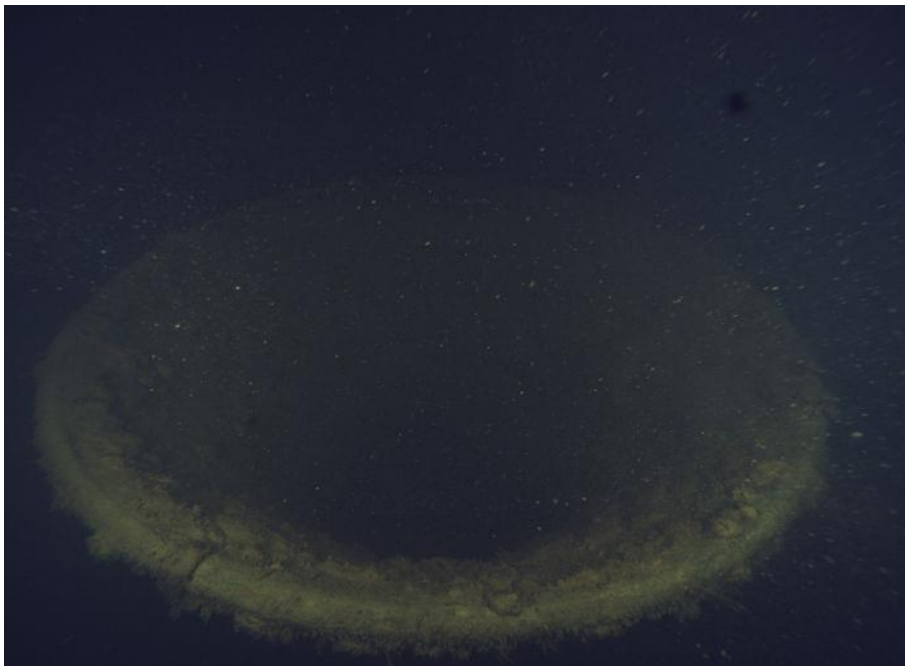
Figure 42 - Top of bellmouth at the end of the inlet pipe. The bellmouth appeared intact and free of obstructions.

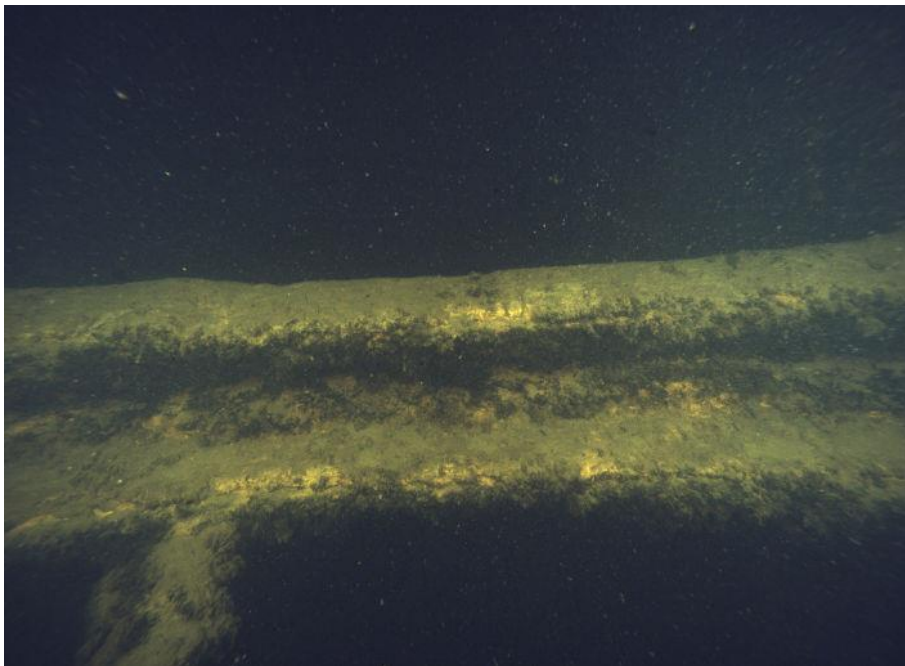
Figure 46 - I-beam beneath inlet pipe. The I-beams appear heavily fouled and are likely deteriorated. Nevertheless, they appear to be intact.

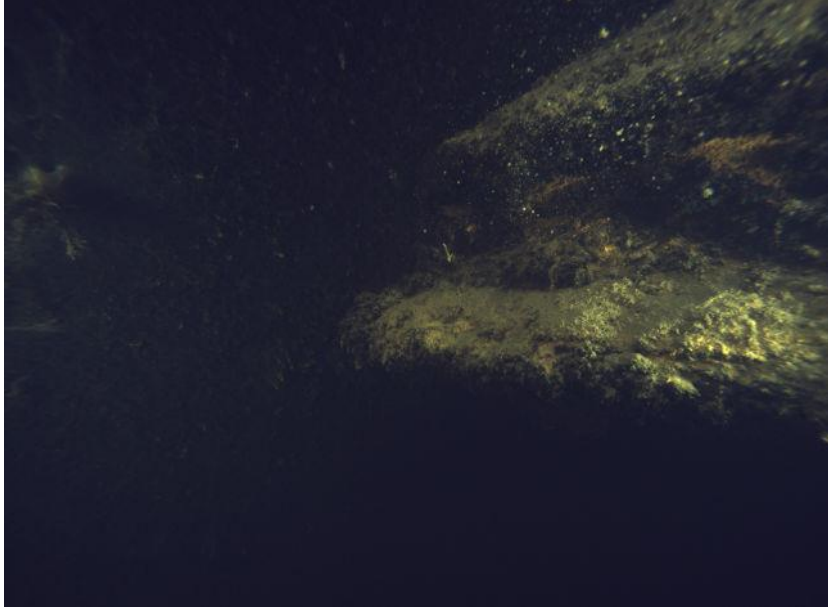
Figure 47 - Interface between I-beam and culvert headwall. The I-beams appear to be embedded within the concrete. The interface appears free of major spalling.

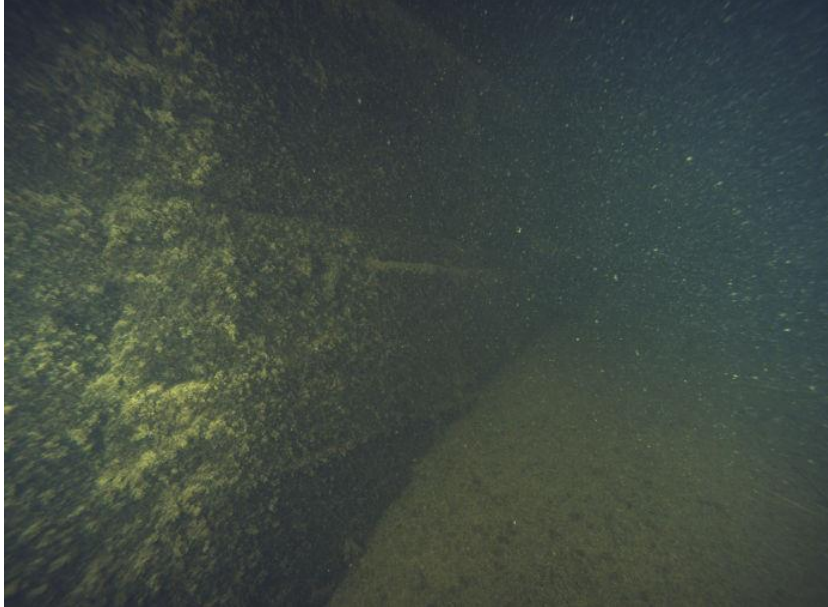
A rectangular concrete coffer dam wall was found 12.5m away from the dam wall. The dimensions of the coffer dam wall were found to be 15m(L) x 3m(W) x 3m(H). The concrete coffer dam wall appeared intact with no sign of major cracking or spalling. The coffer dam wall appeared to be in adequate condition.

Figure 54 - North western end of coffer dam wall. The concrete coffer dam wall appeared intact with no sign of major cracking or spalling.
