# Dam Inspection Report

*Craig Goch Dam*

Welsh Water  
Pentwyn Road  
Nelson, Treharris  
Mid Glamorgan CF46 6LY

Abyss Solutions Pty. Ltd.  
Unit 35 11-21 Underwood Rd  
Homebush NSW 2140  
Australia

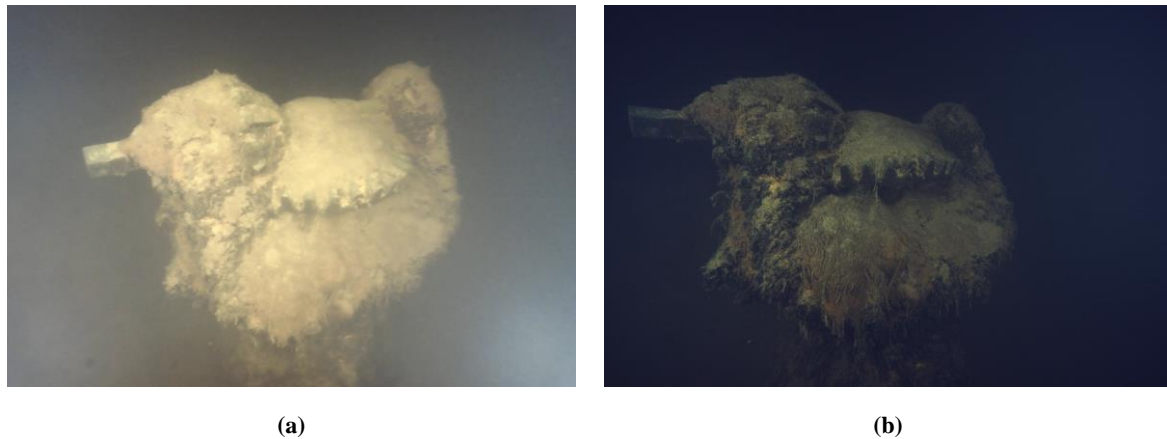
Figure 1 Comparison of the imagery obtained using Abyss Solutions' imaging system and subject to post-processing (a) with the ROV navigation camera imagery (b) of the Craig Goch scour outlet valve headstock.

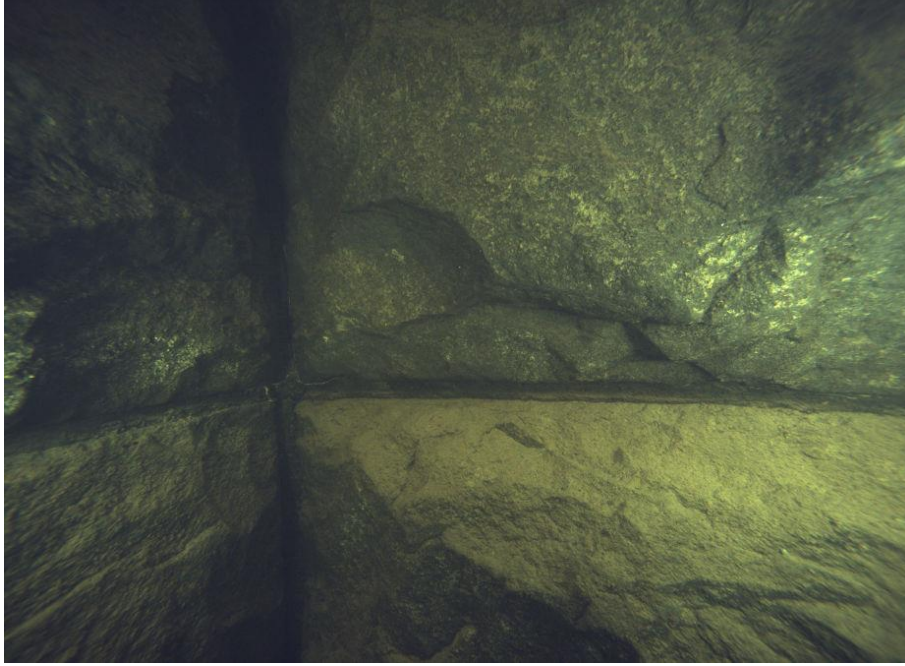
The blockwork at the interface of the dam wall and outlet tower appears to be articulated. The dam wall and outlet tower blockwork appeared to be aligned together from surface to maximum depth. No obvious separation between the outlet tower and dam wall was detected. The interface was as such judged to be in good condition.

**Figure 2 - Western interface of outlet tower and dam wall near surface level. No obvious separation between the outlet tower and dam wall was detected.**

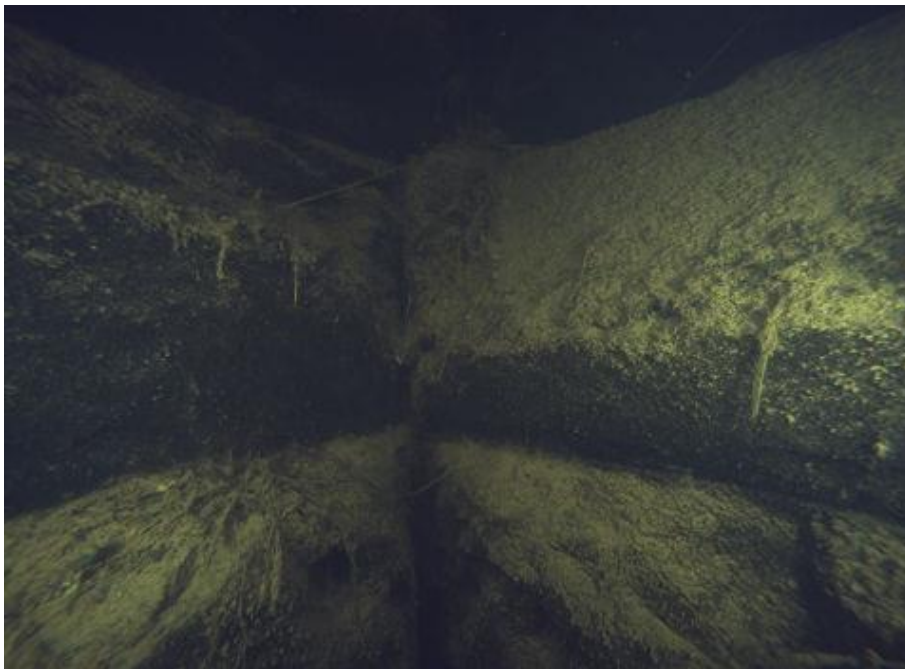
**Figure 3 - Western interface of outlet tower and dam wall at maximum depth. No obvious separation between the outlet tower and dam wall was detected.**

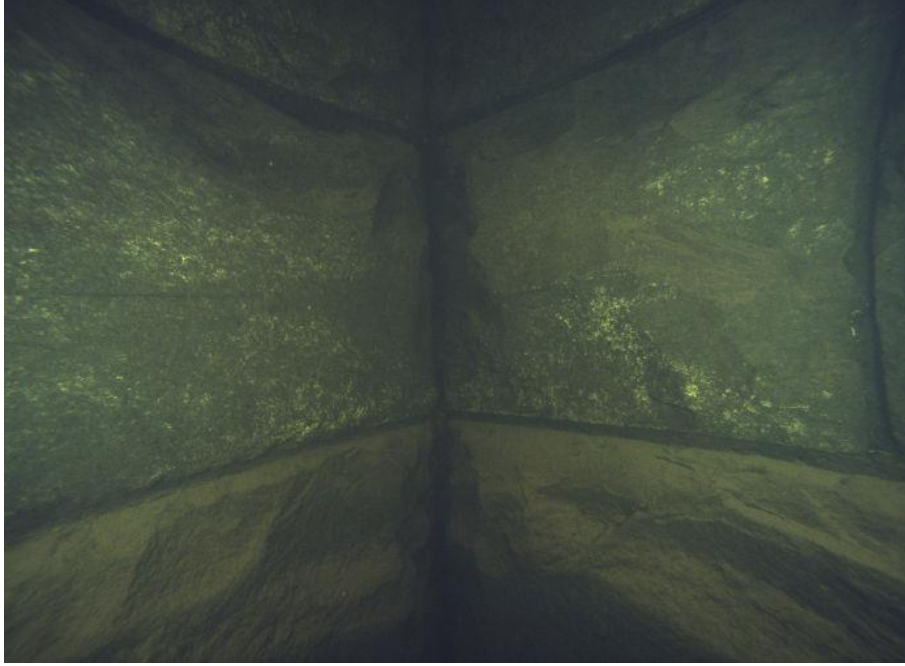
**Figure 4 - Eastern interface of outlet tower and dam wall near surface level. No obvious separation between the outlet tower and dam wall was detected.**

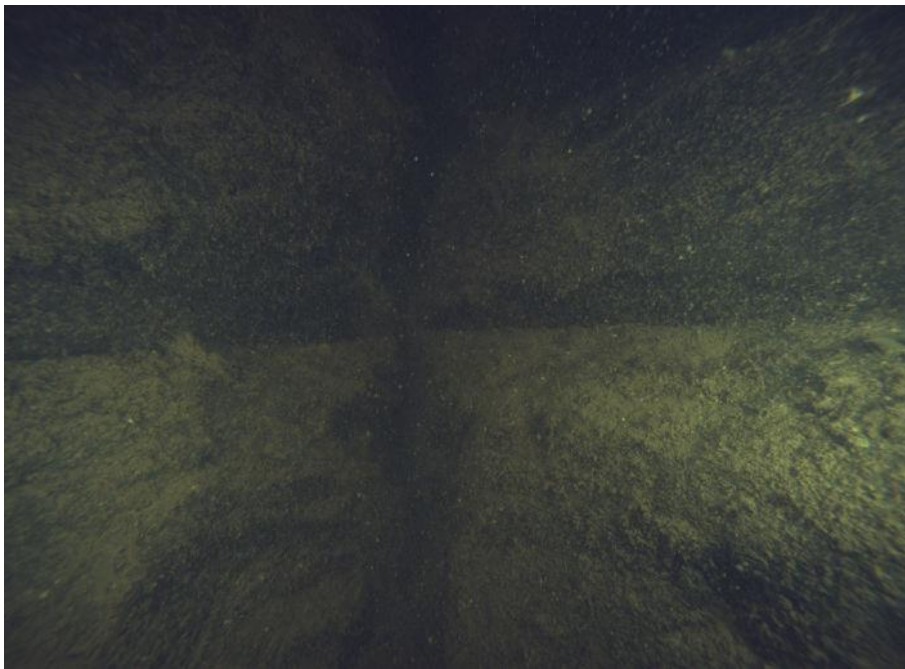
**Figure 5 - Eastern interface of outlet tower and dam wall at maximum depth. No obvious separation between the outlet tower and dam wall was detected.**

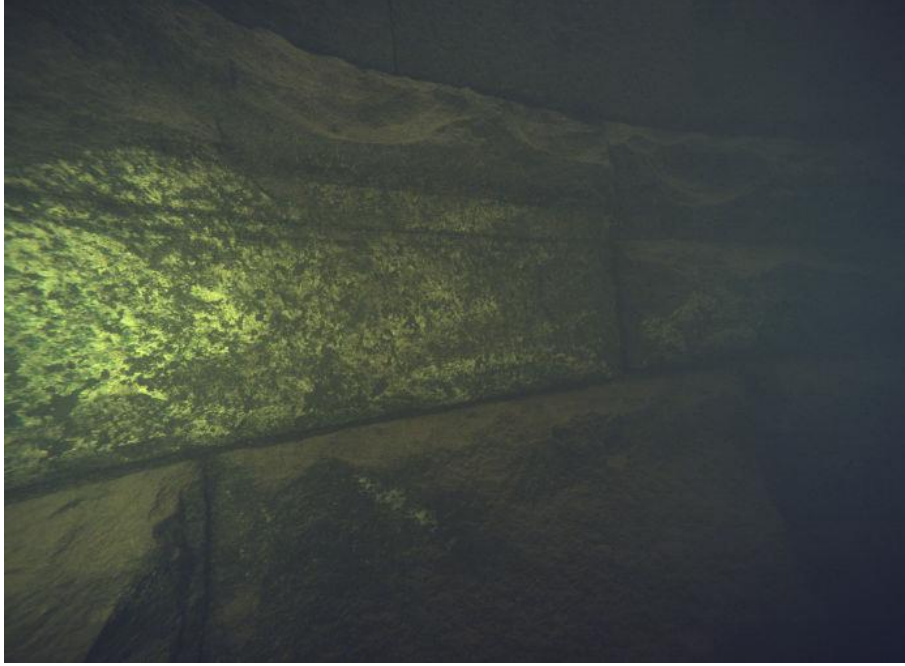
The exterior of the unreinforced concrete dam wall was found to be clad in stone blockwork. Blockwork junctions appeared to be grouted. The outlet tower was constructed with an octagonal profile, with 5 of the walls on the upstream face of the dam. The outlet tower was observed to be constructed of grouted stone blockwork. Condition - The blockwork was found to be intact with no signs of major cracking observed. Grouting appeared to be in place with no instances of missing grout identified. Stone lintels above trash screen grate penetrations appeared intact. The blockwork appeared to be in good condition.

**Figure 7 - Example of stone blockwork near surface level at the western end of dam wall. The blockwork was found to be intact with no signs of major cracking observed. Grouting appeared to be in place with no instances of missing grout identified.**

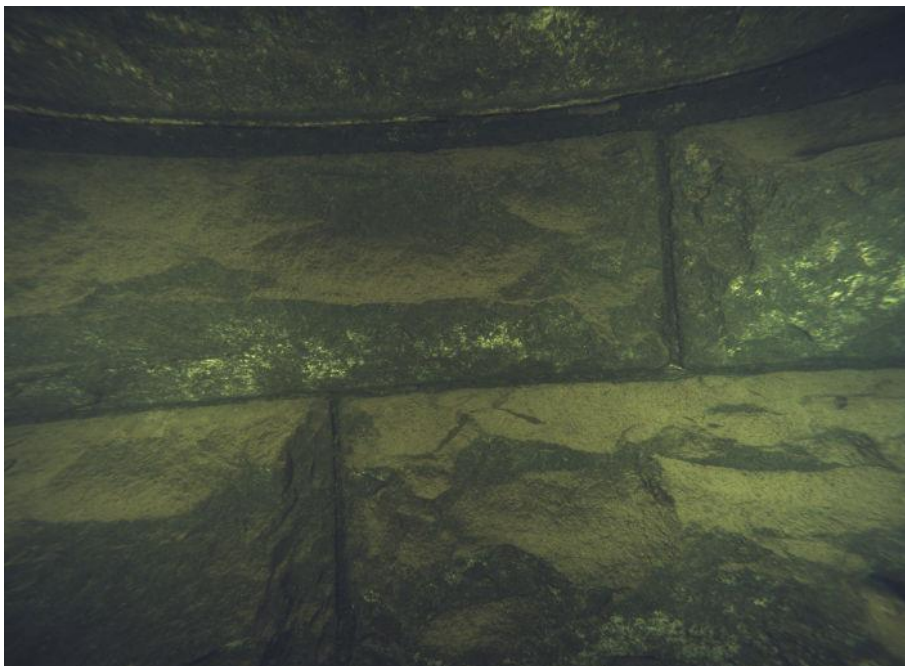
**Figure 8 - Example of stone blockwork near surface level at the western end of the outlet tower. The blockwork was found to be intact with no signs of major cracking observed. Grouting appeared to be in place with no instances of missing grout identified.**

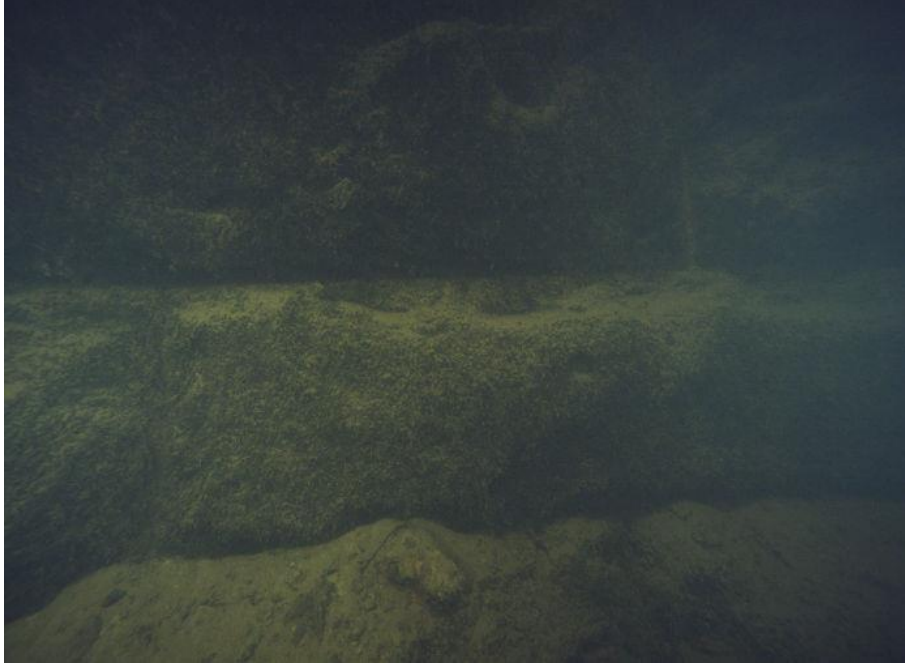
**Figure 9 - Example of stone blockwork at maximum depth near the centre of the dam wall. The blockwork was found to be intact with no signs of major cracking observed. Grouting appeared to be in place with no instances of missing grout identified.**

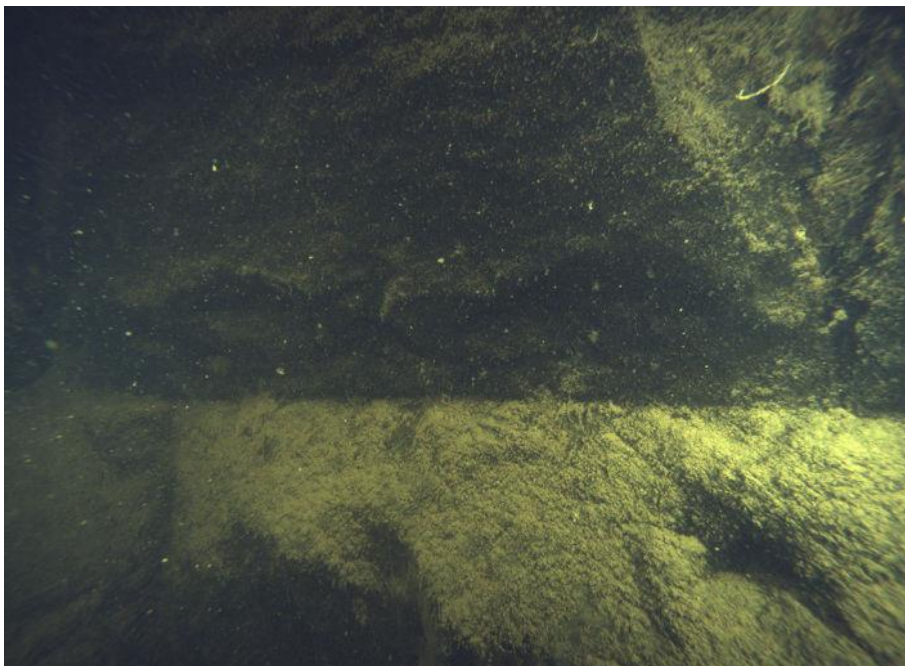
**Figure 10 - Example of stone blockwork at maximum depth at the eastern end of the outlet tower. The blockwork was found to be intact with no signs of major cracking observed. Grouting appeared to be in place with no instances of missing grout identified.**

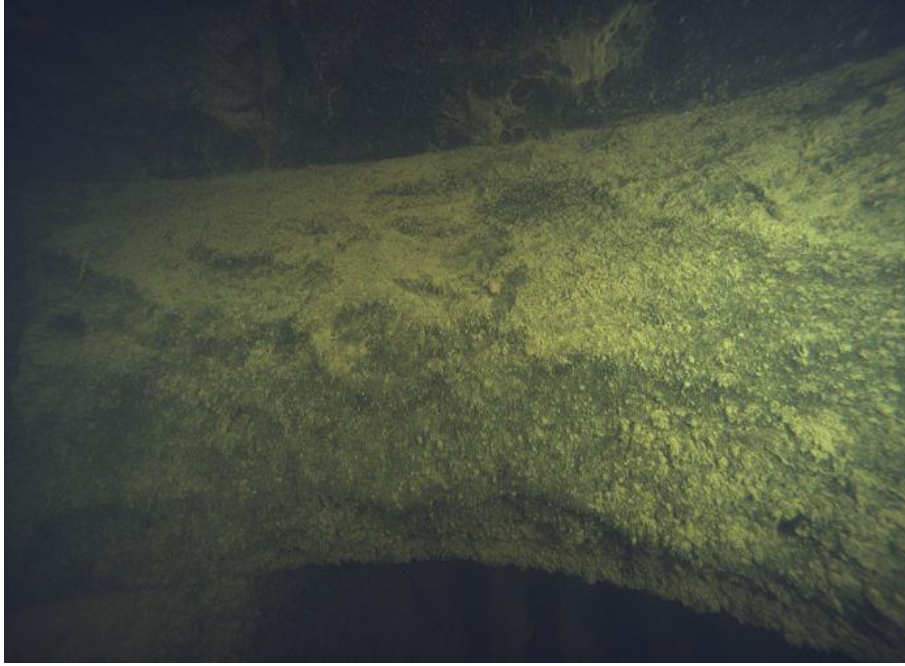
**Figure 11 - Example of stone lintel captured at 8m depth on eastern wall of outlet tower. The lintels appear intact and free of major cracking.**

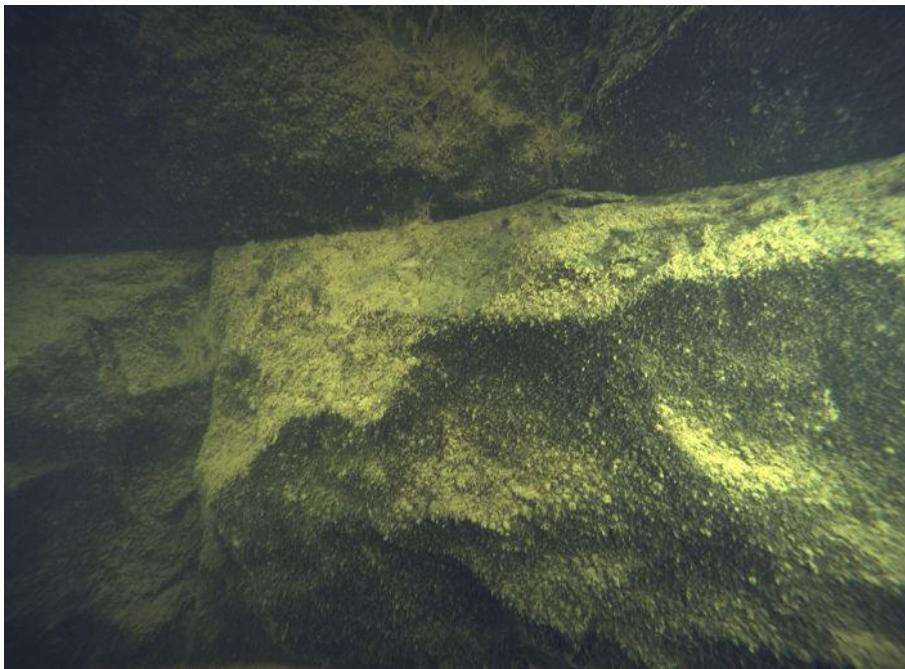
**Figure 12 - Example of stone blockwork captured on western wall of outlet tower. The blocks appear intact and free of major cracking.**

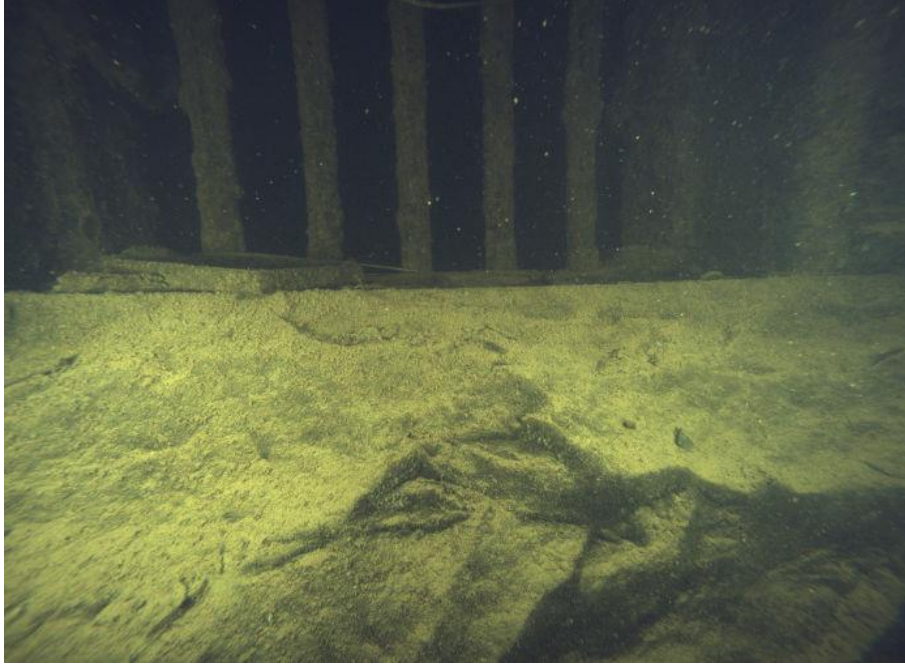
**Figure 13 - Example of stone sill captured at 5m depth on south western wall of outlet tower. The sill blocks appear intact and free of major cracking.**

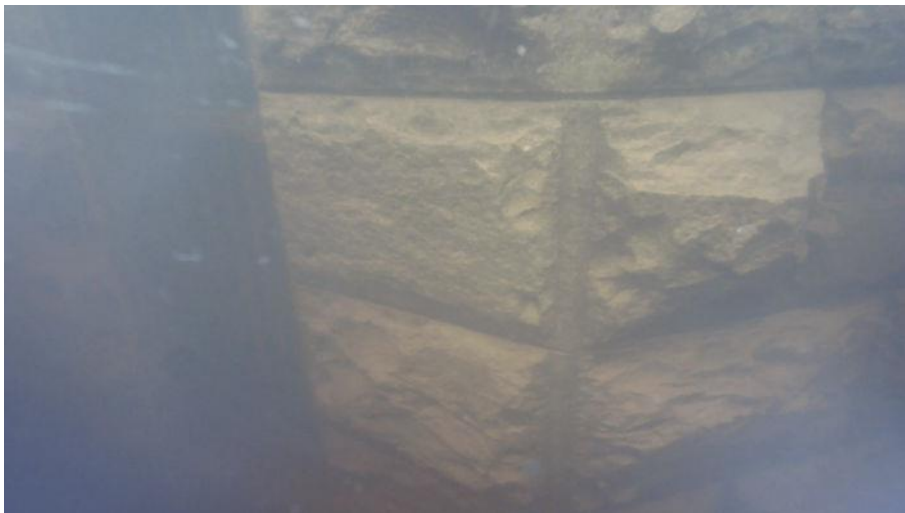
**Figure 14 - Example of stone blockwork at corners captured at 5m depth on south eastern wall of outlet tower. The blocks and grouting appear intact and free of major cracking.**

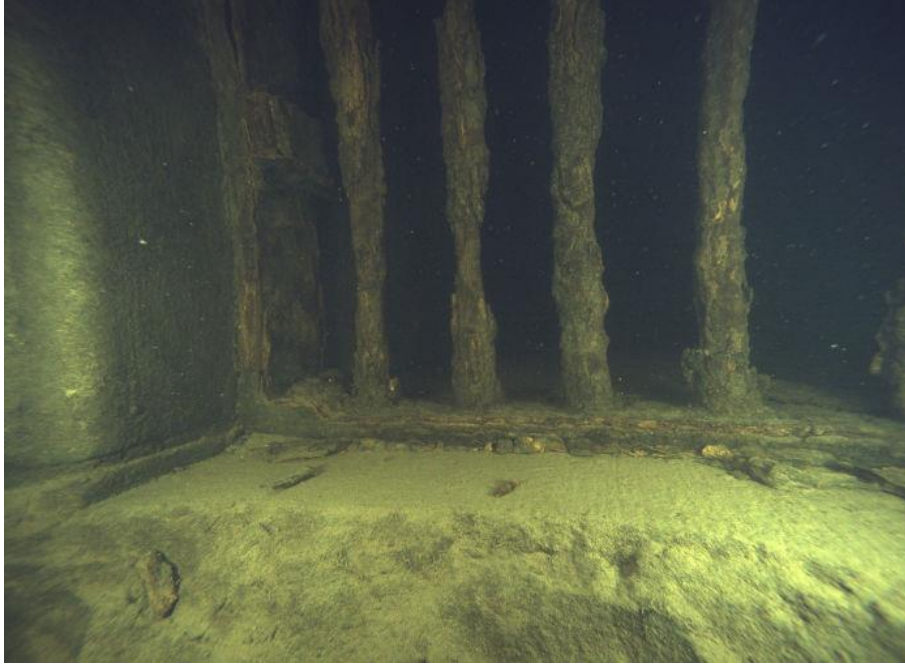
Four rectangular trash screen grates were observed on each of the western, south western, south eastern and eastern walls of the outlet tower. The grates had dimensions of 2.1m(H) x 0.6m(W). The grates consisted of 5 vertical bars with a single cross member at mid-height. The grates were observed to be heavily corroded with significant material loss. Nevertheless, the grates and bars remained in place. The surrounding blockwork appeared intact. material obstructing 10% of the grate at 8m depth on the western wall was observed. The grates are judged to be in poor condition as major deficiencies have been noted. These elements will require repair to continue to operate as designed.

**Figure 17 - Trash screen grate at 1m depth on the western wall of the outlet tower. The grate is heavily corroded with significant material loss.**

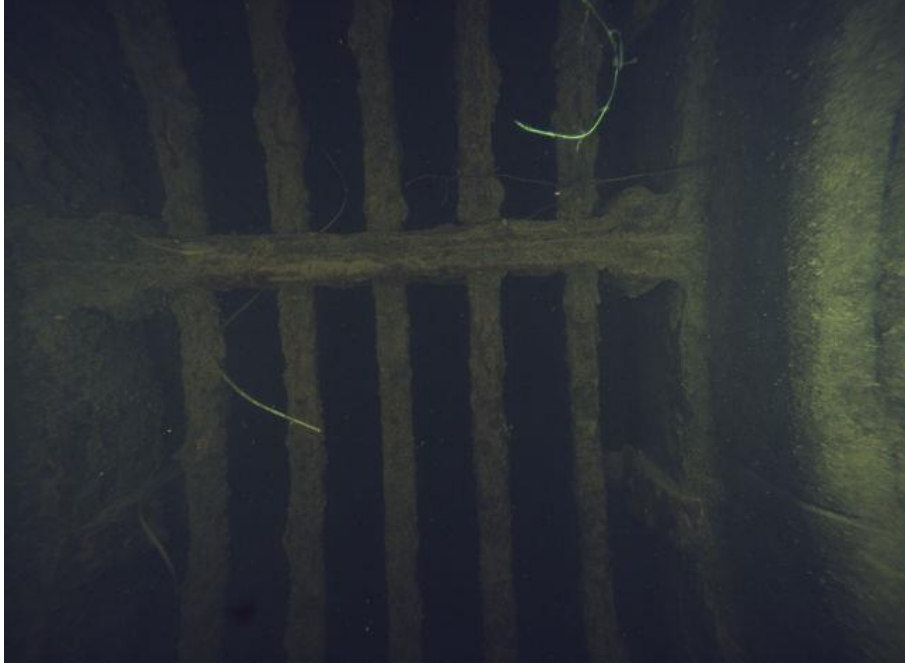
**Figure 19 - Trash screen grate at 5m depth on the western wall of the outlet tower. The grate is heavily corroded with significant material loss.**

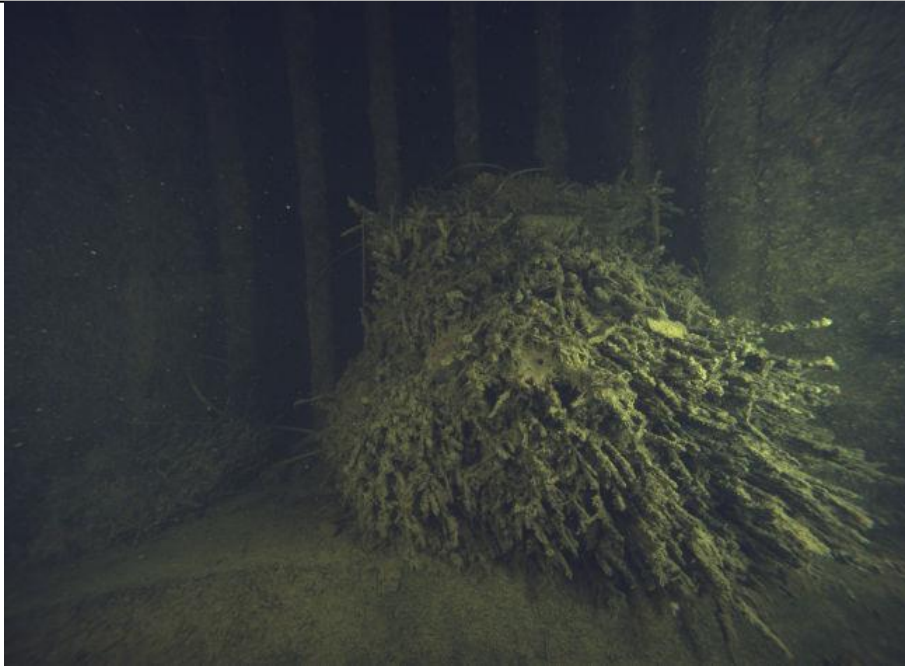
**Figure 21 - Trash screen grate at 8m depth on the western wall of the outlet tower. The grate is heavily corroded with significant material loss. Material obstructing 10% of the grate was observed.**

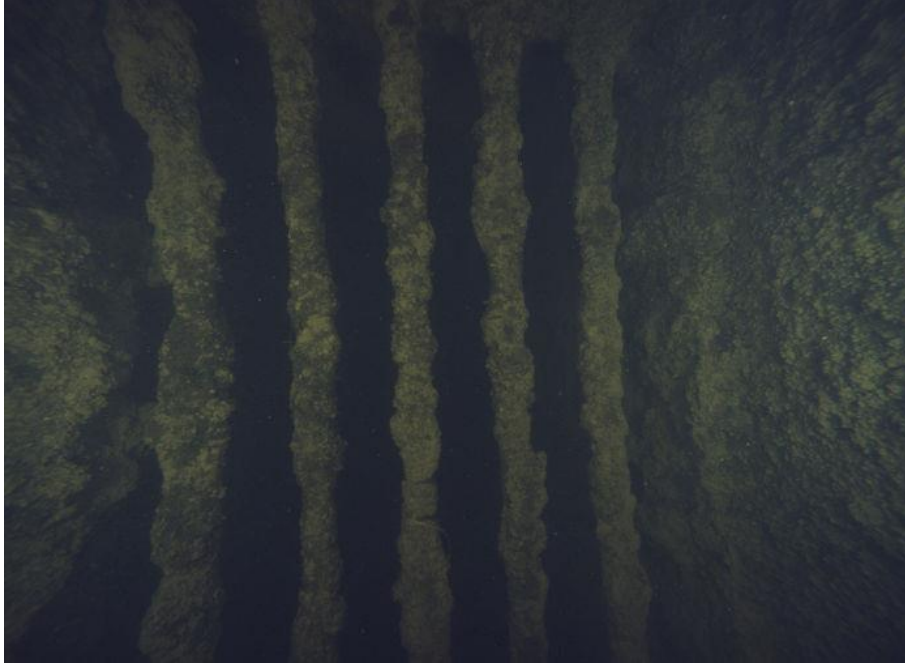
**Figure 23 - Trash screen grate at 10m depth on the western wall of the outlet tower. The grate is heavily corroded with significant material loss.**

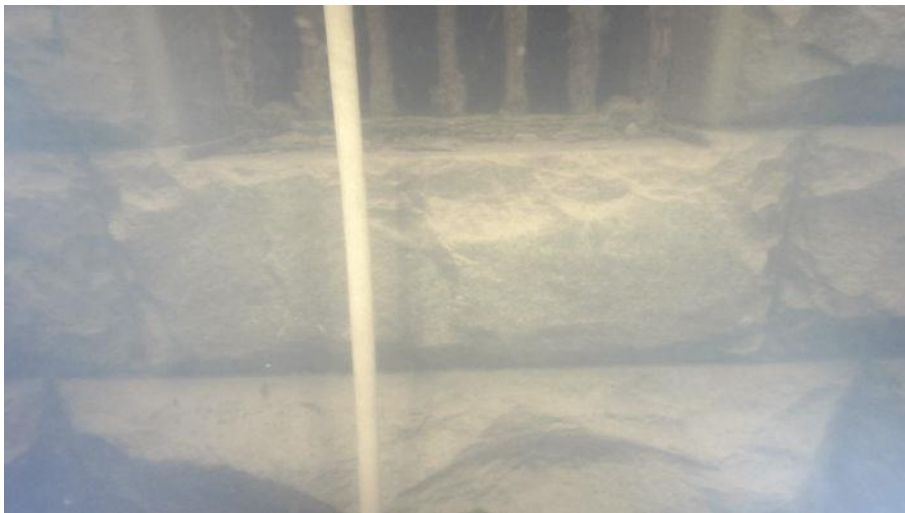
**Figure 24 - Trash screen grate at 1m depth on the south western wall of the outlet tower. The grate is heavily corroded with significant material loss.**

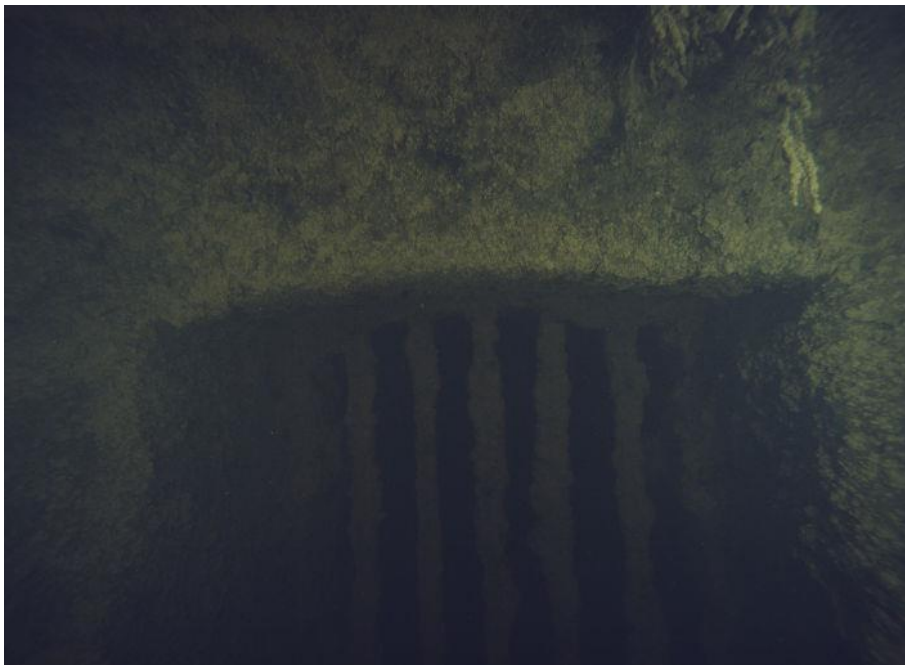
**Figure 26 - Trash screen grate at 10m depth on the south western of the outlet tower. The grate is heavily corroded with significant material loss.**

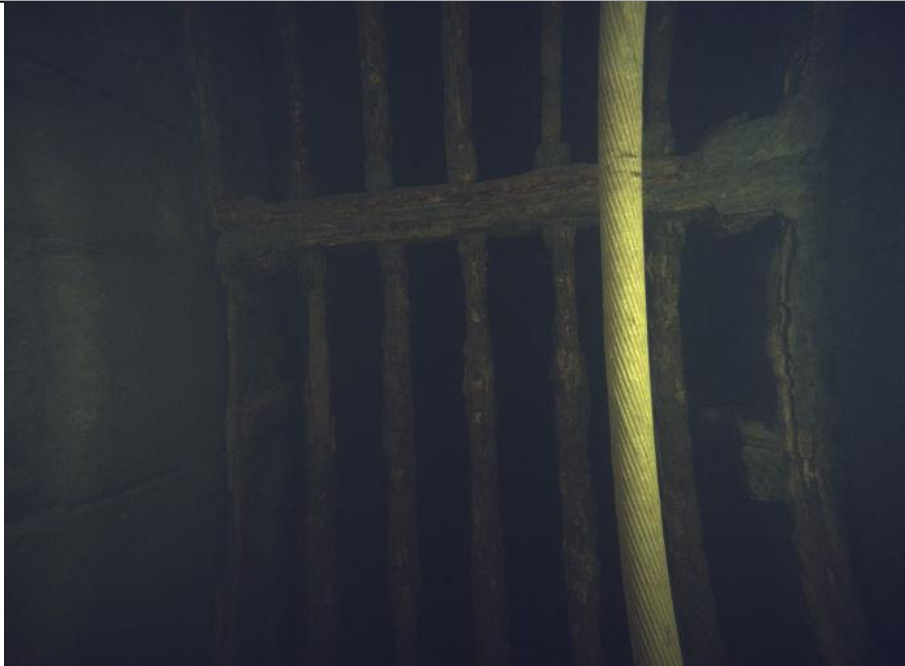
**Figure 27 - Trash screen grate at 1m depth on the south eastern wall of the outlet tower. The grate is heavily corroded with significant material loss.**

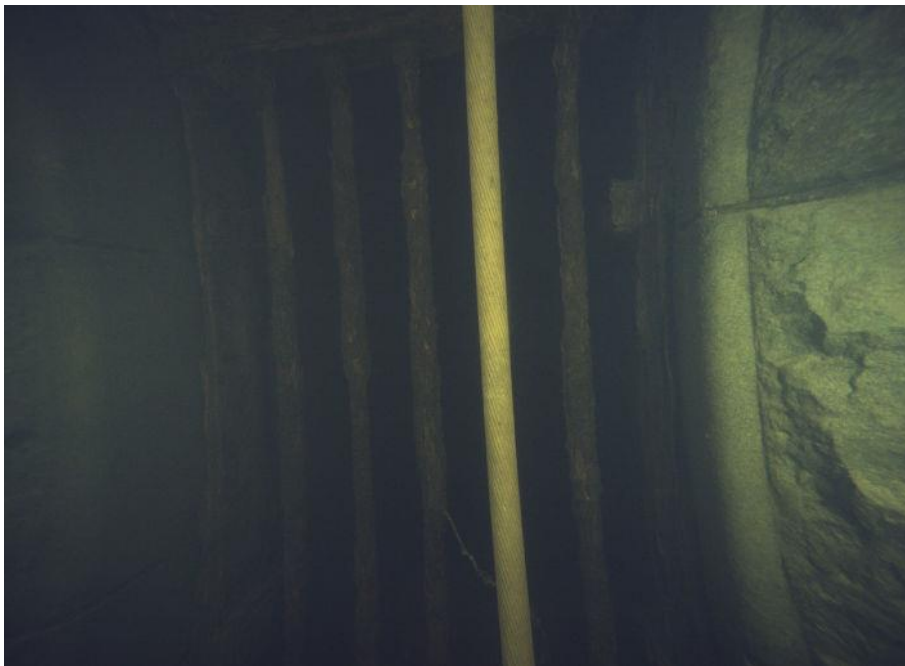
**Figure 28 - Trash screen grate at 5m depth on the south eastern of the outlet tower. The grate is heavily corroded with significant material loss.**

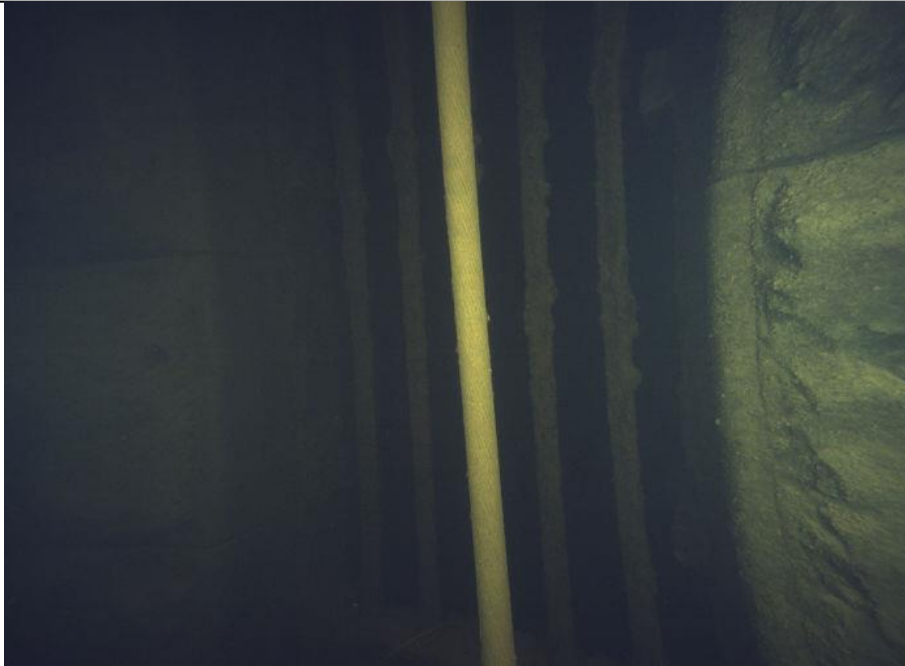
**Figure 29 - Trash screen grate at 8m depth on the south eastern of the outlet tower. The grate is heavily corroded with significant material loss.**

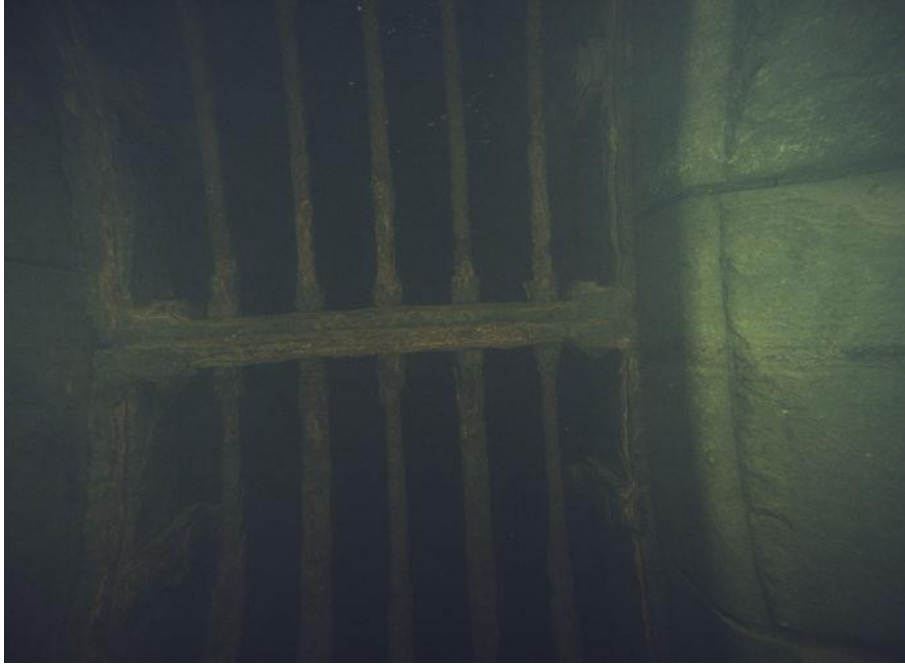
**Figure 31 - Trash screen grate at 1m depth on the eastern wall of the outlet tower. The grate is heavily corroded with significant material loss.**

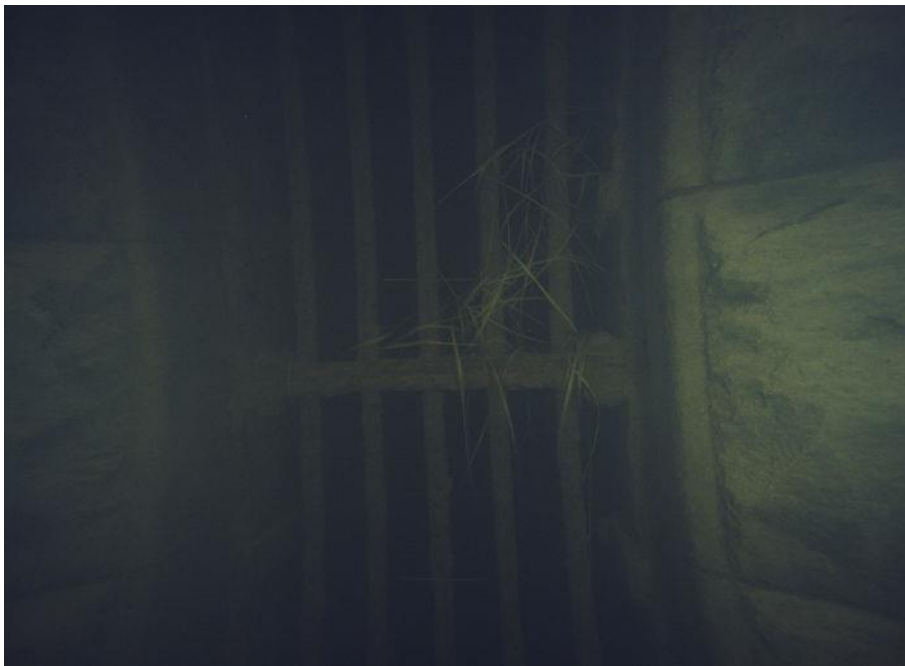
**Figure 32 - Trash screen grate at 5m depth on the eastern wall of the outlet tower. The grate is heavily corroded with significant material loss.**

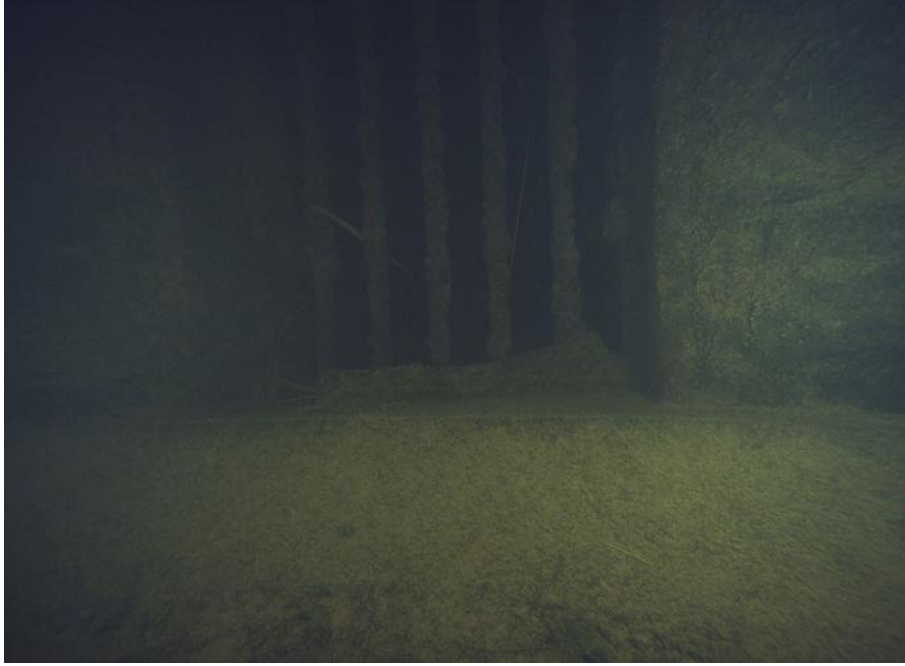
**Figure 33 - Trash screen grate at 8m depth on the eastern wall of the outlet tower. The grate is heavily corroded with significant material loss.**

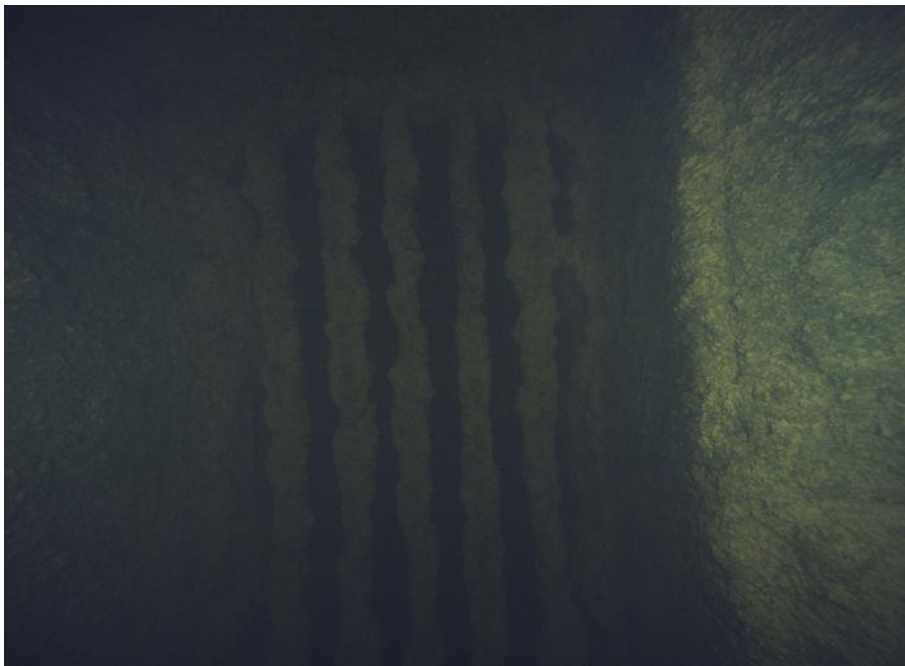
**Figure 34 - Trash screen grate at 10m depth on the eastern wall of the outlet tower. The grate is heavily corroded with significant material loss.**

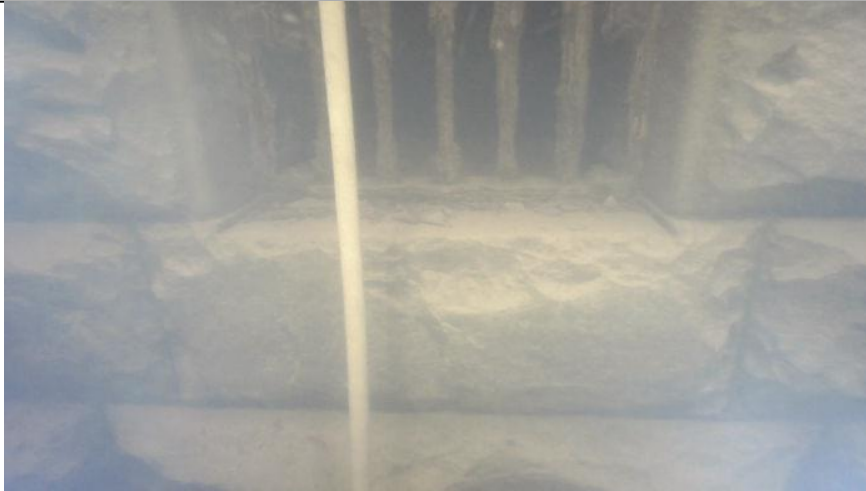
**Figure 36 - Earthing cable at 5m depth. The cable appears intact.**

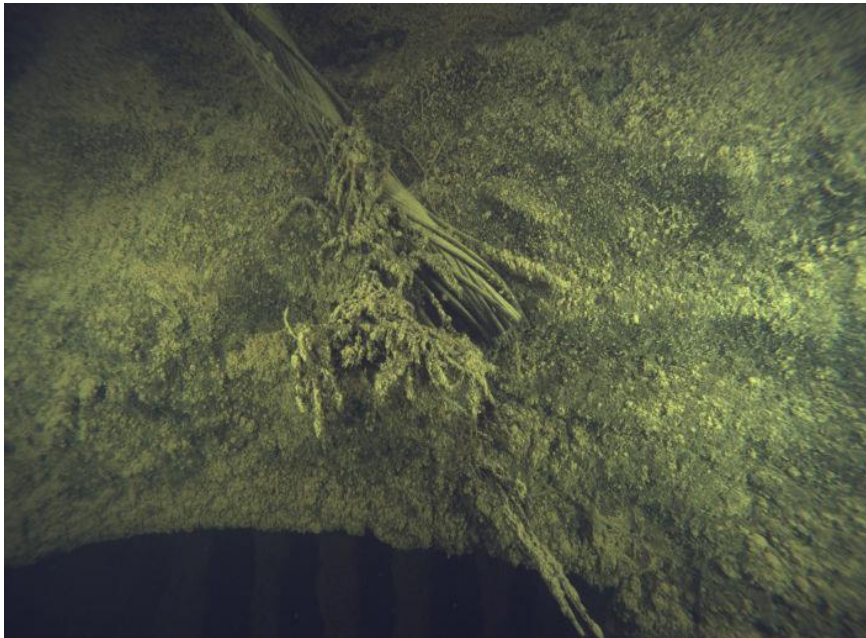
The earthing cable was found to track down the south western wall of the outlet tower unsecured to approximately 8m. The cable was found to be unterminated with the termination device likely missing. Similarly, the lightning cable was found to track along the southern wall of the outlet tower unsecured to 8m. The cable was again found to be unterminated with the termination device likely missing. Both cables appeared intact with no obvious deterioration. However, termination devices at the ends of the cables appeared to be missing.

Moderate deficiencies have been identified which include the missing terminators. These elements will require repair to continue to function as designed. The cables are judged to be in adequate condition.

**Figure 37 - Base of earthing cable at 8m depth. The cable termination device appears to be missing.**

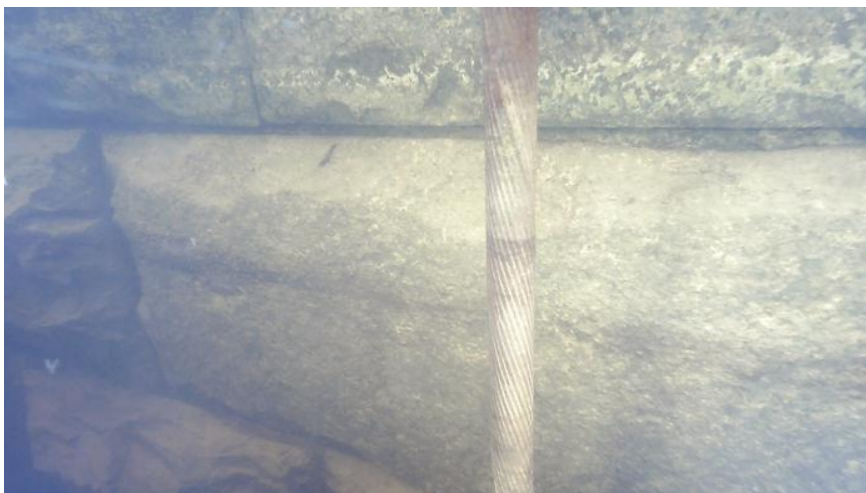
**Figure 38 - Lightning cable at 5m depth. The cable appears intact.**

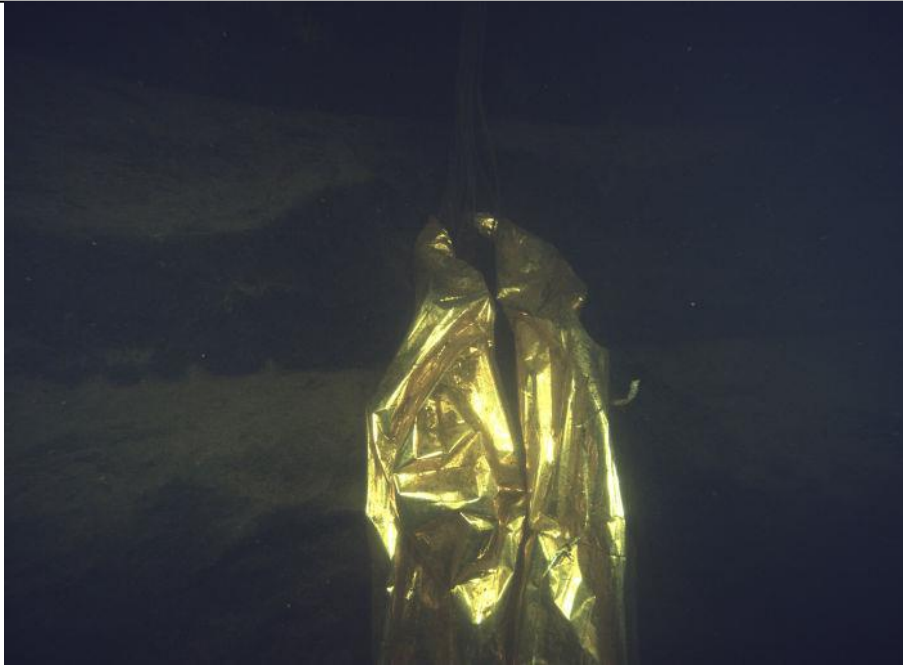
Figure 39 - Base of lightning cable at 8m depth. The cable termination device appears to be missing. A balloon appears to be caught on the end of the cable.

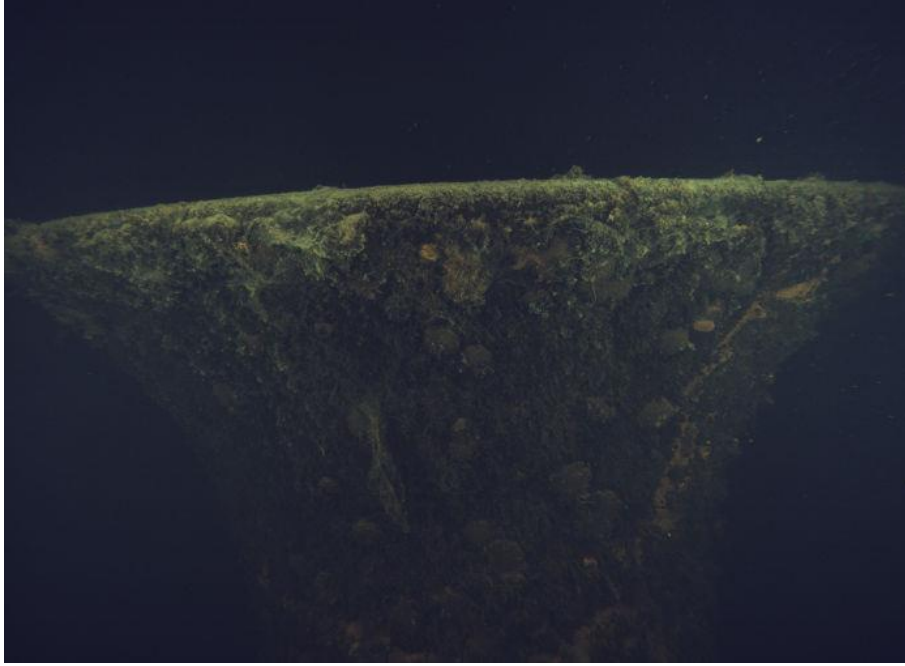
The culvert inlet pipework, supports and bellmouth were found to be intact and covered in heavy fouling. Surface deterioration of the pipework is likely. The bellmouth appeared to be free of obstructions. The I-beam supports appeared to be intact and heavily fouled. The culvert headwall and I-beam interface appeared intact and free of major spalling. Overall the condition of the culvert inlet is judged to be adequate.

**Figure 41 - Bellmouth at the end of the inlet pipe. The bellmouth appeared intact and free of obstructions.**

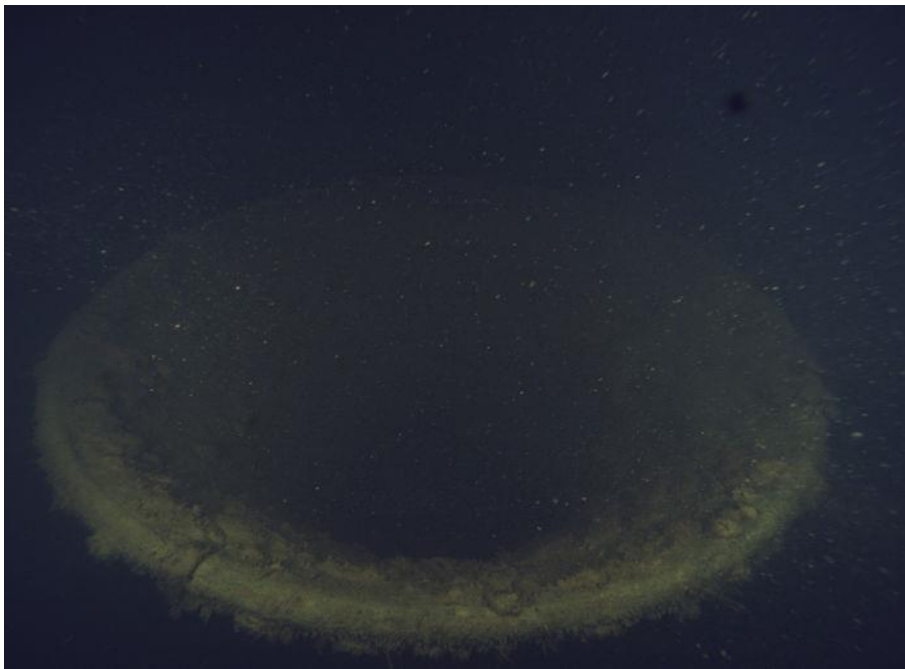
**Figure 42 - Top of bellmouth at the end of the inlet pipe. The bellmouth appeared intact and free of obstructions.**

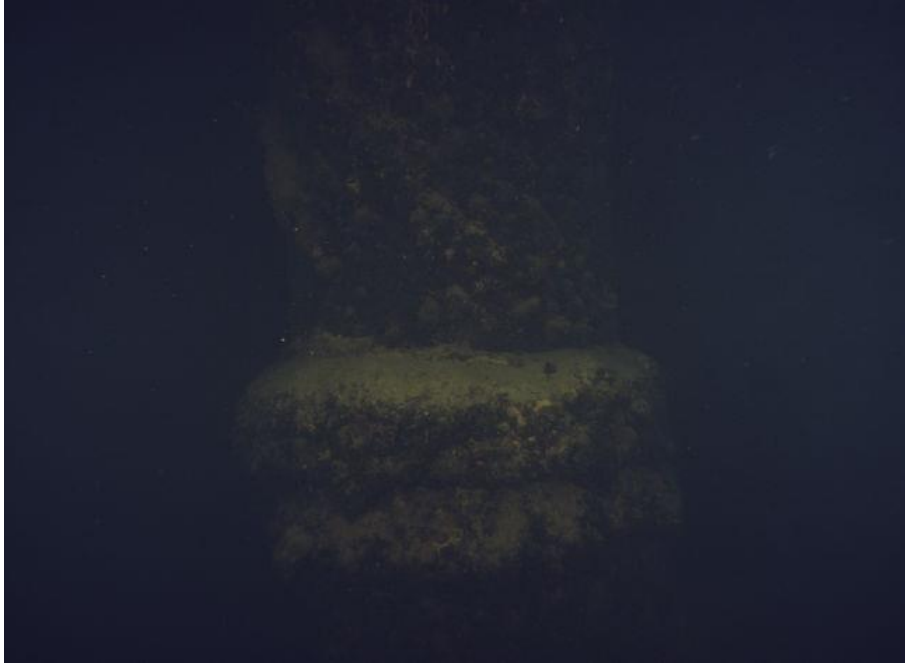
**Figure 43 - Inlet pipework appeared to be intact and covered in heavy fouling.**

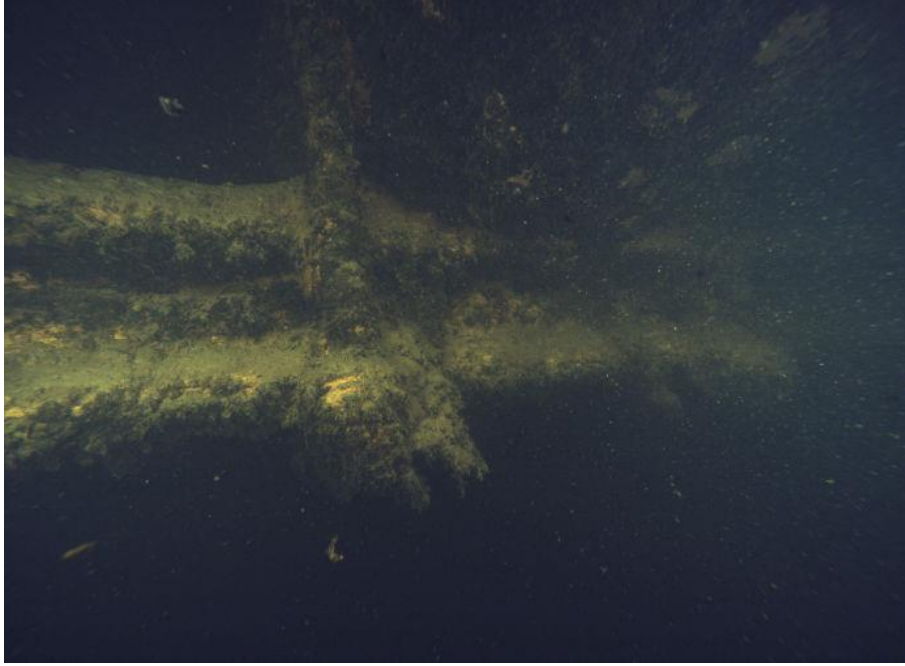
**Figure 45 - I-beam and pipe support brackets beneath inlet pipe. The I-beam and support brackets appear heavily fouled and are likely deteriorated. Nevertheless, they appear to be intact.**

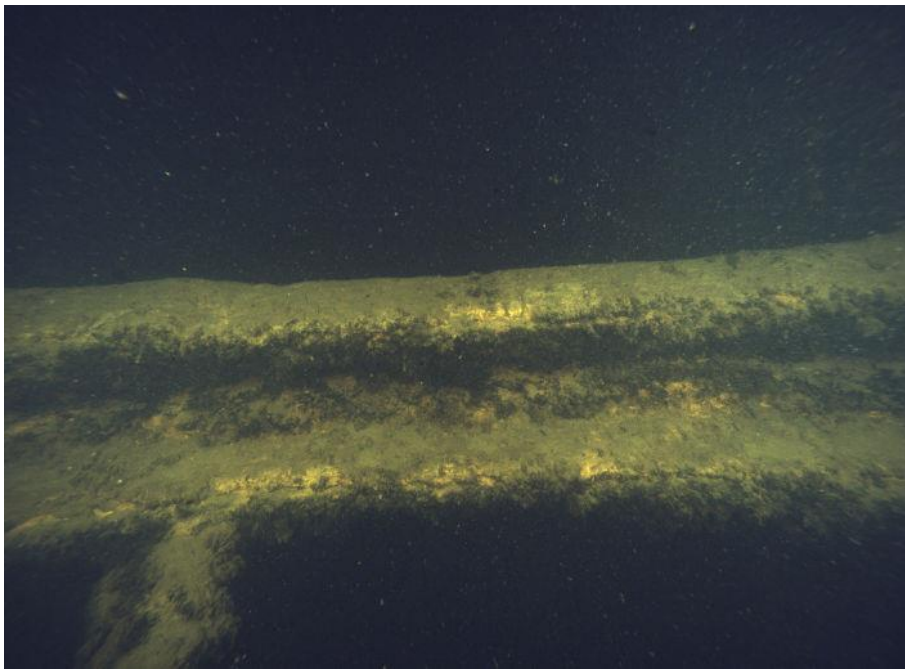
**Figure 46 - I-beam beneath inlet pipe. The I-beams appear heavily fouled and are likely deteriorated. Nevertheless, they appear to be intact.**
