# Dam Inspection Report

*Craig Goch Dam*

Welsh Water  
Pentwyn Road  
Nelson, Treharris  
Mid Glamorgan CF46 6LY

Abyss Solutions Pty. Ltd.  
Unit 35 11-21 Underwood Rd  
Homebush NSW 2140  
Australia

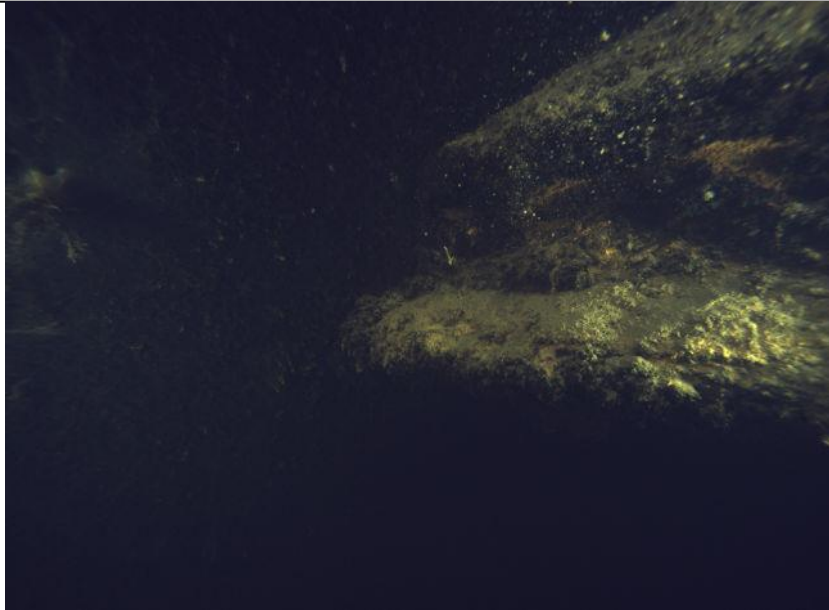
**Figure 47 - Interface between I-beam and culvert headwall. The I-beams appear to be embedded within the concrete. The interface appears free of major spalling.**

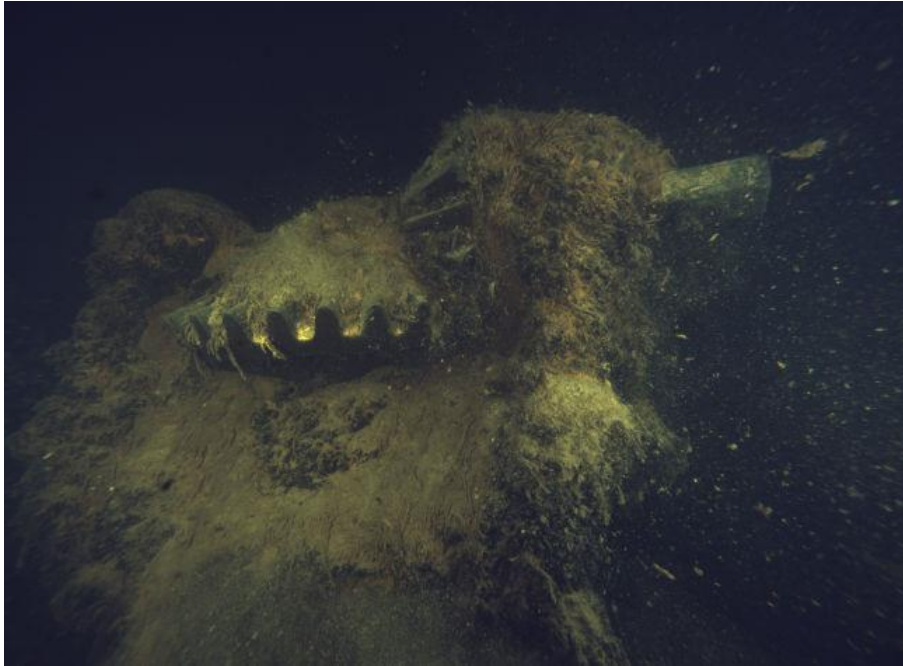
The scour outlet valve headstock operation rod and gearing appeared intact. However, these were heavily fouled. The fouling combined with likely surface corrosion renders the headstock gearing inoperable. The scour outlet and headstock mechanism are likely inoperable. Rehabilitation works will be needed to restore their function.

**Figure 50 - Scour outlet valve headstock gearing. The gearing appears intact however is heavily fouled and likely to have experienced surface corrosion.**

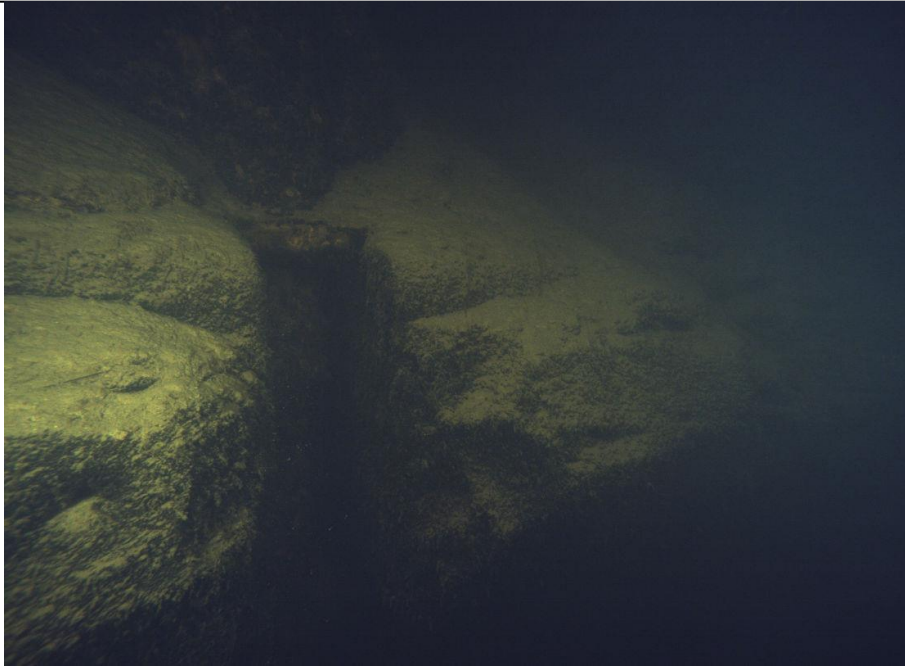
Figure 52 - Scour outlet valve operation rod. The rod appears intact however is heavily fouled and likely to have experienced surface corrosion.

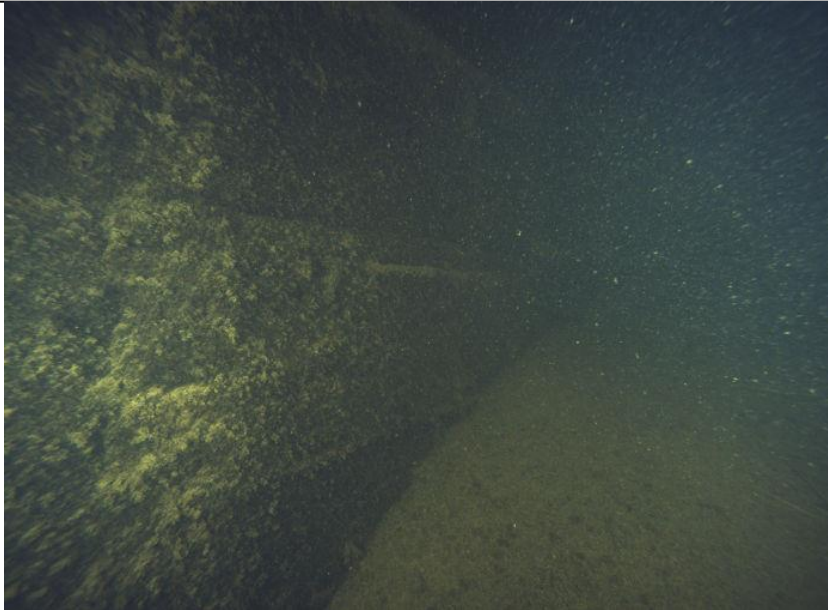
A rectangular concrete coffer dam wall was found 12.5m away from the dam wall. The dimensions of the coffer dam wall were found to be 15m(L) x 3m(W) x 3m(H). The concrete coffer dam wall appeared intact with no sign of major cracking or spalling. The coffer dam wall appeared to be in adequate condition.

**Figure 54 - North western end of coffer dam wall. The concrete coffer dam wall appeared intact with no sign of major cracking or spalling.**

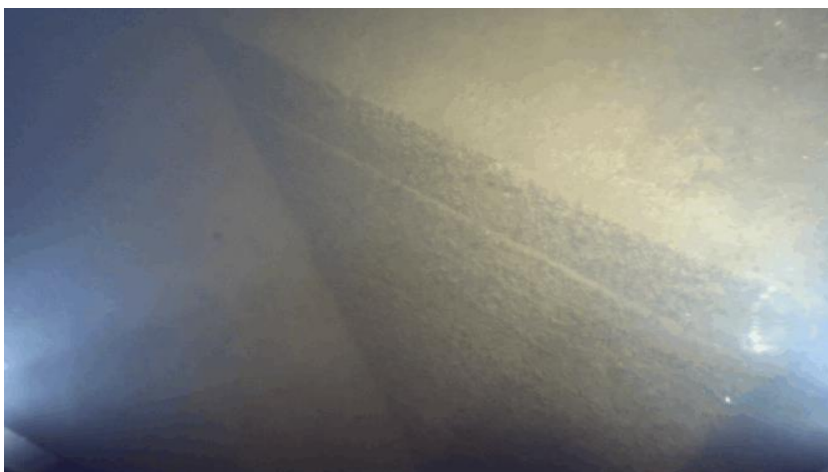
**Figure 56 - North eastern end of coffer dam wall. The concrete coffer dam wall appeared intact with no sign of major cracking or spalling.**
