Dam Inspection Report

Craig Goch Dam

Welsh Water
Pentwyn Road
Nelson, Treharris
Mid Glamorgan CF46 6LY

Abyss Solutions Pty. Ltd.
Unit 35 11-21 Underwood Rd
Homebush NSW 2140
Australia

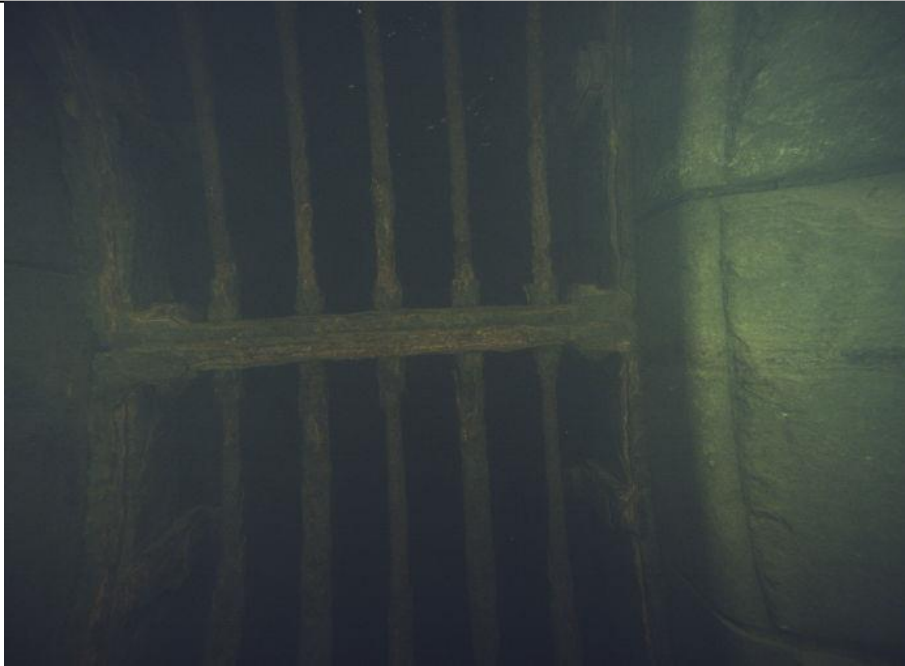
Figure 31 - Trash screen grate at 1m depth on the eastern wall of the outlet tower. The grate is heavily corroded with significant material loss.

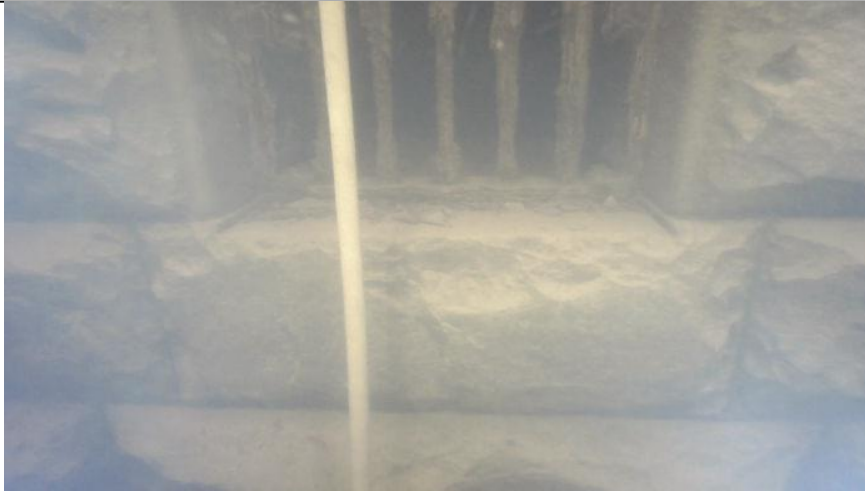
Figure 36 - Earthing cable at 5m depth. The cable appears intact.

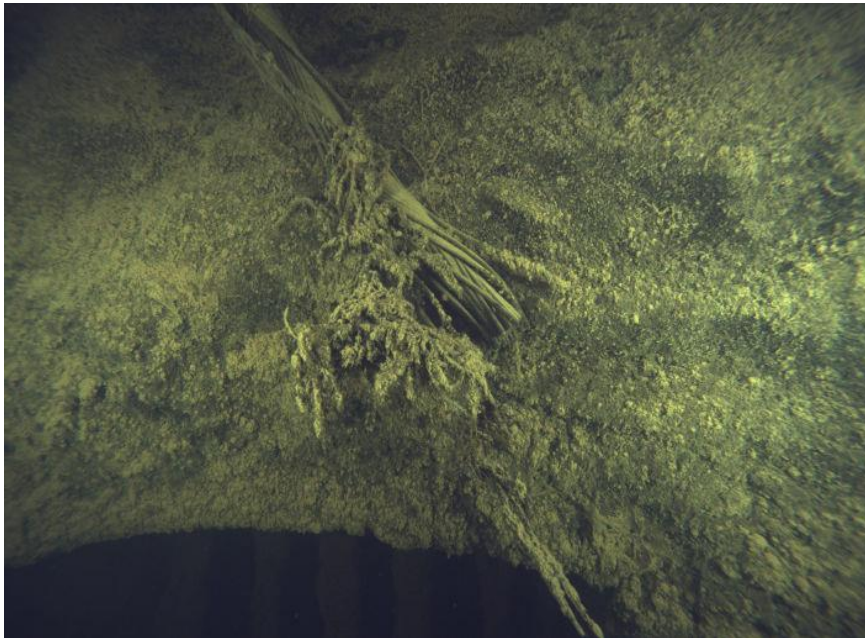
Moderate deficiencies have been identified which include the missing terminators. These elements will require repair to continue to function as designed. The cables are judged to be in adequate condition.

Figure 37 - Base of earthing cable at 8m depth. The cable termination device appears to be missing.

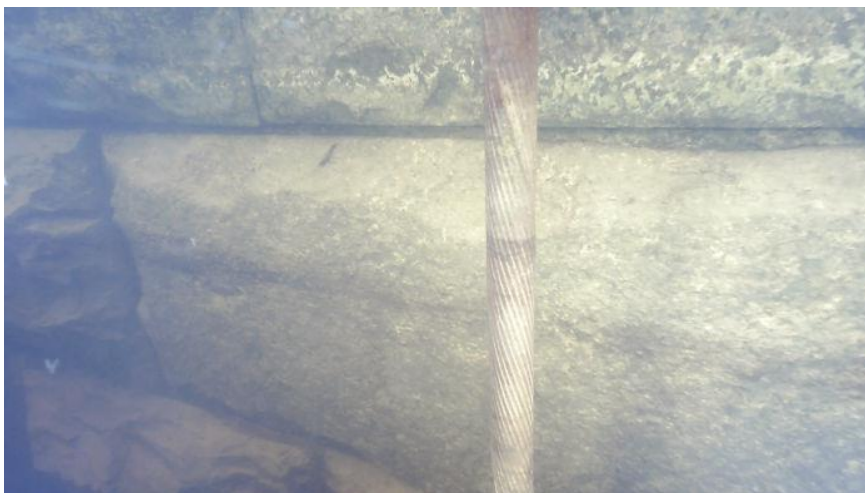
Figure 38 - Lightning cable at 5m depth. The cable appears intact.

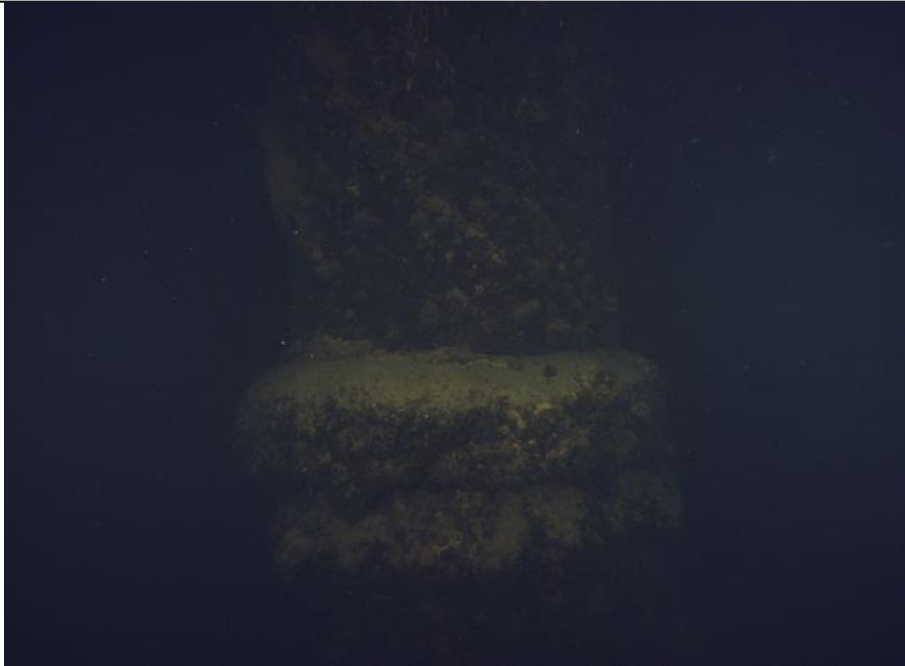
The culvert inlet pipework, supports and bellmouth were found to be intact and covered in heavy fouling. Surface deterioration of the pipework is likely. The bellmouth appeared to be free of obstructions. The I-beam supports appeared to be intact and heavily fouled. The culvert headwall and I-beam interface appeared intact and free of major spalling. Overall the condition of the culvert inlet is judged to be adequate.

Figure 43 - Inlet pipework appeared to be intact and covered in heavy fouling.

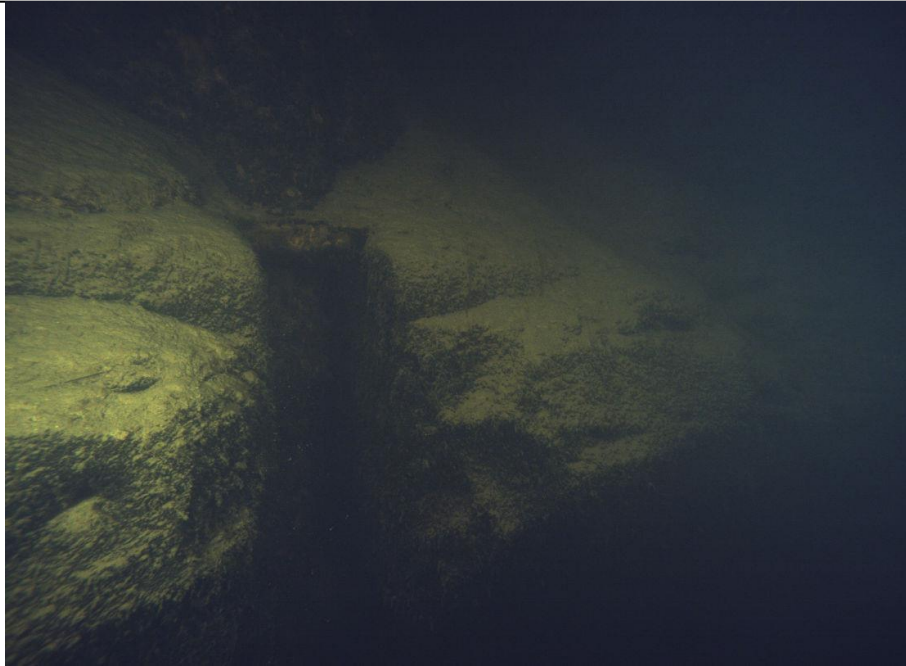
Figure 52 - Scour outlet valve operation rod. The rod appears intact however is heavily fouled and likely to have experienced surface corrosion.

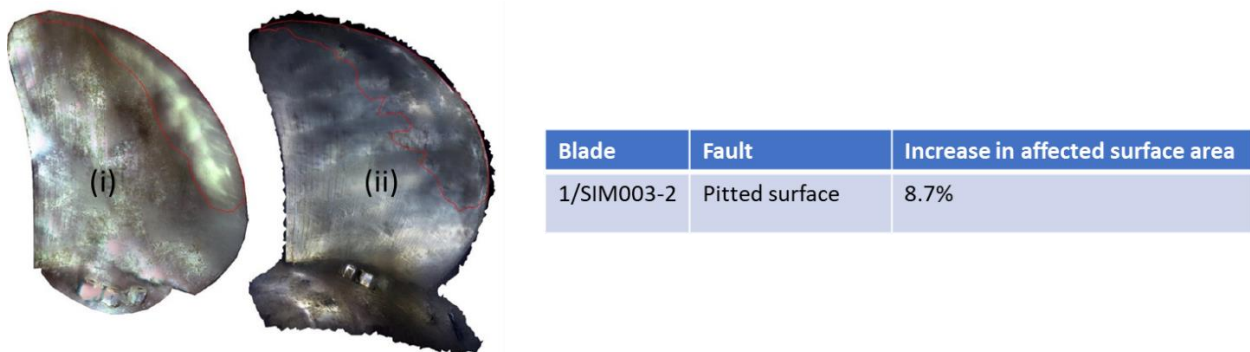
Figure 58 - Pitting corrosion highlighted on 3D models of a propeller blade between successive inspections. The change in affected surface area is estimated between the (i) first and (ii) second inspections.
