CanSat 2025 Post Flight Review (PFR) Outline

Team #3114
Robotics for Space eXploration (UofT)

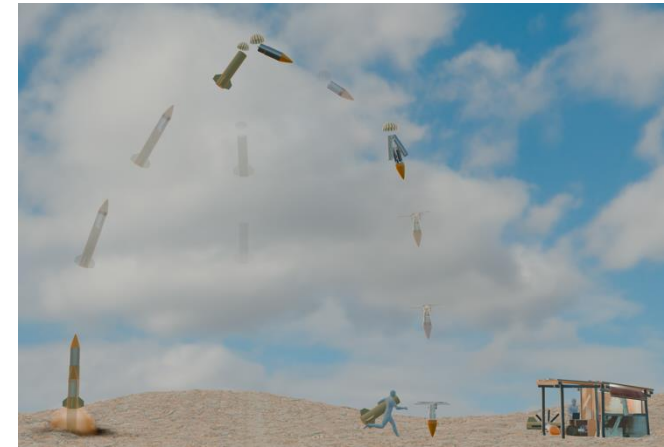
1. CC is released but does not descend using parachute.
2. All telemetry is transmitted but not all sensors sent valid data.
3. The cameras stopped working mid mission due to over heating.

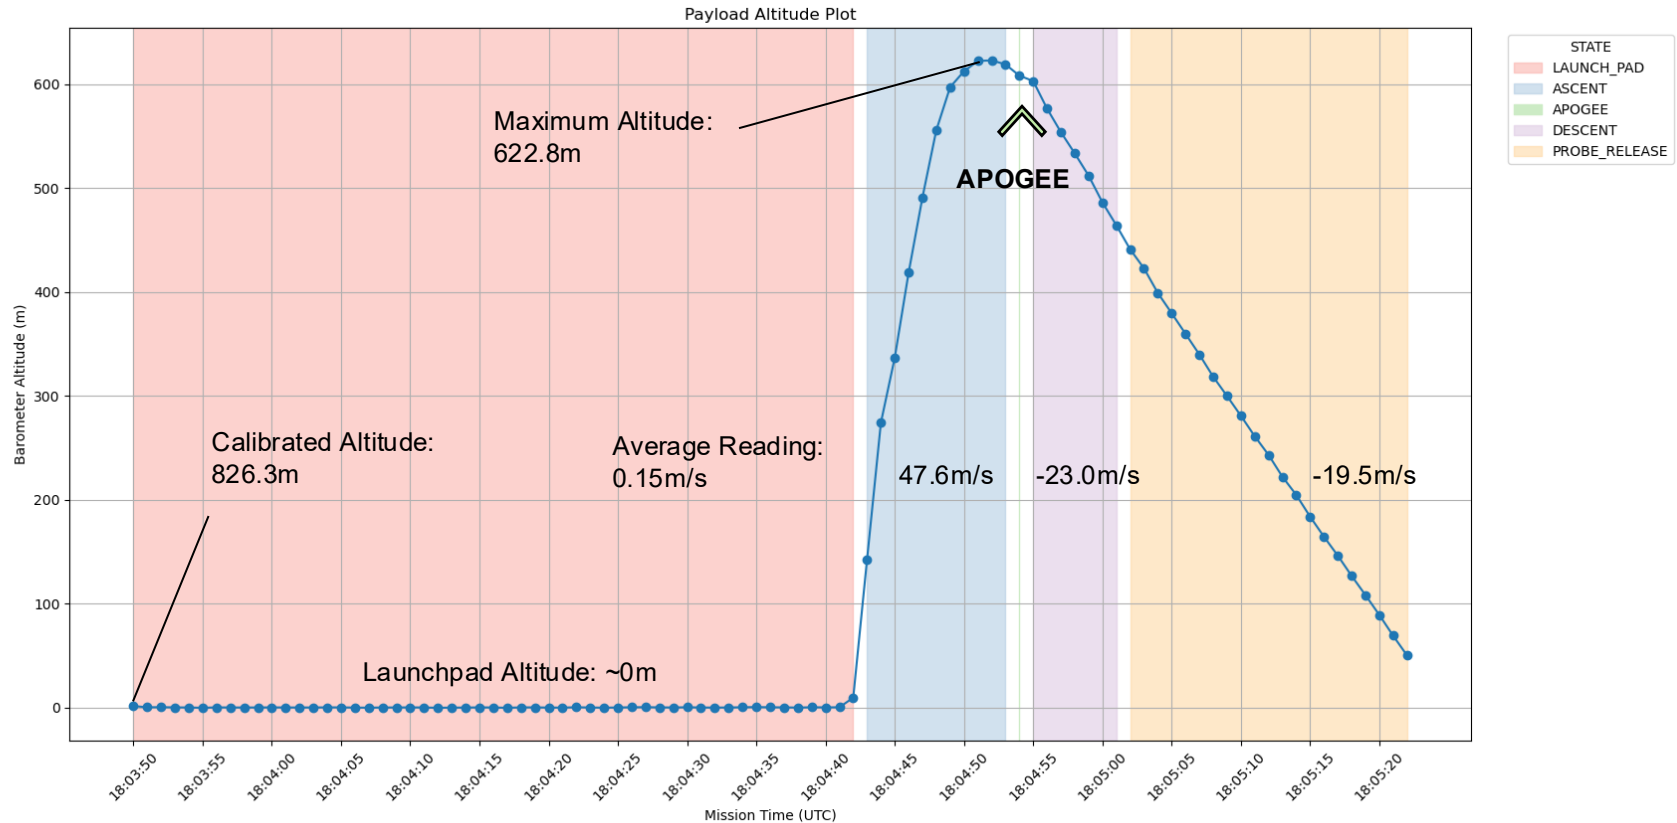
Payload Altitude Plot

The ground station received all packets sent by the CanSat until 18:05:20 UTC, where the XBee was dislodged from the adapter upon ground impact.

Note that we were able to reach the required descent velocity despite the parachute failure.

- Avoid relying on header pins for securing electronics, especially for critical components like the XBee.
- Sensors with mounting holes should continue using standoffs; however, for modules without mounting features, design and implement 3D-printed enclosures or brackets to ensure mechanical stability.
- Bolting down all sensors improves durability, reliability, and resistance to vibration/shock during flight.

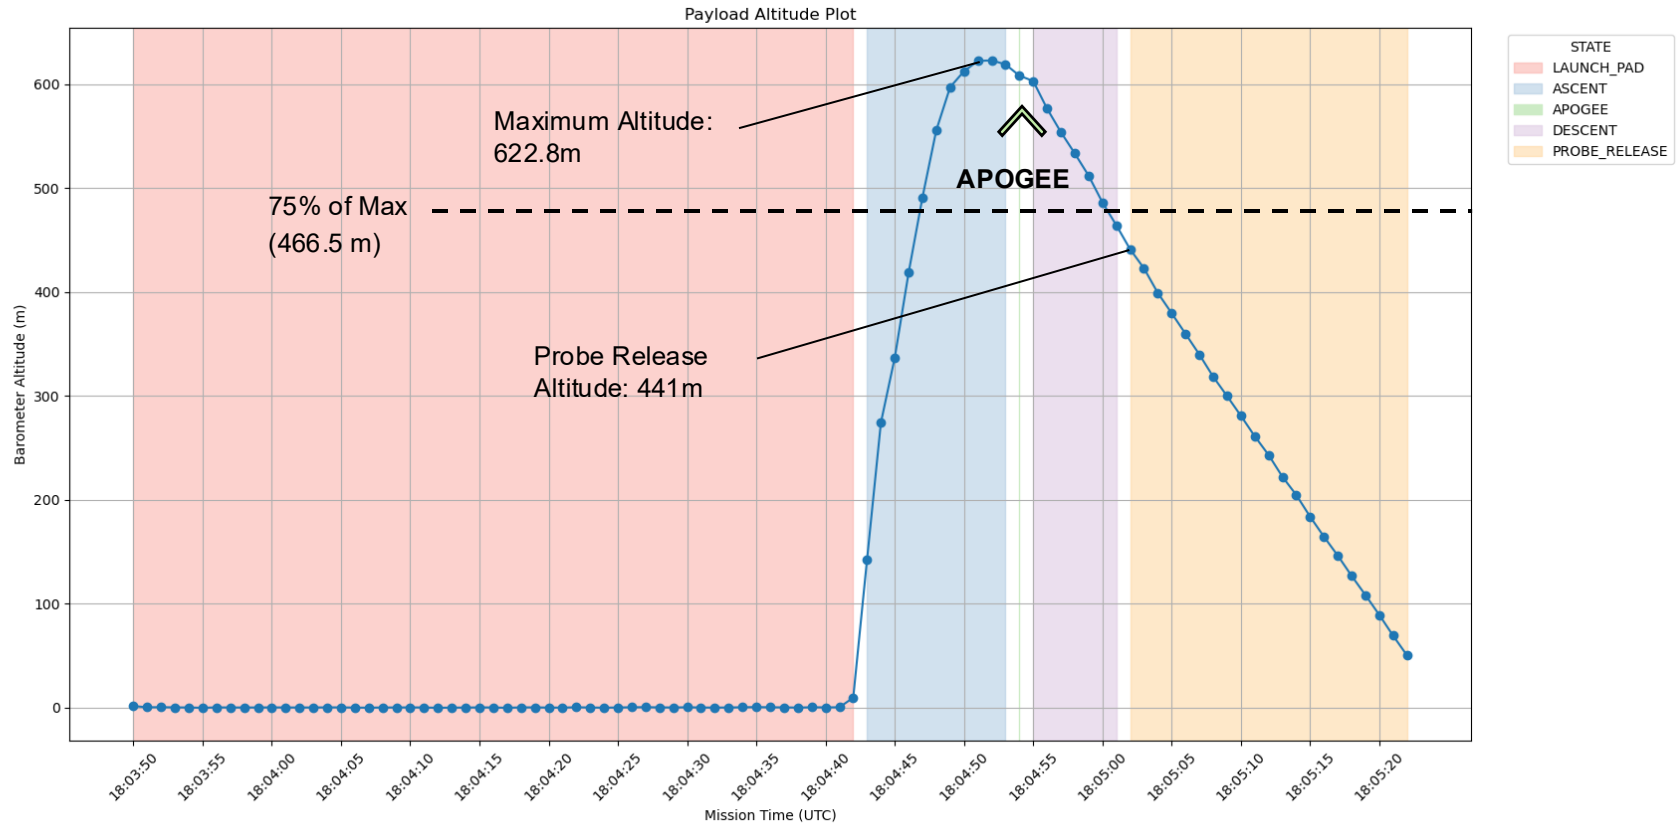
Probe Release at 75% (1/2)

From telemetry data, we can see a transition to the PROBE_RELEASE state at 441m, which is ~70% of the maximum altitude.

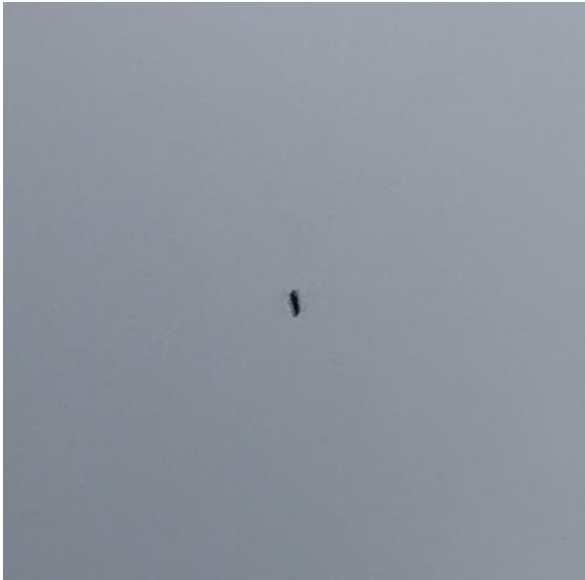
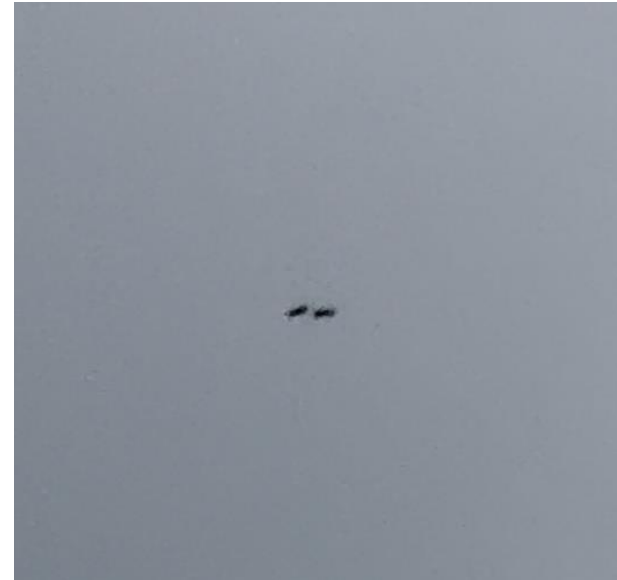
Probe Release at 75% (2/2)

The FSW was able to successfully separate the payload and container at this time, as shown below:

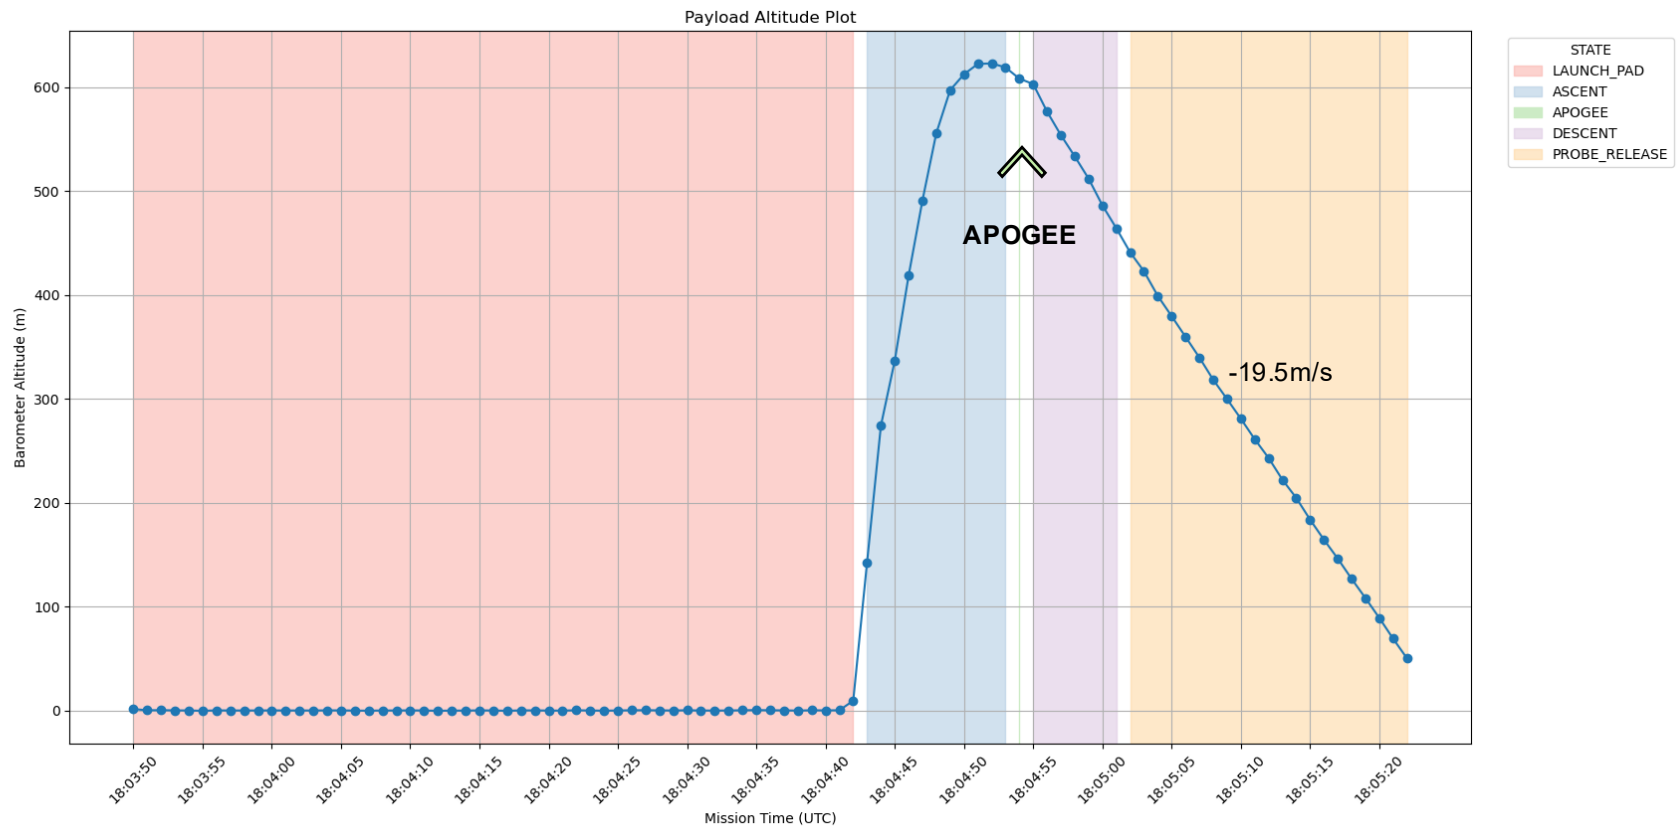
Auto-Gyro Descent Rate at 5 m/s

The auto-gyro did not properly deploy as it was in an unstable tumble because of the container parachute failure. As such, the payload tumbled to the ground at an average speed of 19.5m/s.

- Select a more robust parachute capable of withstanding higher-than-expected loads at apogee.
- Conduct stress testing beyond nominal conditions to simulate worst-case deployment scenarios.

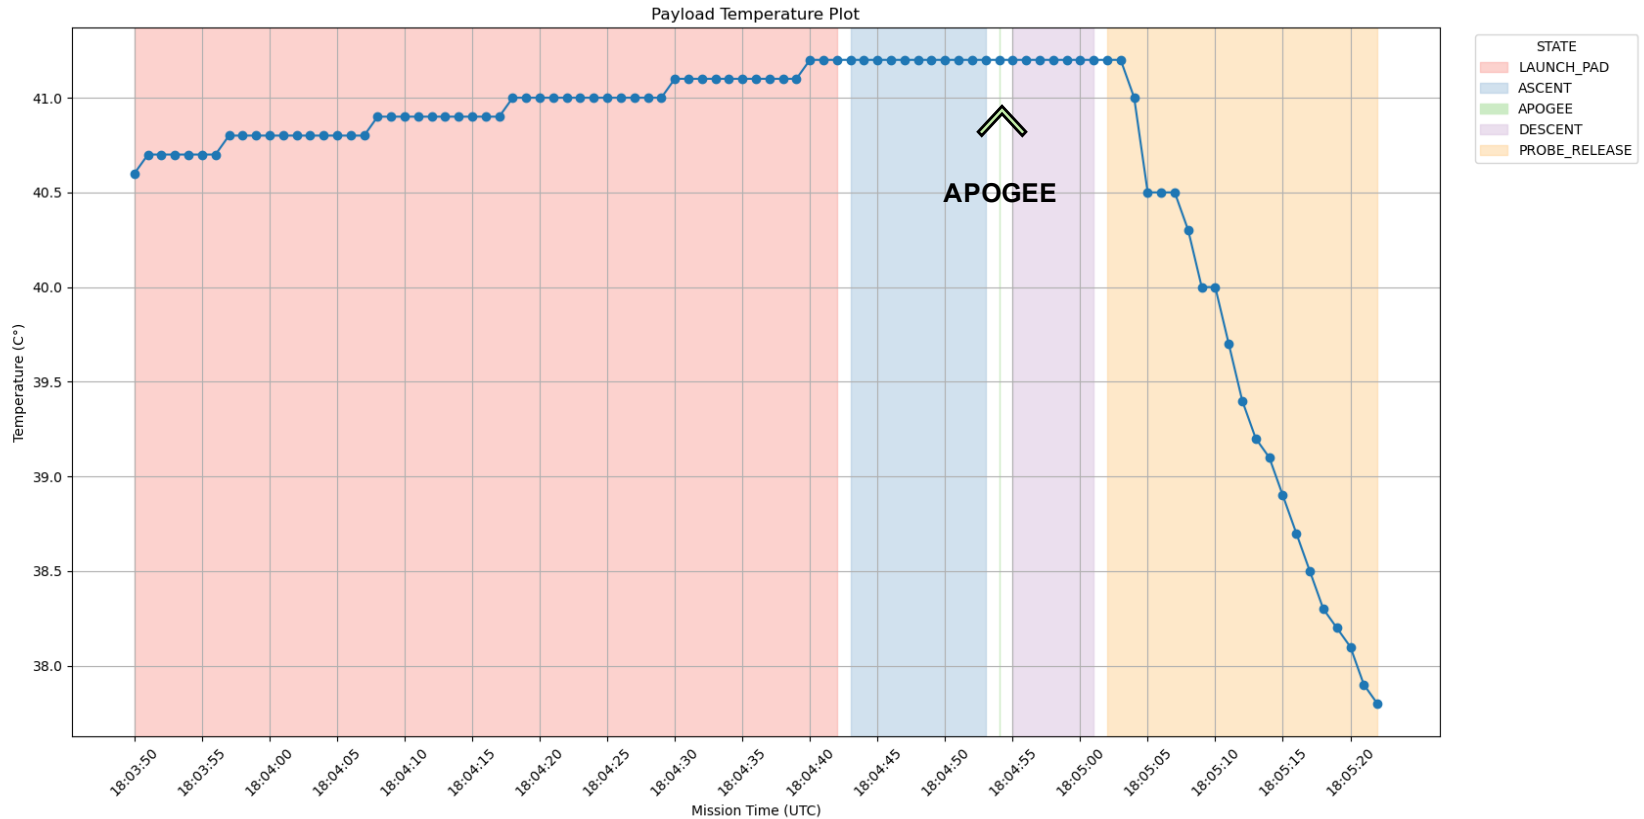
Payload Temperature Sensor Plot

The payload was heating up while waiting on the launch pad. As soon as the payload was ejected from the container, the airflow through the shroud cooled the payload down.

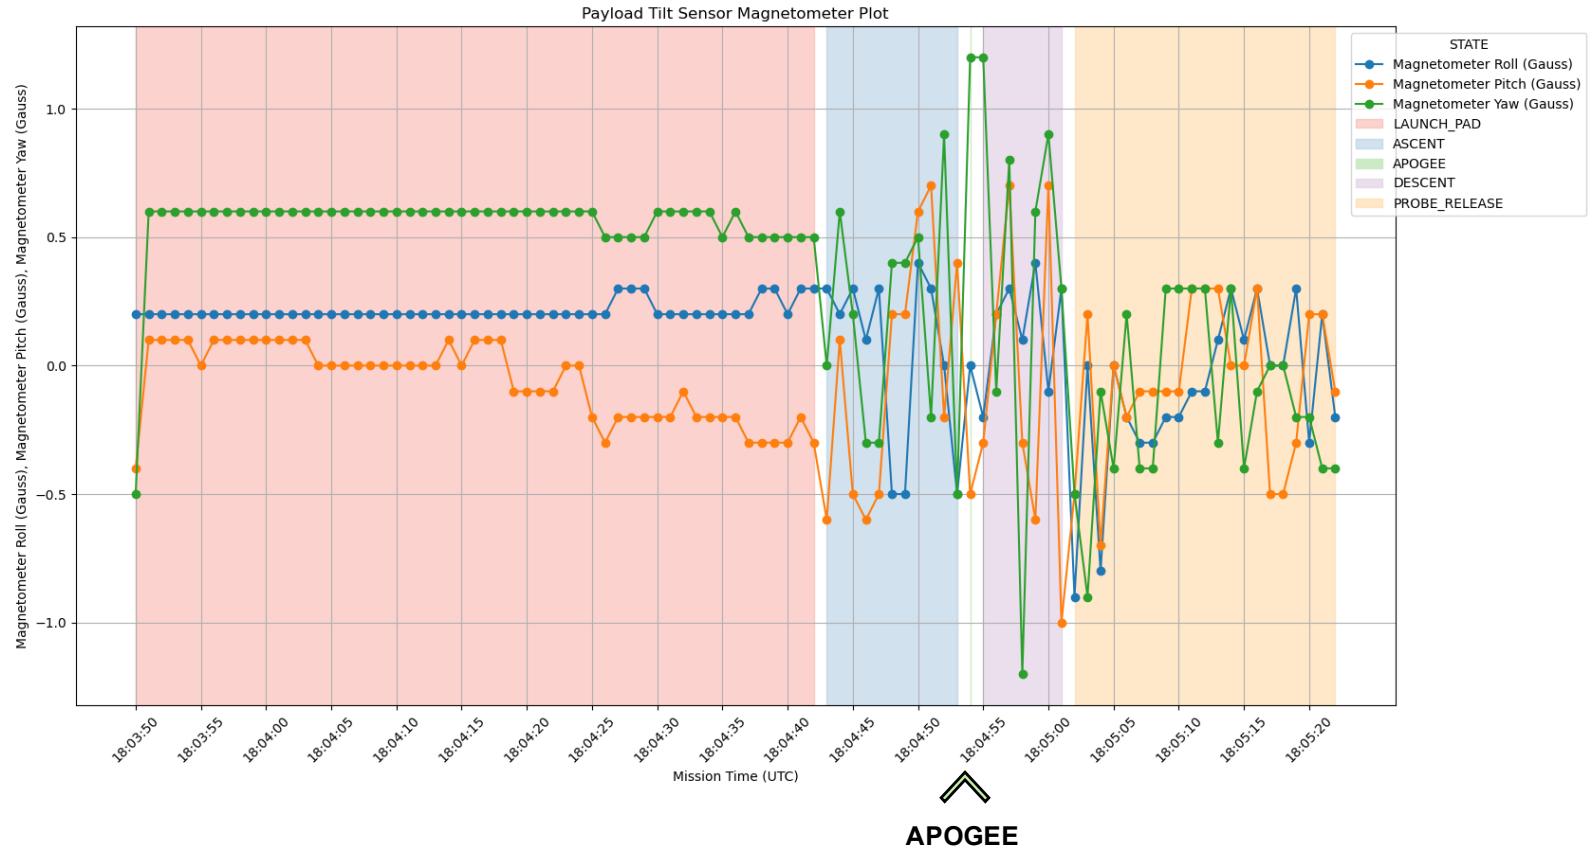
Magnetometer readings are stable at the launch pad. Increasing movement is seen during ascent, apogee, and descent, with less chaotic movements during probe release.

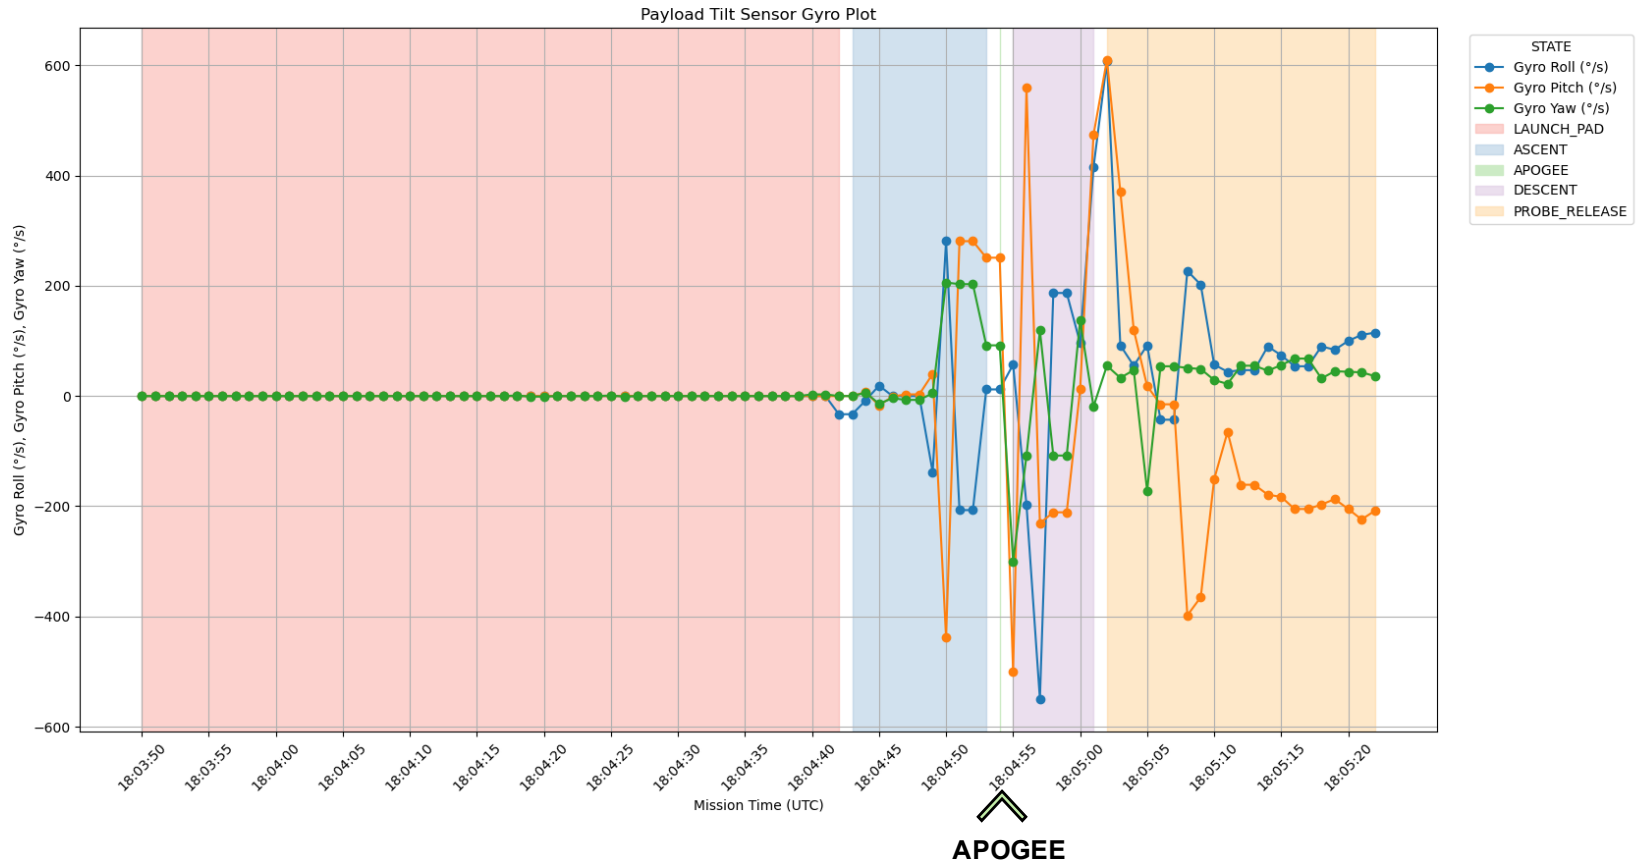
During the launch pad phase, we see all readings are 0. We see activity increase in ascent with huge spikes in descent and probe release. This is an accurate reflection of the tumbling we observed during the flight.

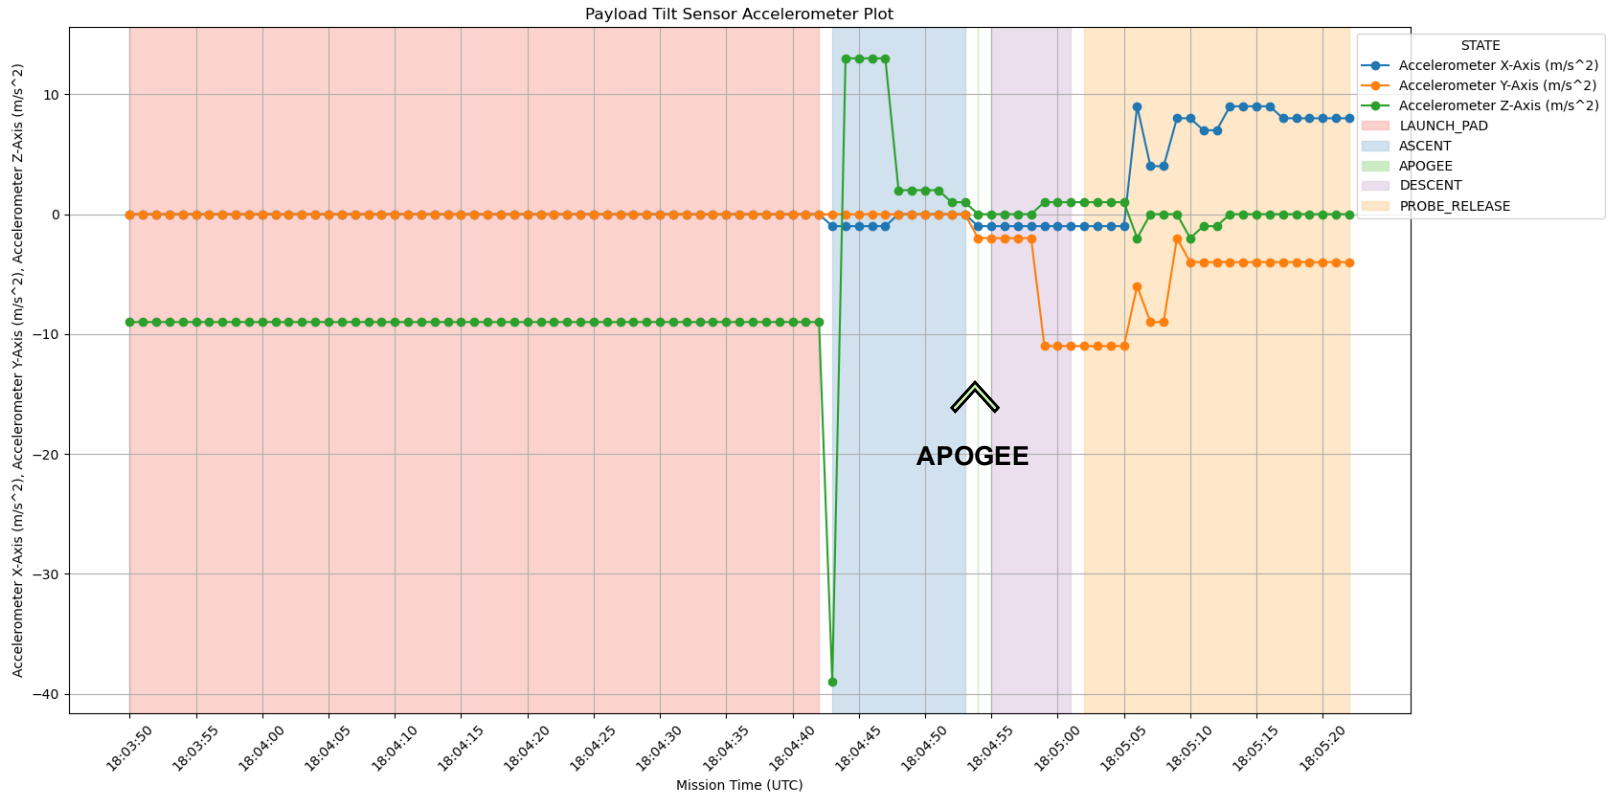
We see a consistent reading of $\sim 9m/s^2$ due to gravity on the Z-Axis on the launch pad, then consistent positive acceleration during ascent, dropping towards zero/negative during descent/probe release.

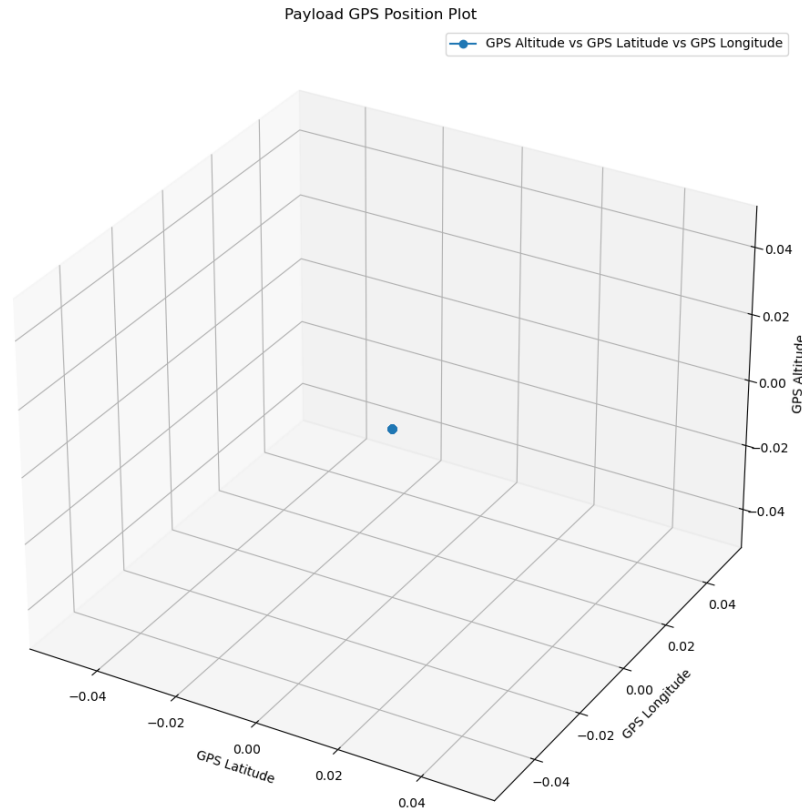
Payload GPS Position Plot

Due to a last-minute failure of our BN-220 GPS module, we had to integrate a NEO-6M GPS module donated to us by the University of Hawai'i CanSat team. Unfortunately, this GPS did not receive a single fix on any satellites throughout the entirety of the launch even though it did during testing

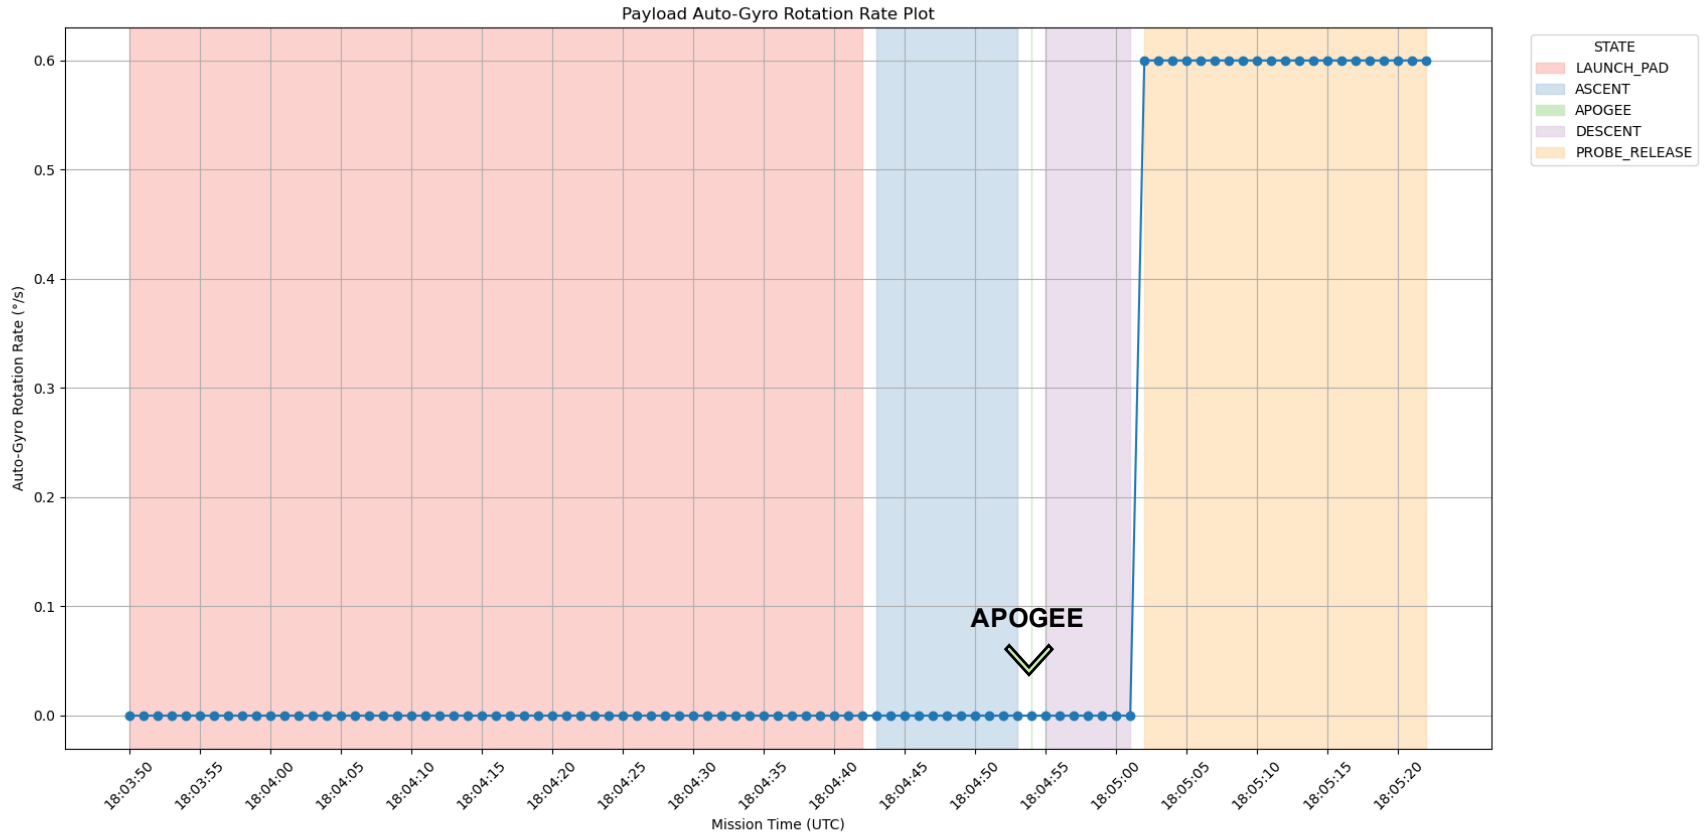
Auto-Gyro Rotation Rate Plot

Accurately represents what was physically observed as after probe release, the rotor blades jam and essentially stopped spinning due to the lack of stabilization from a missing parachute. Although some spinning was observed, the magnet likely passed by the hall sensor one single time – an artificial measurement of the rotation rate.

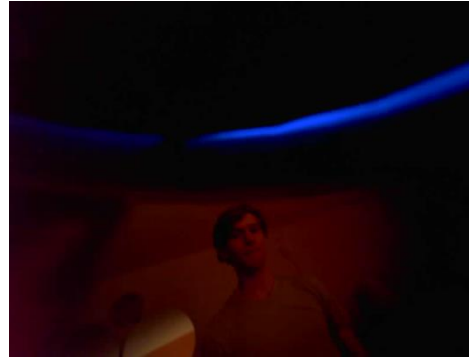
Signs of eminent sensor failure were present when conducting a postmortem of launch day:

As you can see, the images captured on and after launch day with the camera are extremely dark and are primarily only red or blue—in stark contrast to footage recorded prior to the extreme heat of launch day.

- Implement active or more effective passive cooling systems instead of relying solely on airflow during descent and limited runtime.
- Conduct full environmental testing on all systems, including thermal testing of components such as onboard cameras.
- Note: Camera thermal testing was omitted due to incomplete test specifications; this must be addressed in future protocols.
