# ES\_LPC1850/30/20/10

Errata sheet LPC1850, LPC1830, LPC1820, LPC1810

Rev. 6.1 — 22 November 2013

Errata sheet

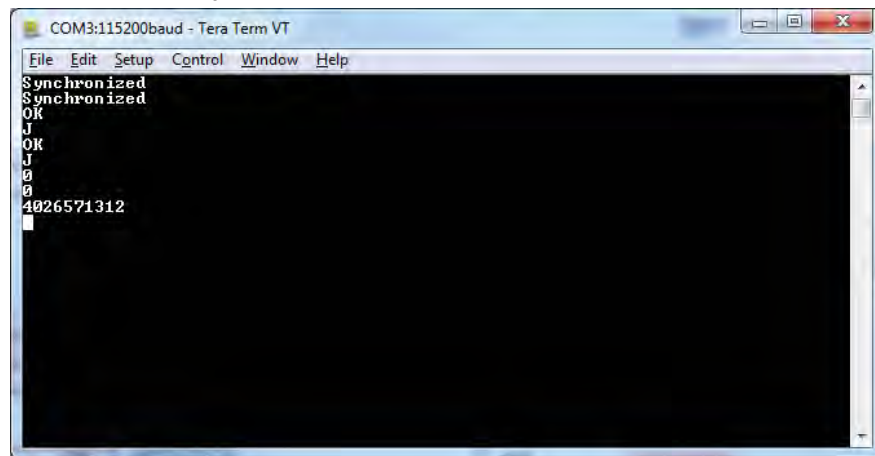
Incorrect example:

The 'J' command in ISP mode should return an error code, followed by an ASCII string representation of the part ID, followed by a 0. However what is actually returned is the error code, followed by a 0, followed by an ASCII string representation of the part ID. The problem is the last two items returned are swapped.

There is no work-around for this problem.

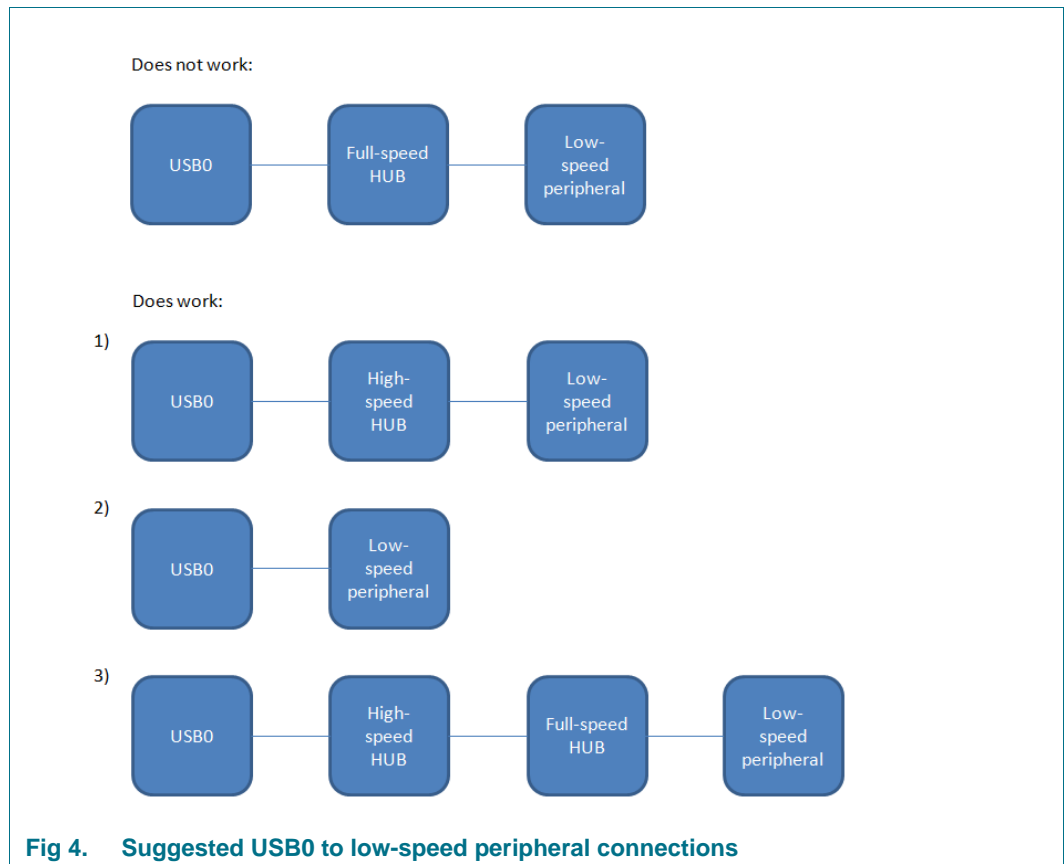
The USB controller called USB0 is unable to communicate with a low-speed USB peripheral in host mode when there is a full-speed hub directly connected to the USB0 port and a low-speed peripheral is connected in the tree somewhere below this full-speed hub. Only USB0 has this problem; the other USB controller, USB1 does not.

There is no work-around for this problem. It is suggested that the low-speed USB peripheral is either connected directly to USB0 or a high-speed hub is placed between that peripheral and USB0.
