ISEC2076

Physical Security

Assessment

Name of Facility	BMO Bank of Montreal	Address	360 Lacewood Dr, Halifax, NS B3S 1M7
------------------	----------------------	---------	--------------------------------------

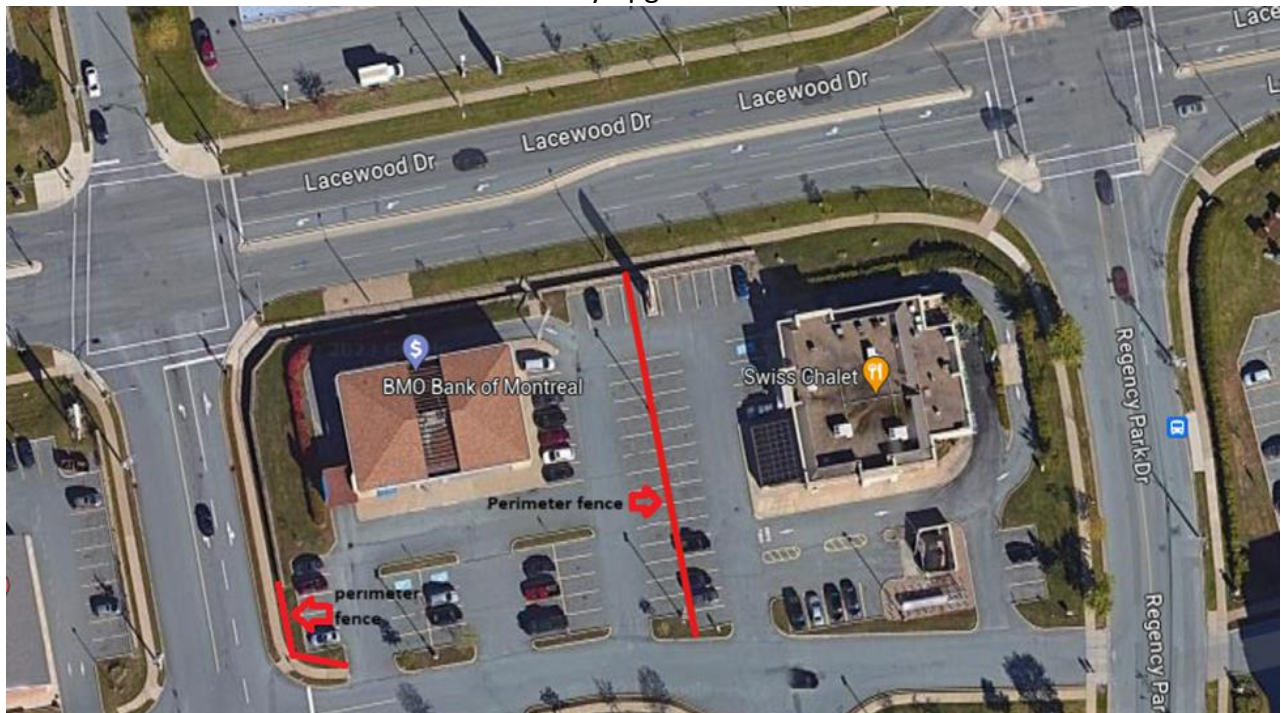
Aerial view of Site and recommended security upgrades

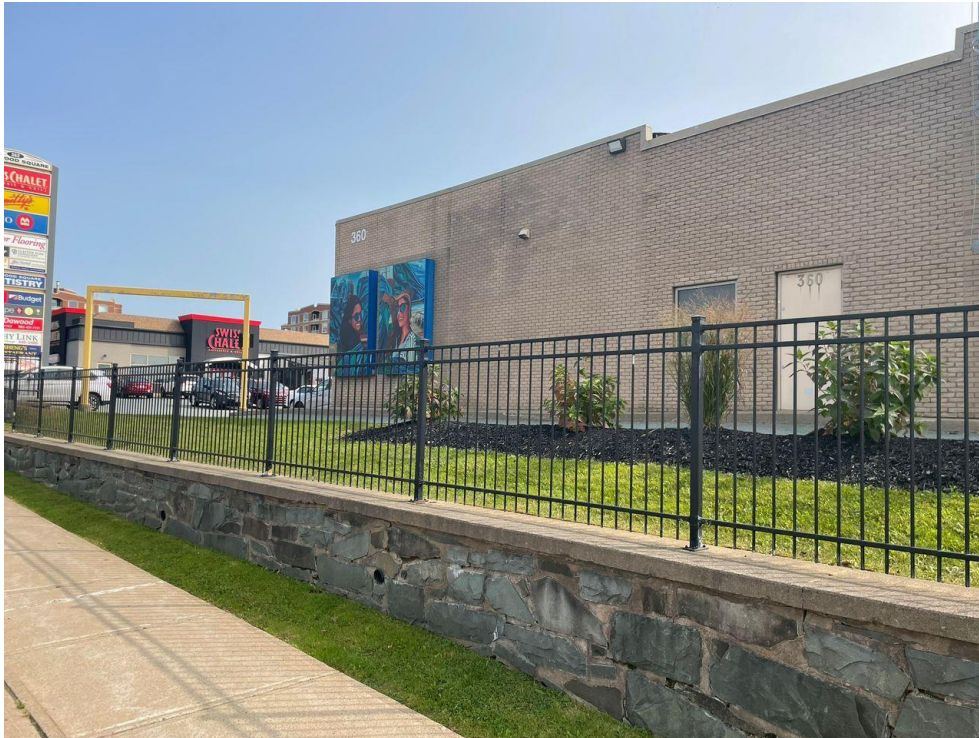
Image of maintained, levelled and cleared areas.

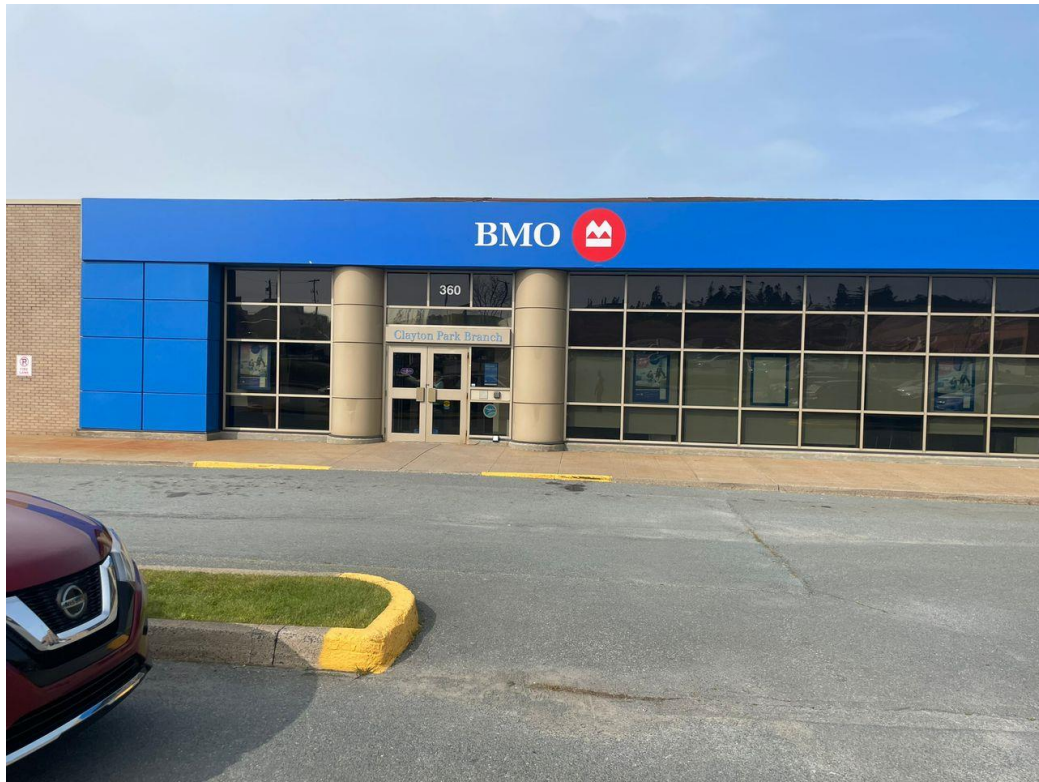
1. Steel and glass front entrance door
2. No access controls on the back and front doors

Site Main Entrance Front View

1. Install a bulletproof solid steel door for the front entrance or bulletproof heavy-duty tinted windows for the front entrance.
2. Equip the site with effective access control on the exit and entrance doors, such as biometric access control, security personnel, or security dogs.

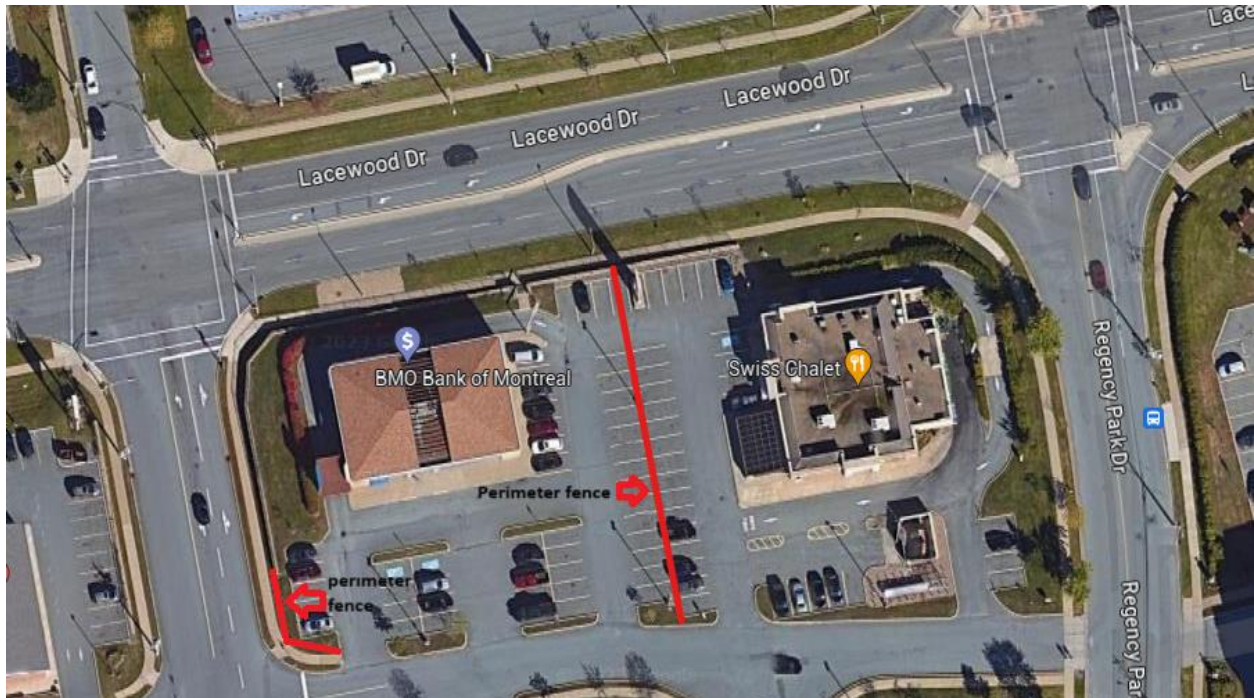
1. A perimeter fence surrounds only 90 degrees of the site.
2. No access gate.

Site Recommended Perimeter fence

1. Equip the perimeter fence to surround 180 degrees of the site.
2. Equip the site with an access gate.

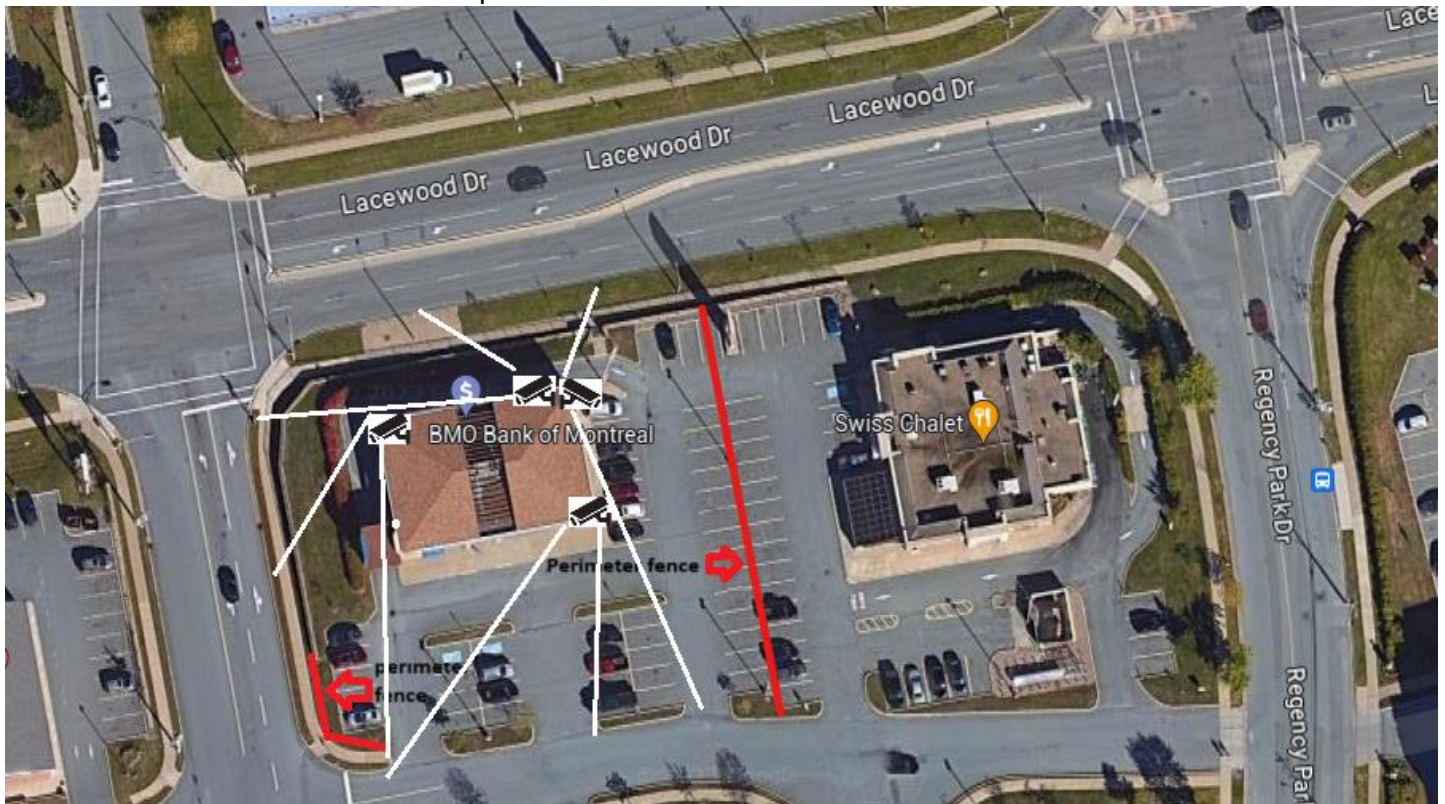
1. No active monitoring of ATM CCTV.
2. Lack of CCTV cameras on the site.
3. The only CCTV is on the ATM.
4. Not closing windows and blinds at night and turning on all the interior lights.
5. The site does not use CCTV cameras externally.
6. No CCTV cameras are linked to the site alarm system.
7. No manned guard.

Recommended CCTV camera positions on the exterior

1. Install digital CCTV cameras (with infrared) around the site covering the entire perimeter as suggested below.
2. Ensure someone is monitoring both the exterior and interior CCTV round the clock (24/7 daily throughout the whole year)
3. The recorded feed should be on & off-site and retained for a minimum of 2 months.
4. Ensure CCTV cover entrance and exits and any area of interest (sensitive areas)
5. Close all blinds before leaving the office and ensure to turn off the interior light. The facility manager can be tasked to turn off the light.

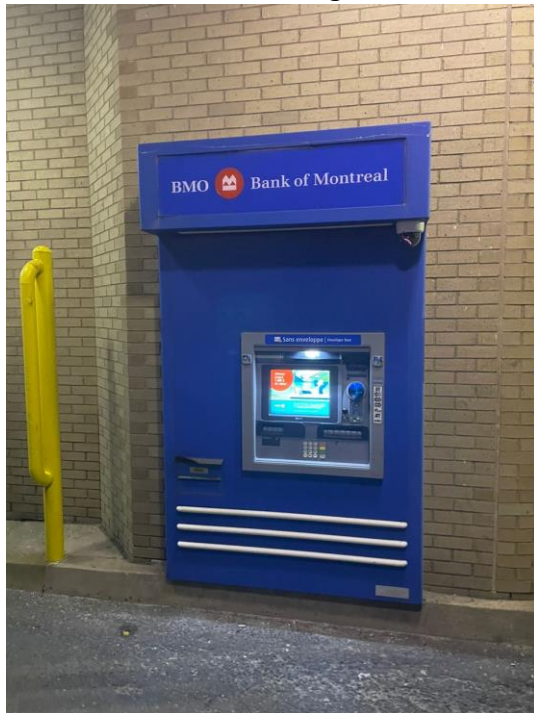
Site ATM with CCTV at night

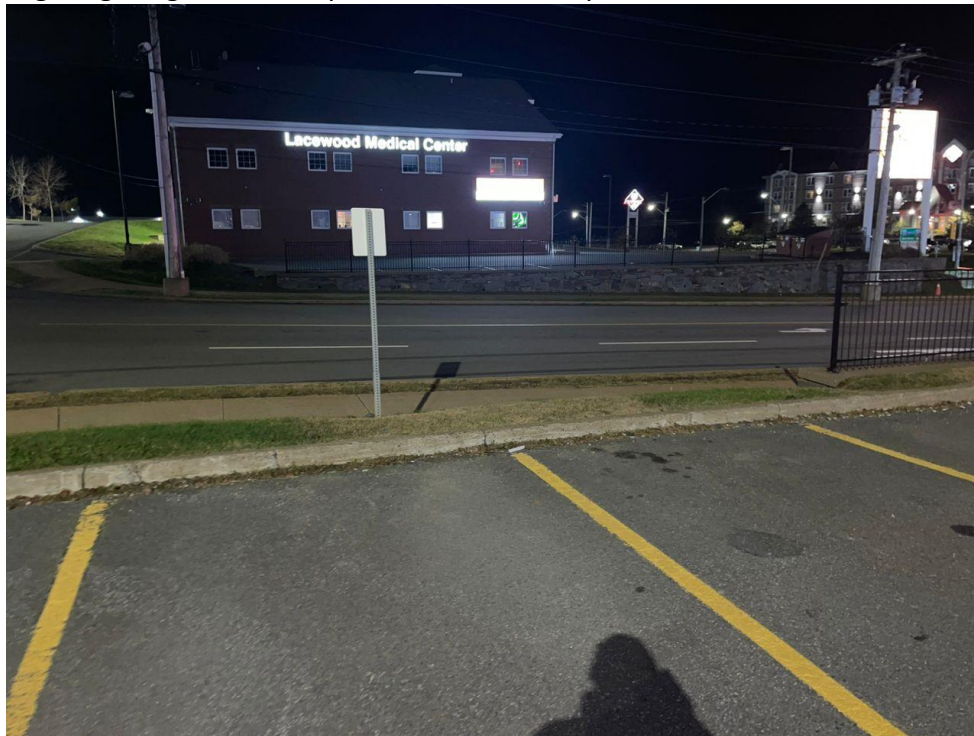
Night lighting where the perimeter fence stops.

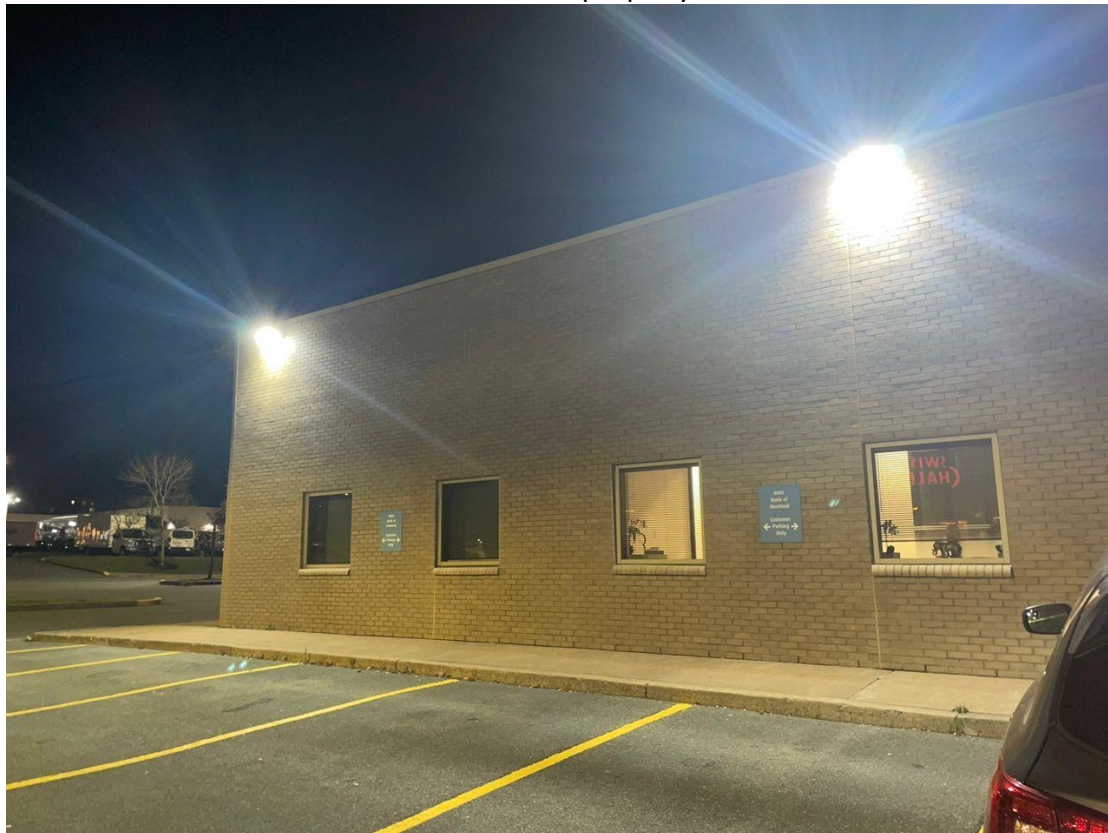
1. All lights are turned on at night, providing visibility into the office interior.
2. Windows blinds are not properly used or closed. It is visible that window blinds are installed on some of the east windows.

Site East side shows windows blinds are not properly closed and the interior is visible.

1. Each staff member should shut their windows blind before leaving the office.
2. Turn off the interior bank lighting at night or by close of business.
3. Ensure power backup supply for the lighting system, CCTV, alarm & intrusion detection during a power outage.
