The Therac 25

A case study in safety failure

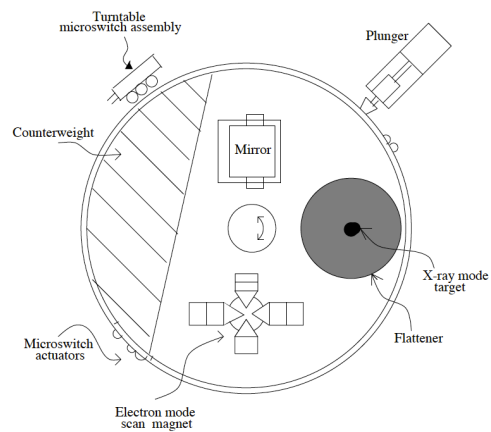
- Computer adjusts turntable position
- Microswitches detect turntable setting
- 3-bit binary code used to encode turntable setting
- Software checks replace hardware interlocks

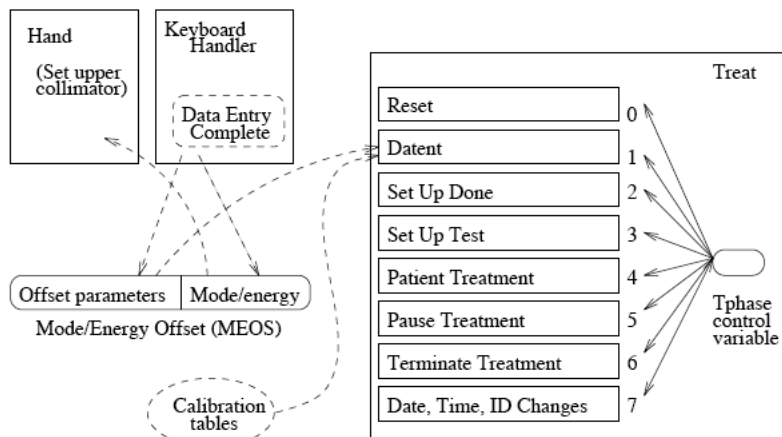
Figure 3: Tasks and subroutines in the code blamed for the Tyler accidents.

Tyler Accident Race Condition

The keyboard handler parses the mode and energy level specified by the operator and places an encoded result in another shared variable, the 2-byte Mode/Energy Offset variable (MEOS). The low-order byte of this variable is used by another task (Hand) to set the collimator/turntable to the proper position for the selected mode and energy. The high-order byte of the MEOS variable is used by Datent to set several operating parameters.

Initially, the data-entry process forces the operator to enter the mode and energy except when the photon mode is selected, in which case the energy defaults to 25 MeV. The operator can later edit the mode and energy separately. If the keyboard handler sets the Data Entry Complete flag before the operator changes the data in MEOS, Datent will not detect the changes because it has already exited and will not be reentered again. The upper collimator (turntable), on the other hand, is set to the position dictated by the low-order byte of MEOS by another concurrently running task (Hand) and can therefore be inconsistent with the parameters set in accordance with the information in the high-order byte. The software appears to contain no checks to detect such an incompatibility.

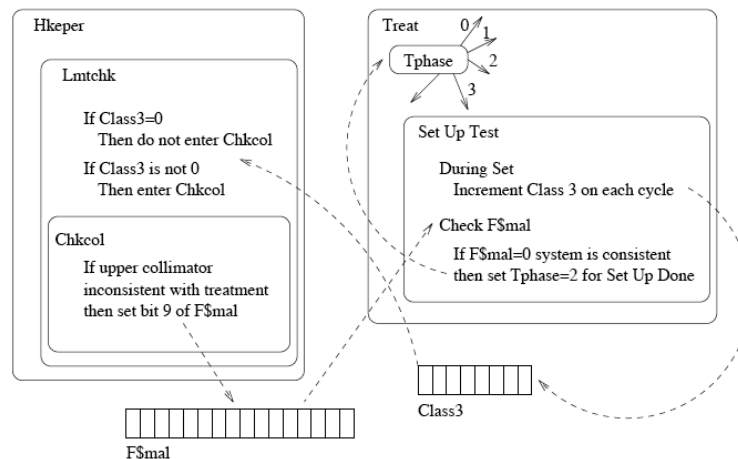
Figure 4: The Yakima software flaw.

Yakima Accident Race Condition

During machine setup, Set-Up Test will be executed several hundred times since it reschedules itself waiting for other events to occur. In the code, the Class3 variable is incremented by one in each pass through Set-Up Test. Since the Class3 variable is 1 byte, it can only contain a maximum value of 255 decimal. Thus, on every 256th pass through the Set-Up Test code, the variable overflows and has a zero value. That means that on every 256th pass through Set-Up Test, the upper collimator will not be checked and an upper collimator fault will not be detected.

The overexposure occurred when the operator hit the "set" button at the precise moment that Class3 rolled over to zero. Thus Chkcol was not executed, and F\$mal was not set to indicate the upper collimator was still in field-light position. The software turned on the full 25 MeV without the target in place and without scanning. A highly concentrated electron beam resulted, which was scattered and deflected by the stainless steel mirror that was in the path.

- Numerous hardware and software changes
- All interruptions related to dosimetry not continuable
- independent hardware & software shutdowns
- potentiometer on turntable
- hardware interlocks
- "dead man switch" motion enable
- Fix documentation, messages, & user manuals
- etc
