**Investigation of wireline failure**  
**Reference: Dimension Bid – CWR-1280**

**Danum Well Services Ltd**

The Laboratory was commissioned by Danum Well Services to assess wireline break that occurred during operational use by Dimension Bid.

Well : LARUT A-27L

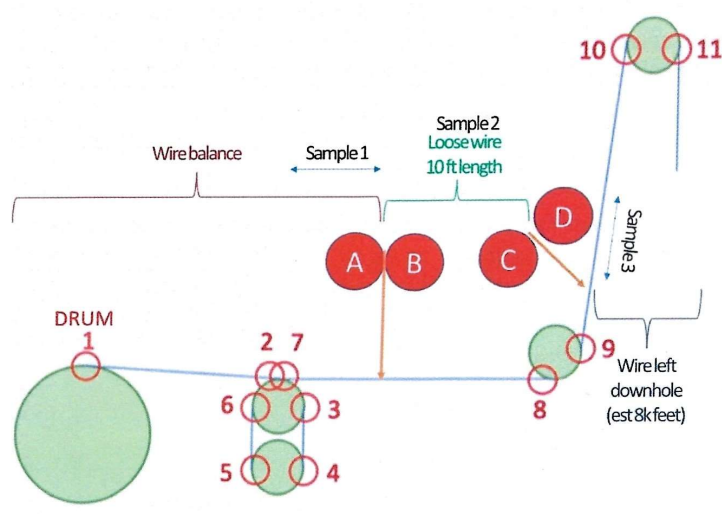
Observed parted points

“Crew offshore (night shift) reported that during WOL, while tension to firing spring jar @ 2641m-RKB, wire parted in between counter wheel assembly and hay pulley (2 parted points A-B and C-D).” Below image provided by customer.

1. A,B,C,D, are based on images of fractured end of parted wire.
2. Wire parted at 2 points; A-B and C-D.
3. Parted point A-B is between mp16 (7) and Hay Pulley (8)
4. Parted point C-D is between Hay Pulley (9) and Stuffing box (10).

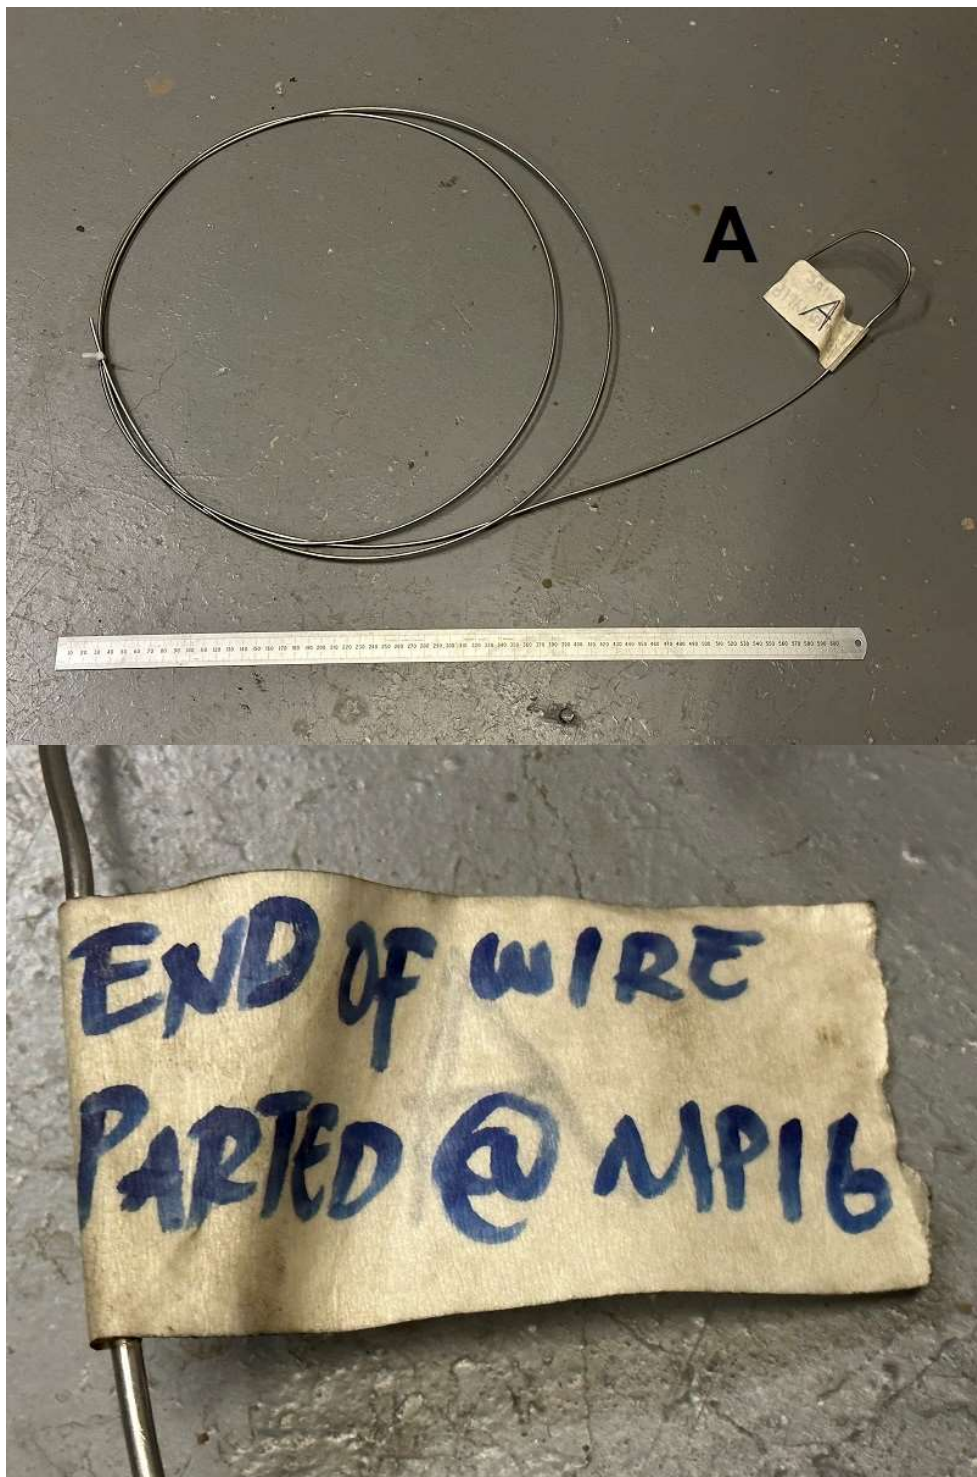
Figure 1, As received Sample A

- Sample A is the sample that parted at MP16, the wire forms a coil and is only bend close to the fracture, Figure 1.
- Sample B-C has undergone kinking and loss of circular cast, typical for wire jumping out of the sheave/pulleys, Figure 2.
- Sample D kinked and damaged opposite to location C, Figure 3.

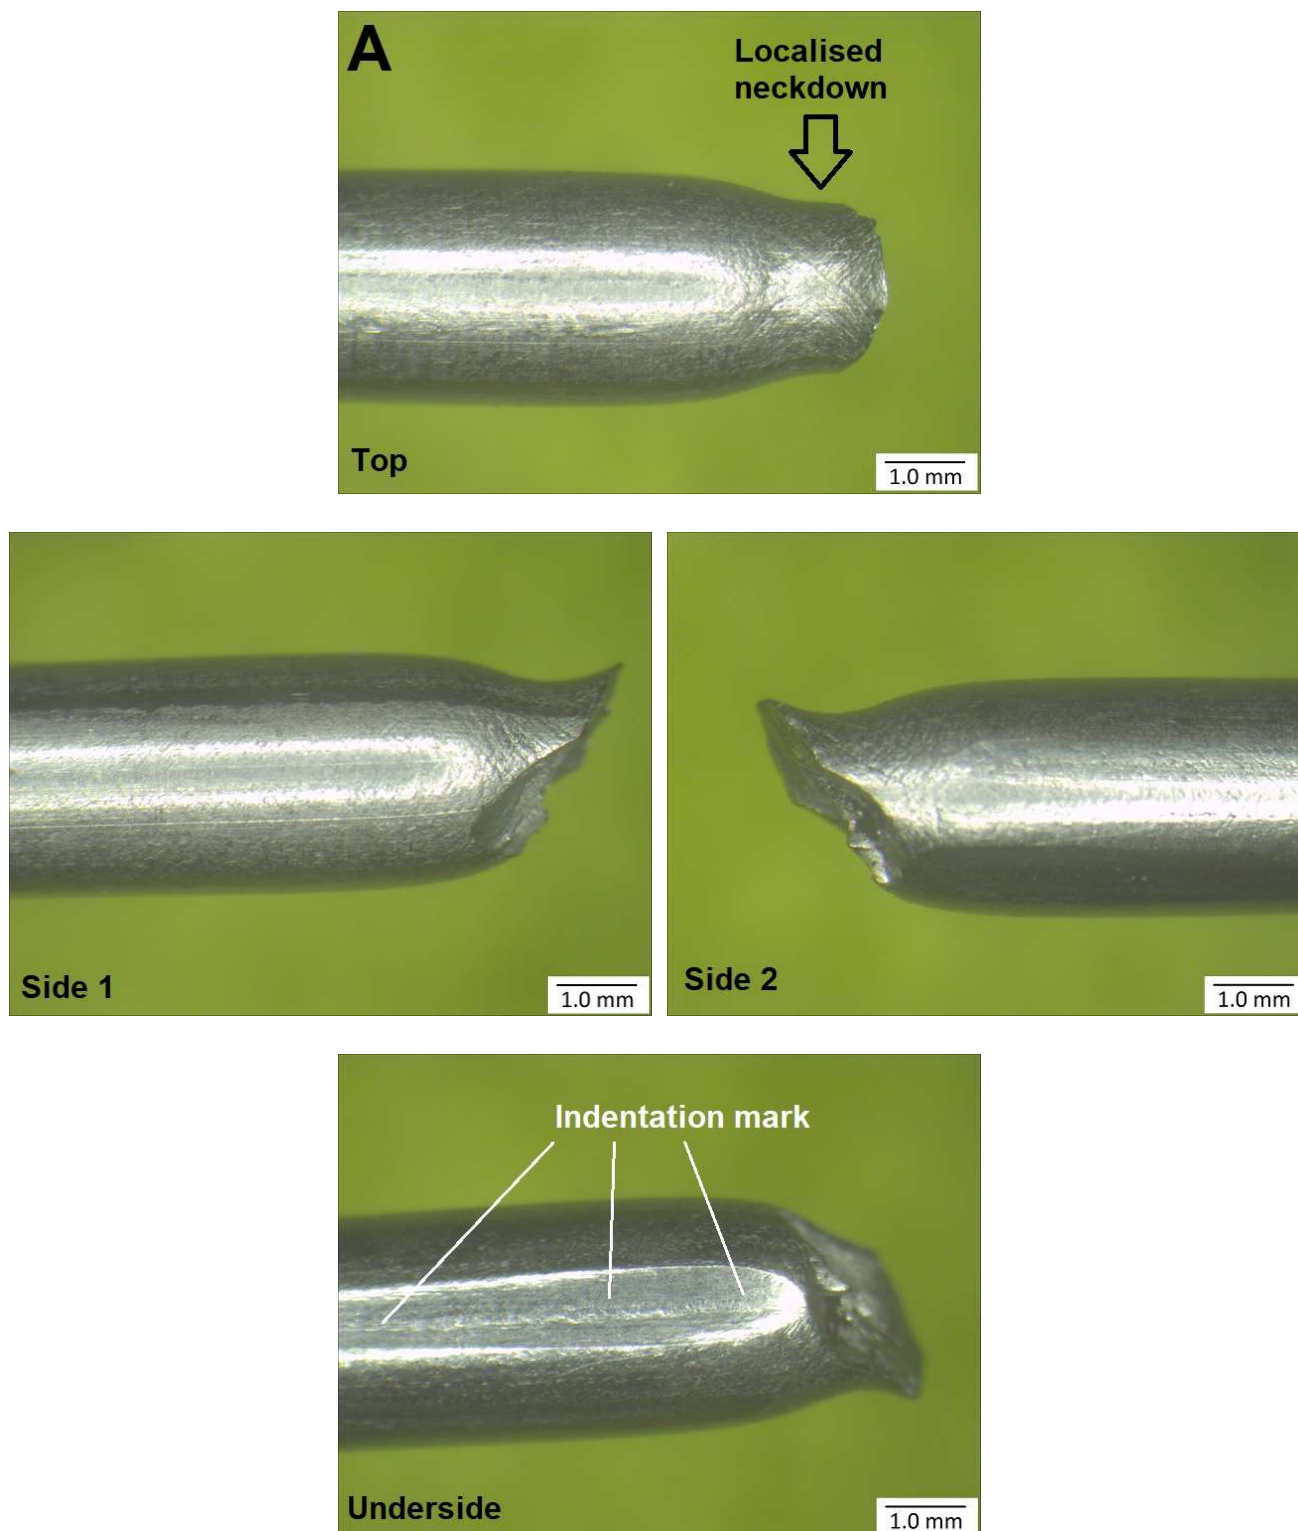
Location A, the wire has locally necked down, indicating a good level of ductility, and then parted in a semi-shear nature, Figure 4. Associated with the fracture is an indentation mark, possibly from cross cutting or lapping with the line itself at MP16.

**Figure 4, Images taken of the fracture at Location A**

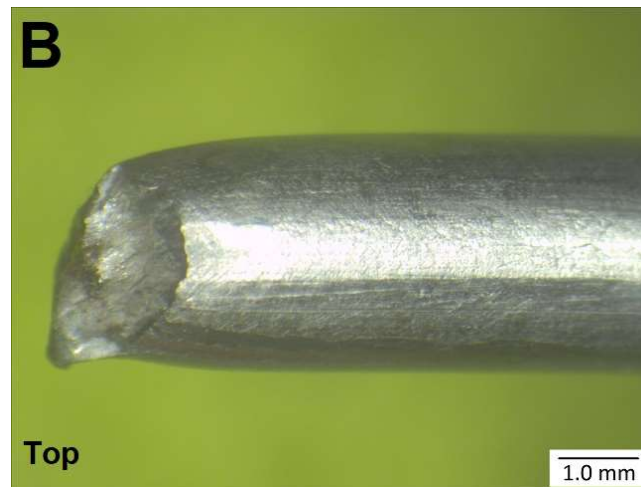
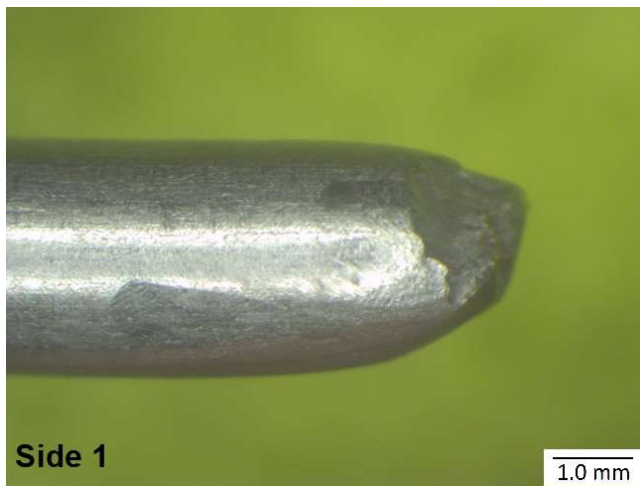
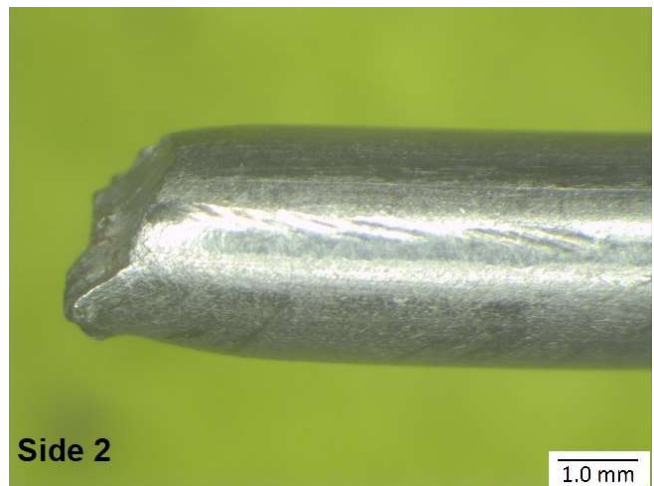
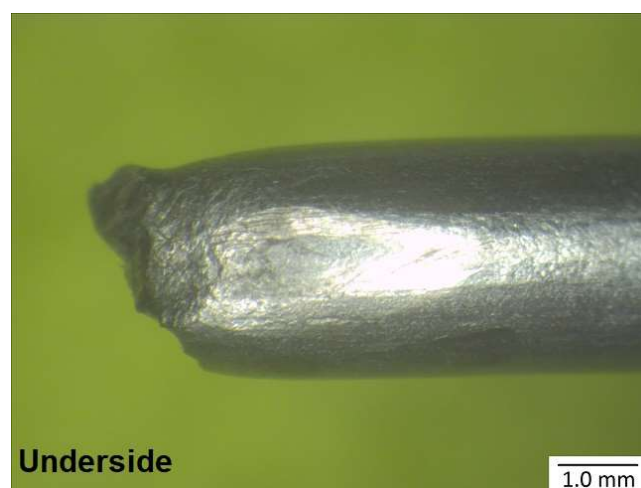
On the opposite side, Location B, there is more post failure mechanical damage due to the wire being free to contact the deck floor and ancillary equipment, Figure 5. Even though Location B was damaged, the Laboratory was still able to match the two ends to confirm that A-B parted via tensile overload with localised necking down, Figure 6.

Figure 5, Images taken of the fracture at Location B

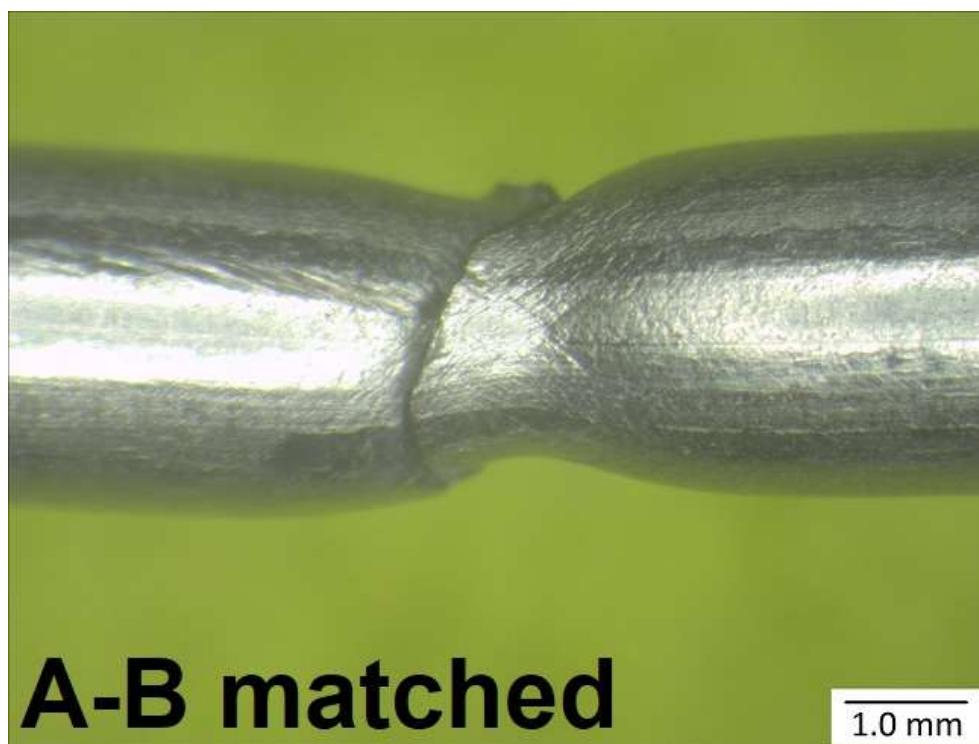
The fractures marked as Locations A and B were successfully matched and analysis confirmed that with the localised necking down, final failure occurred via tensile overload. However, a contributing factor is the indentation at the side of the line resulting from either cross cutting typically on the drum when loose wraps were present or trapped in a sheave if the line has jumped. The indentation becomes a stress raiser which can effectively reduce the applied load to failure.

Figure 6, Locations A and B matched, neck down tensile overload

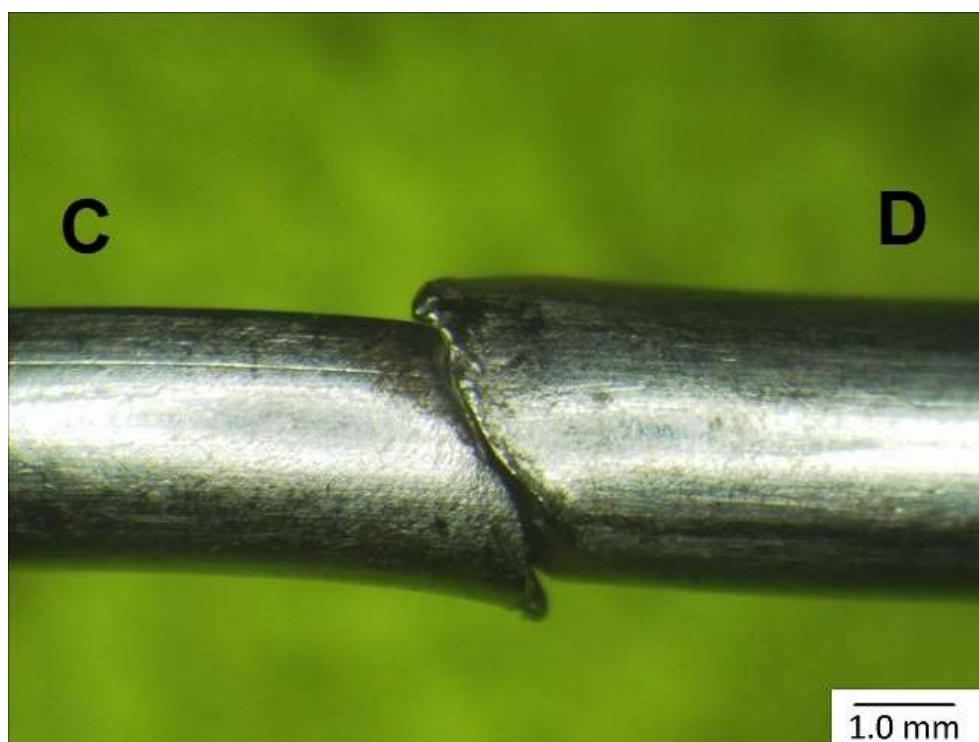
Locations C-D were matched and appear to be shear in nature with no necking down, Figure 7. Higher magnification images of the top of the fracture found an indentation than spanned both sides of the fracture, Figure 8. The bottom image provided further confirmation that the fractures were a pair with the continuation of a chatter mark from the D side of the break to C.

The fracture at C and D is the result of contact damage causing the line to shear. This may have been the result of the line jumping out of the sheave which then came into contact with a deflection point.

Figure 7, Locations C and D seems to have sheared

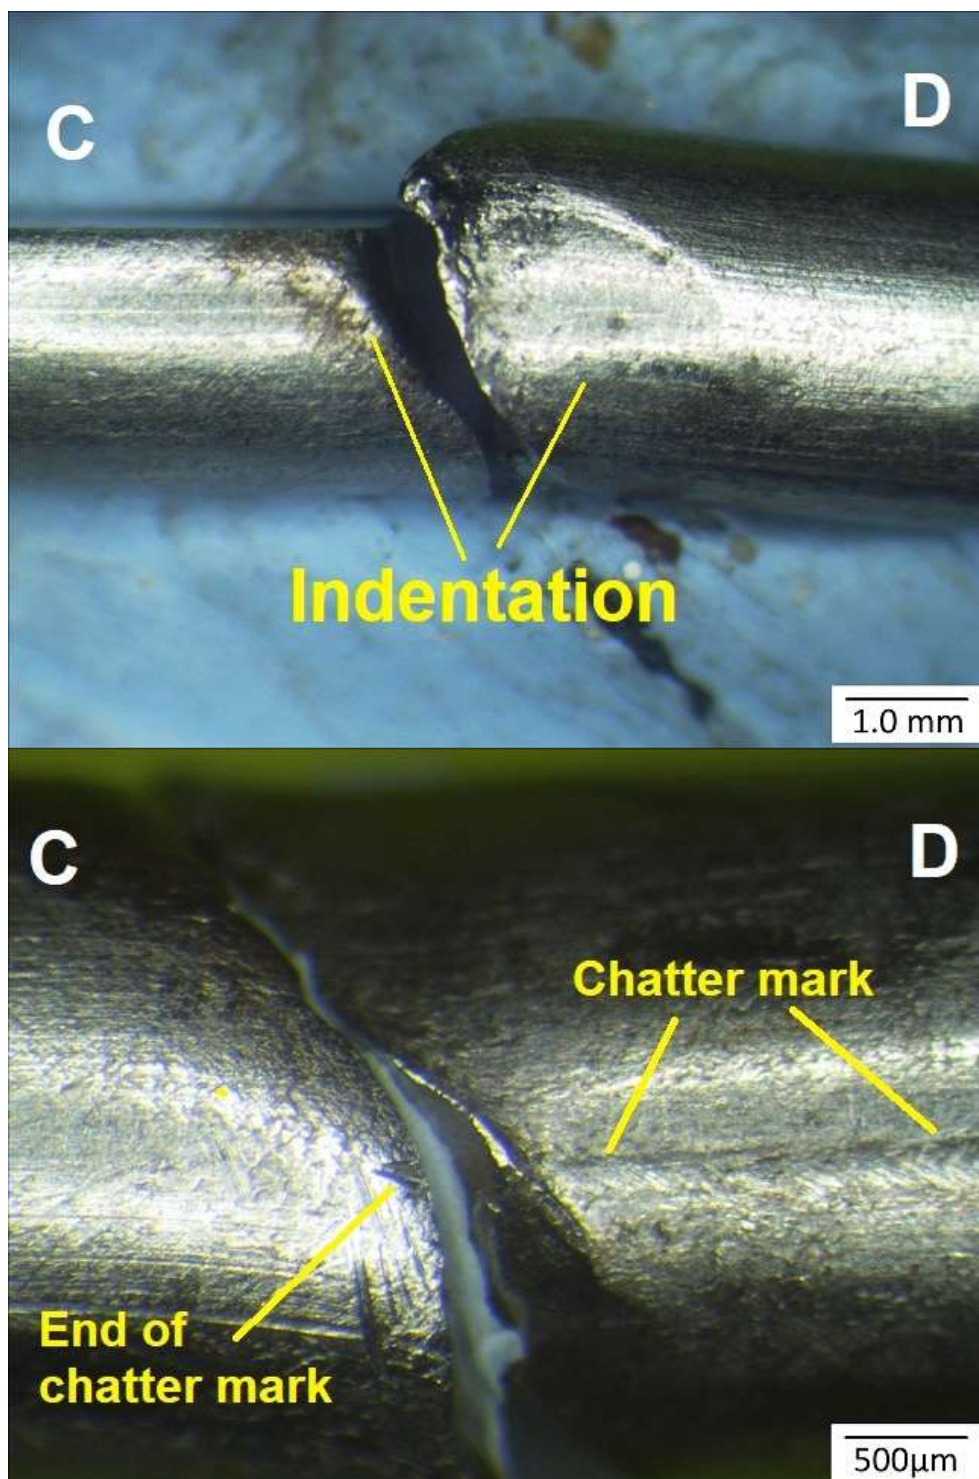
Figure 8, higher magnification images of the C-D fracture confirmed the shear break is concentrated from a surface indentation, further confirmation of the match is the chatter mark

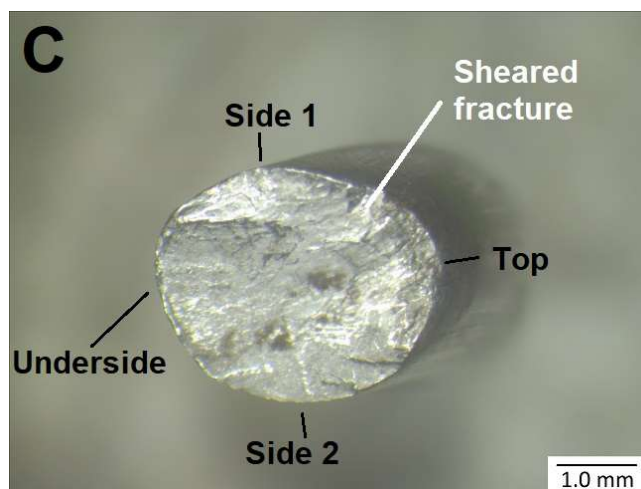
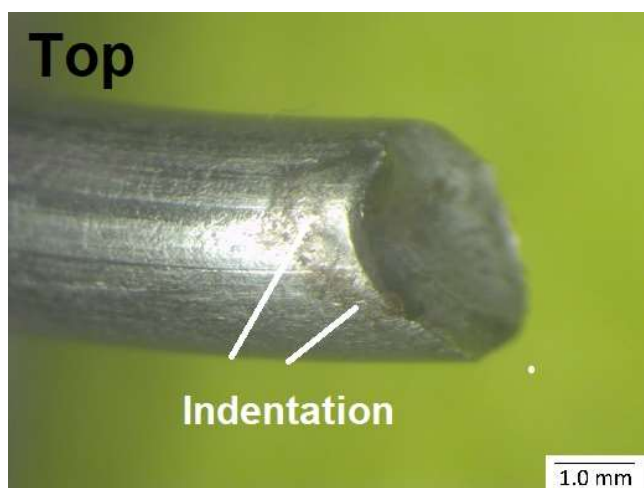
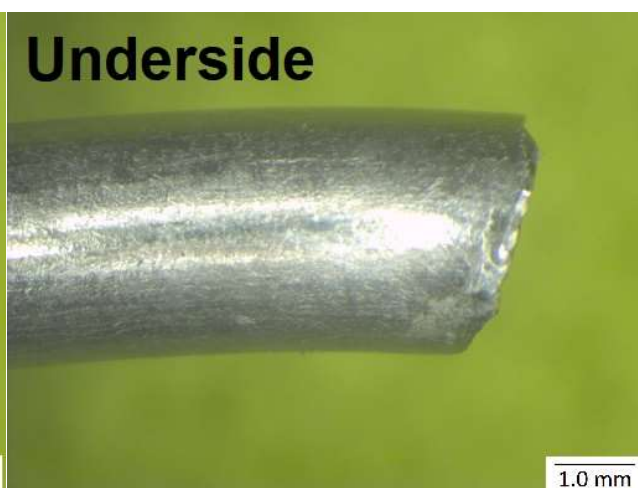
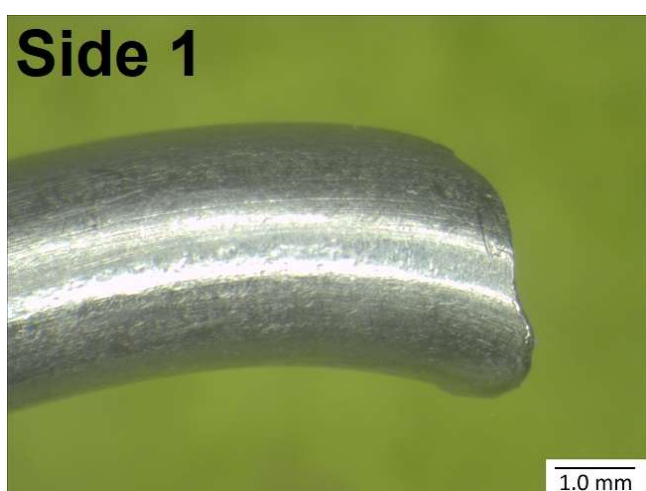
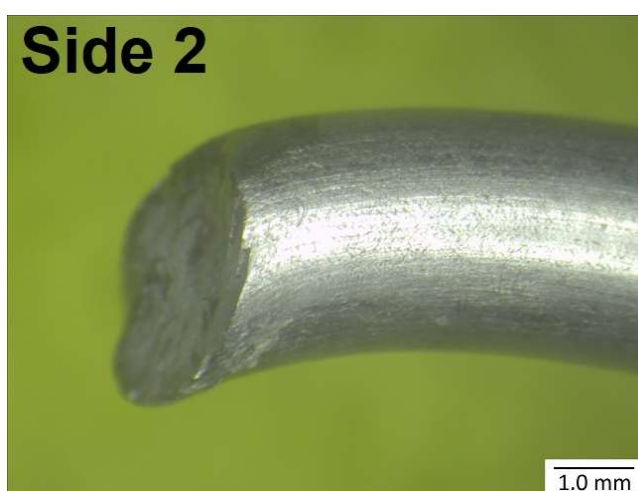
Higher magnification images of the fractures at Location C and D are presented in Figures 9 and 10. The shear nature of the break is clearly evident on both sides.

Figure 9, fracture has initiation from the top side and parted resulting from shearing action towards the underside

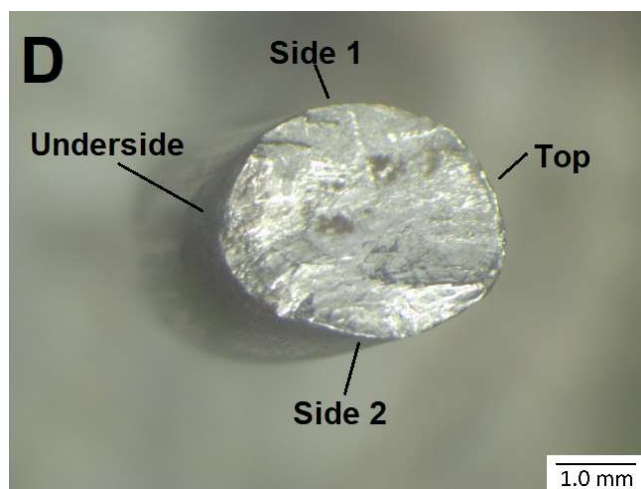
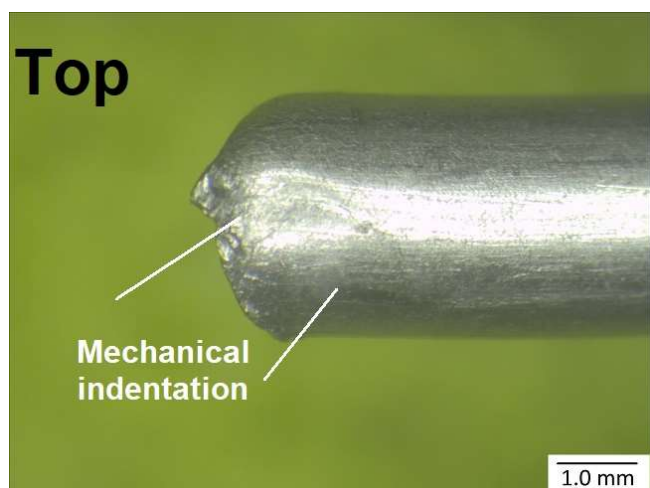
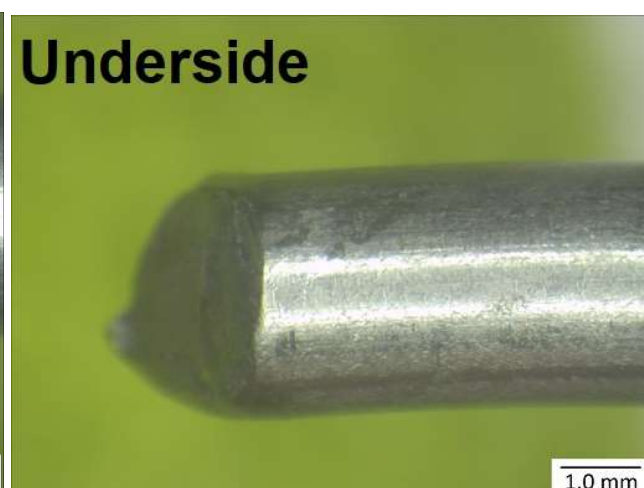
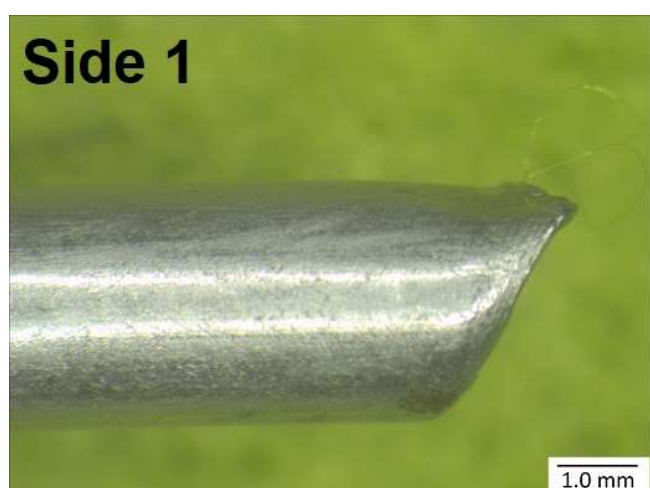
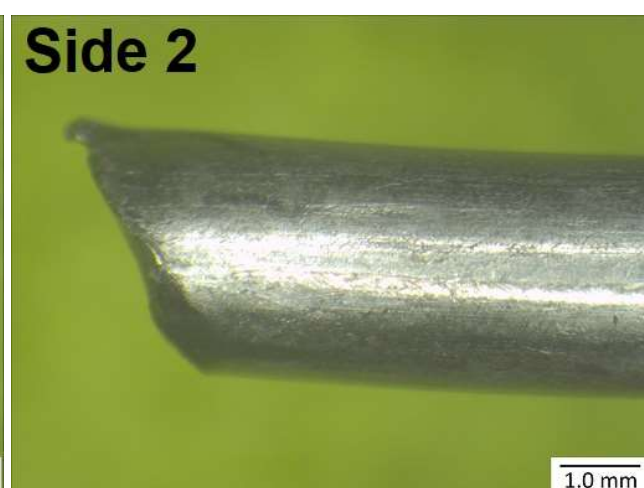
Figure 10, fracture has initiation from the top side and parted resulting from shearing action towards the underside

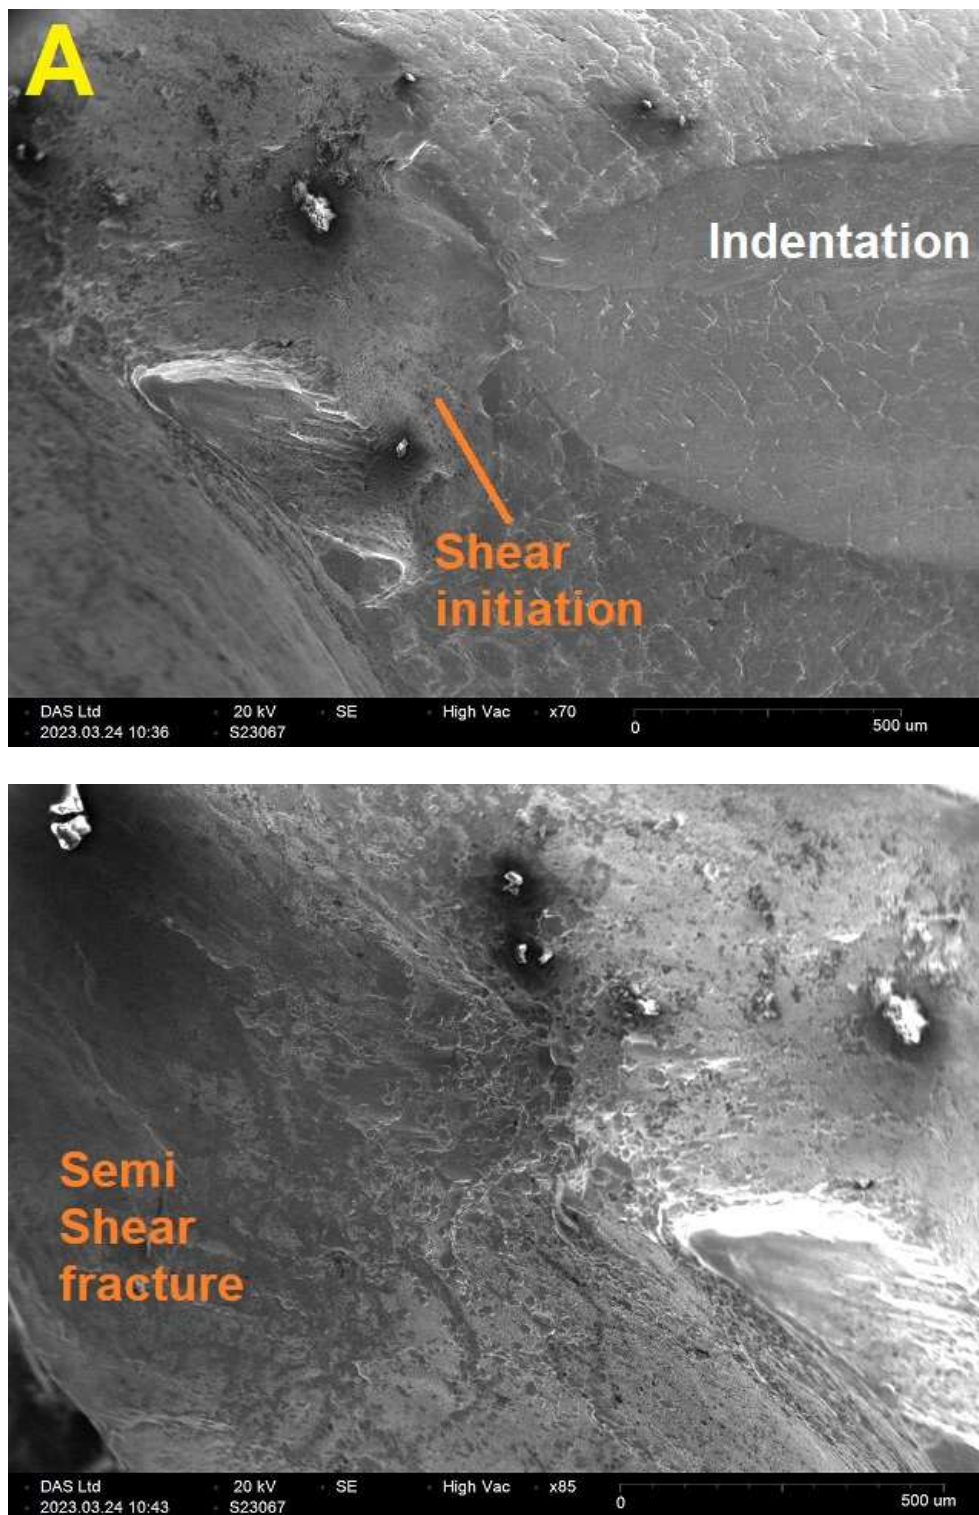
At Location A, it is evident that even though the region had necked down, due to high applied load, the final shear fracture was initiated by the indentation on the side of the wire, Figure 11.

**Figure 11, although the fracture region has necked down, the final fracture is shear in nature due to the applied stress from the indentation.**

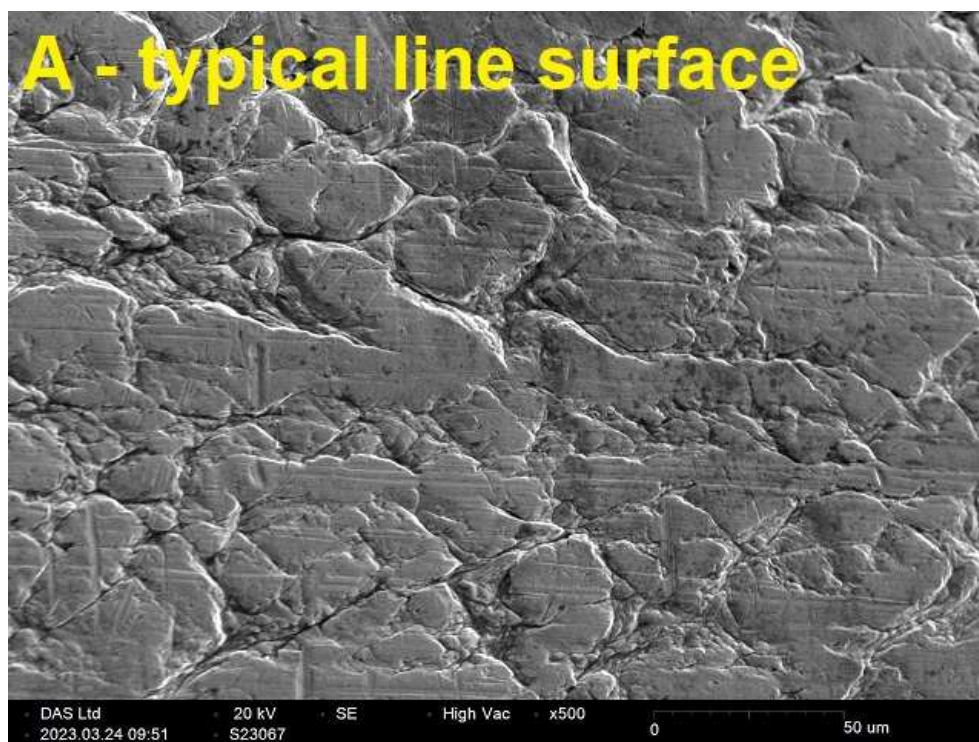
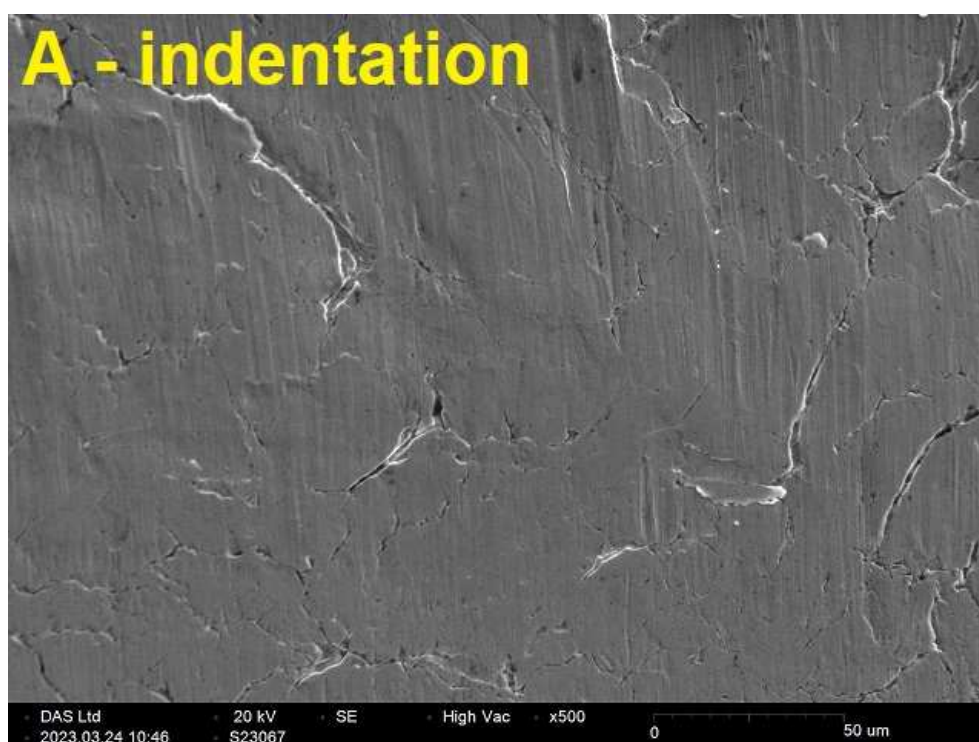
A comparison of the typical wire surface and indented surface is presented in Figure 12. On the indented surface the grain boundaries are still present but flattened. EDS analysis of the wire surface confirmed the line to be manufactured from SUPA75, a corrosion resistant super austenitic stainless steel used in medium to sour well conditions around the globe, Figure 13. EDS analysis of the indentation again found it to be SUPA75, no other foreign material was present, Figure 14. It can therefore be concluded that the indentation was formed by cross cutting with the line itself.

**Figure 12, comparison of the typical wire surface showing elongated grains and the smooth indented surface**

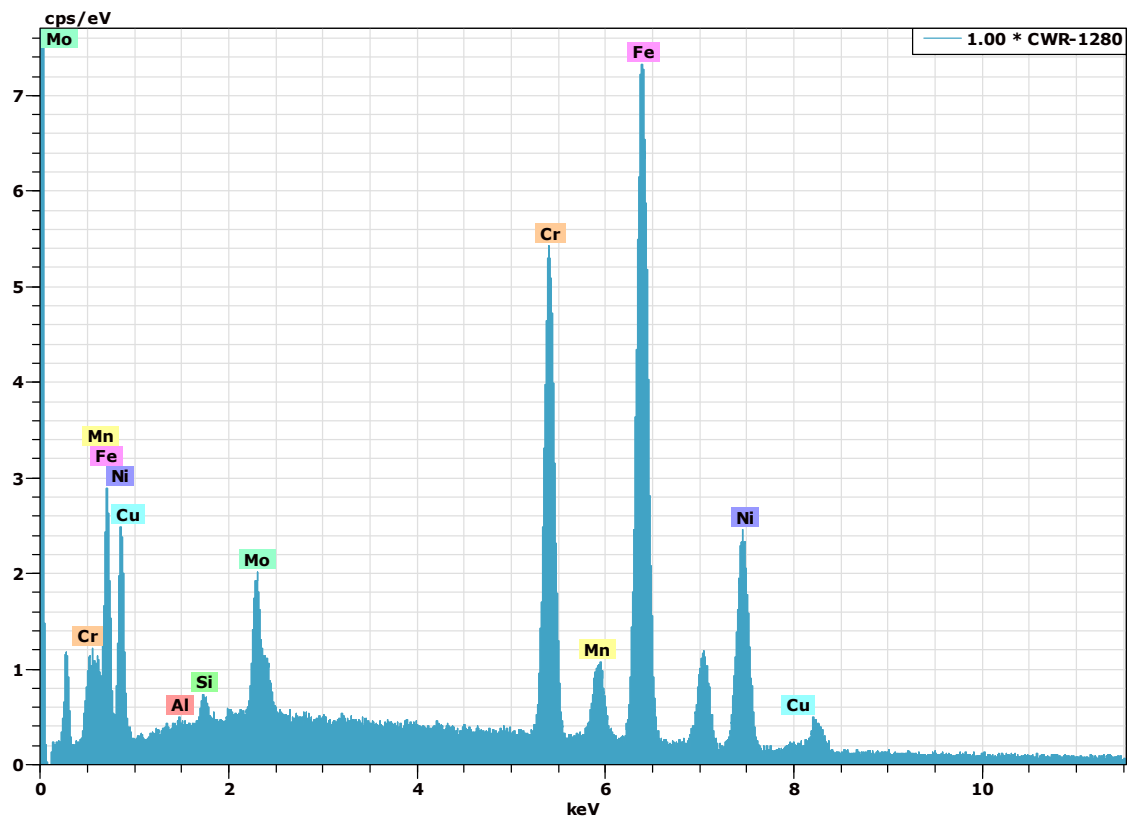
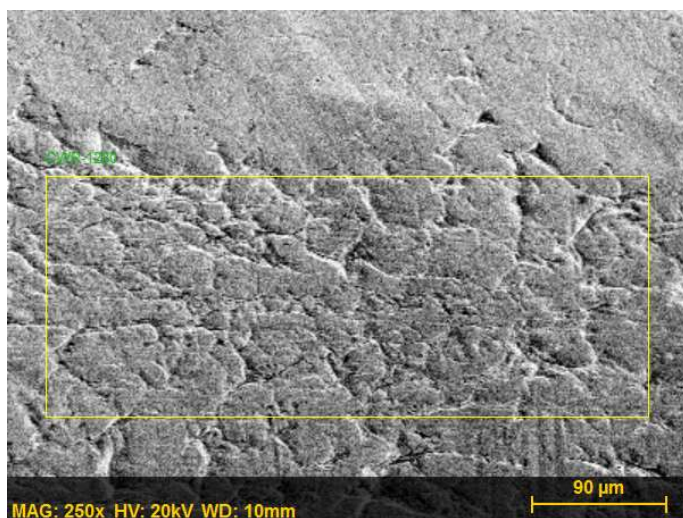
Figure 13, EDS analysis of the line surface confirmed the material to be GD31Mo

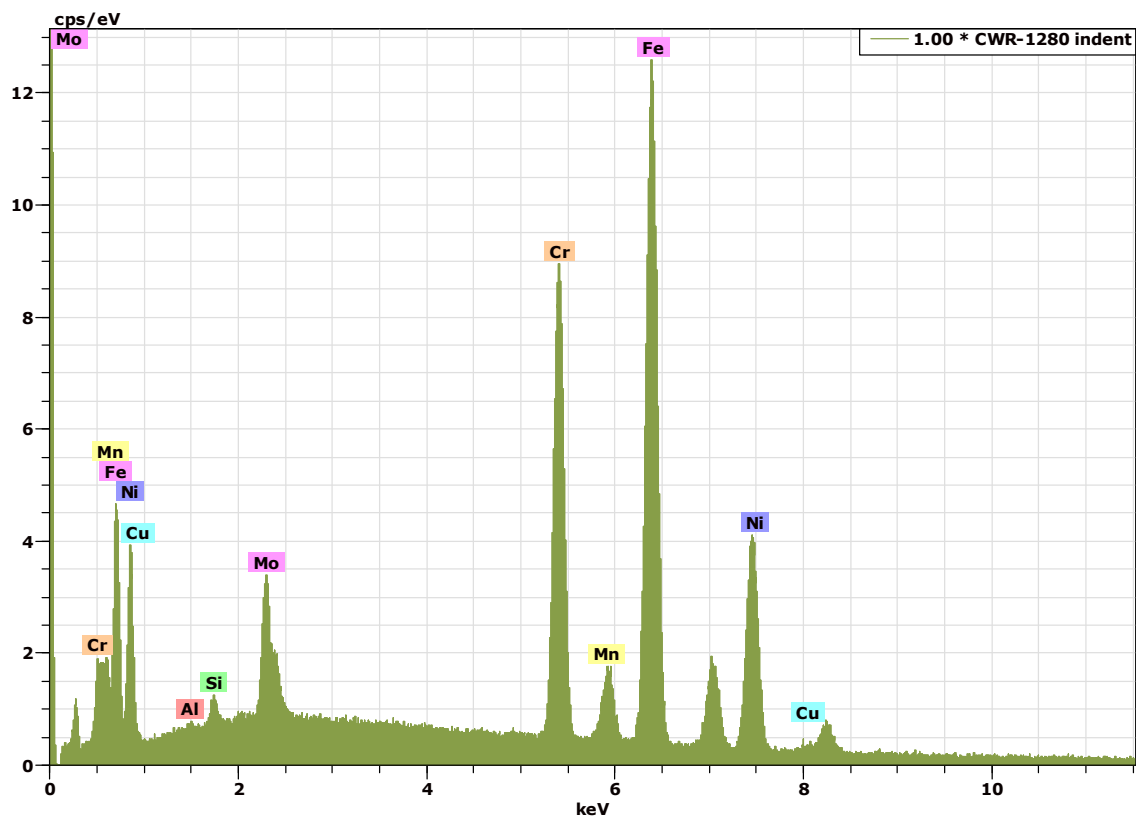
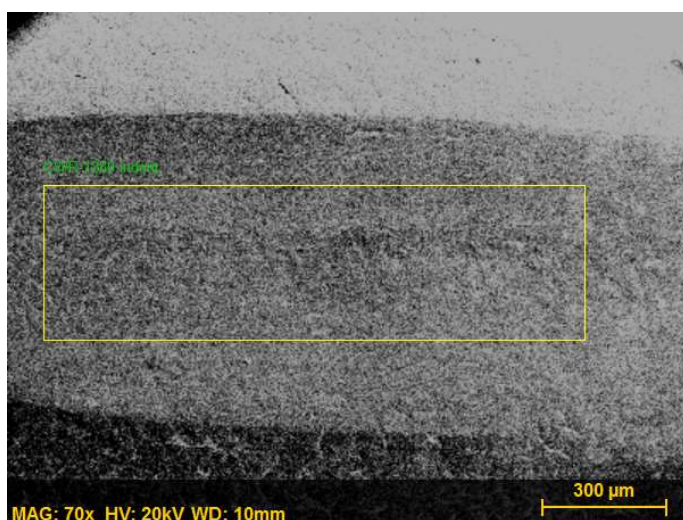
Figure 14, EDS analysis of the indentation did not find foreign material present, just the original wire surface

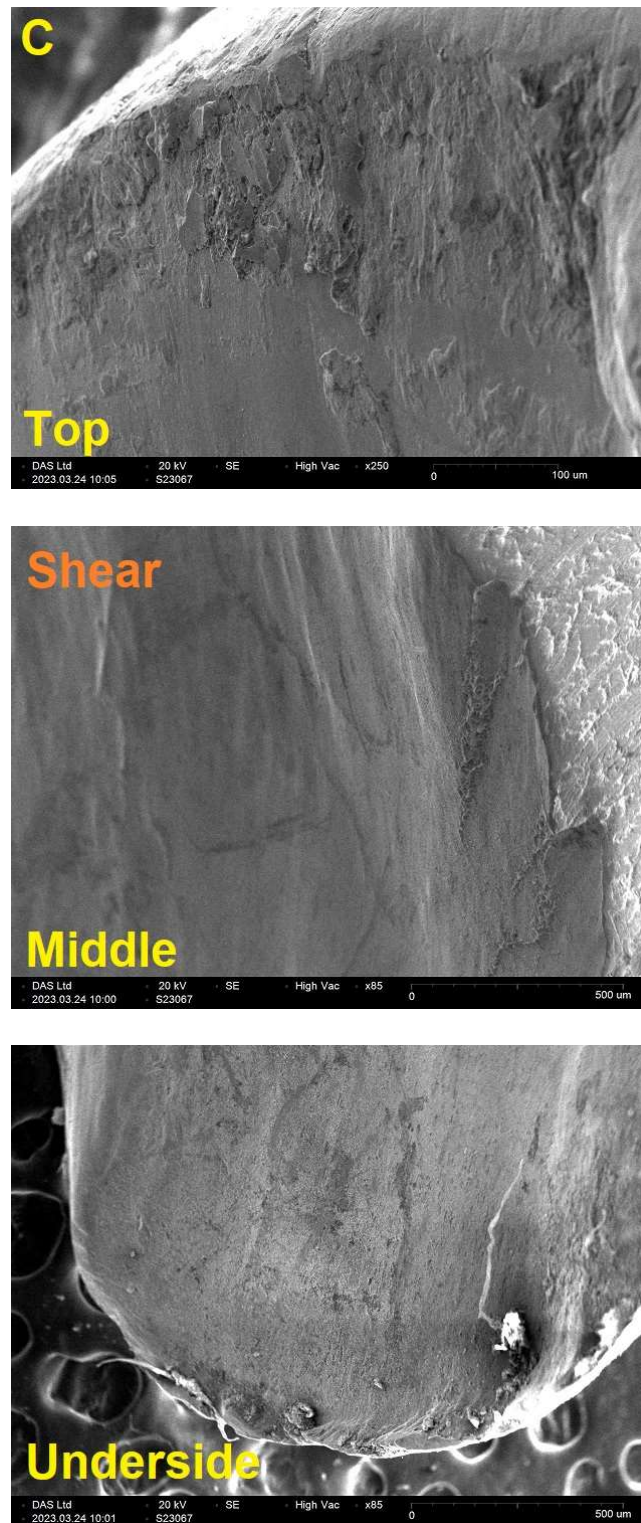
At Location C, analysis of the fracture face confirmed the shear nature of the fracture initiated from the top, Figure 15.

Figure 15, high resolution SEM images of the fracture face taken at Location C, the line parted in shear

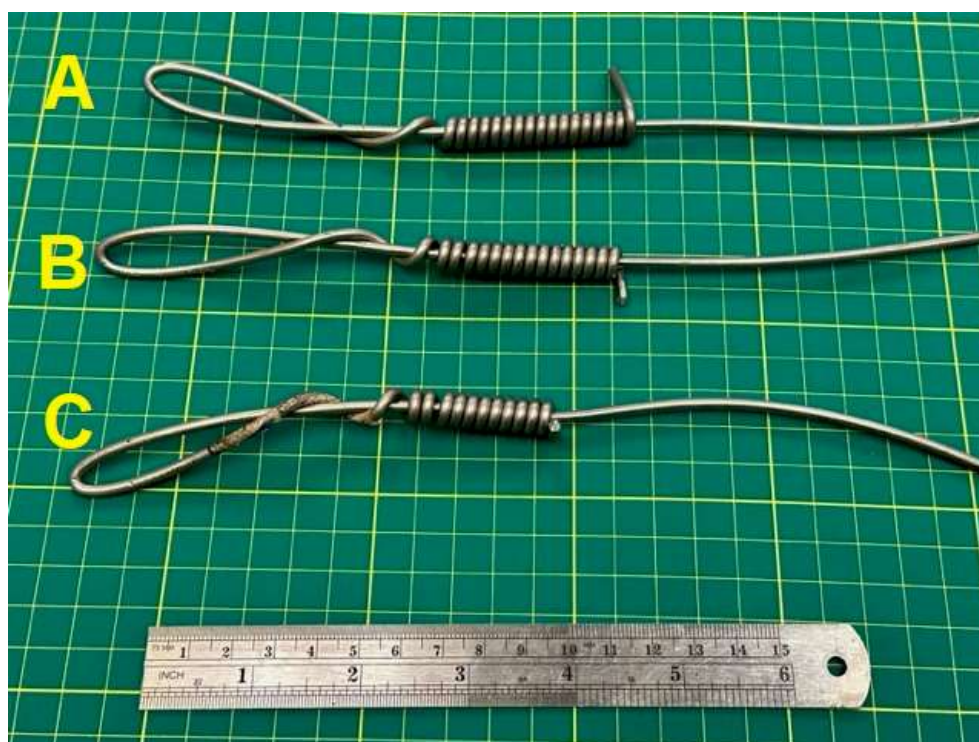
Wrap ductility testing was performed adjacent to the fractures at Locations A, B and C, Figure 17. Higher magnification images of the test pieces are presented in Figure 18. All passed without cracks or ruptures present.

Figure 17, wrap test samples performed at Locations A, B and C

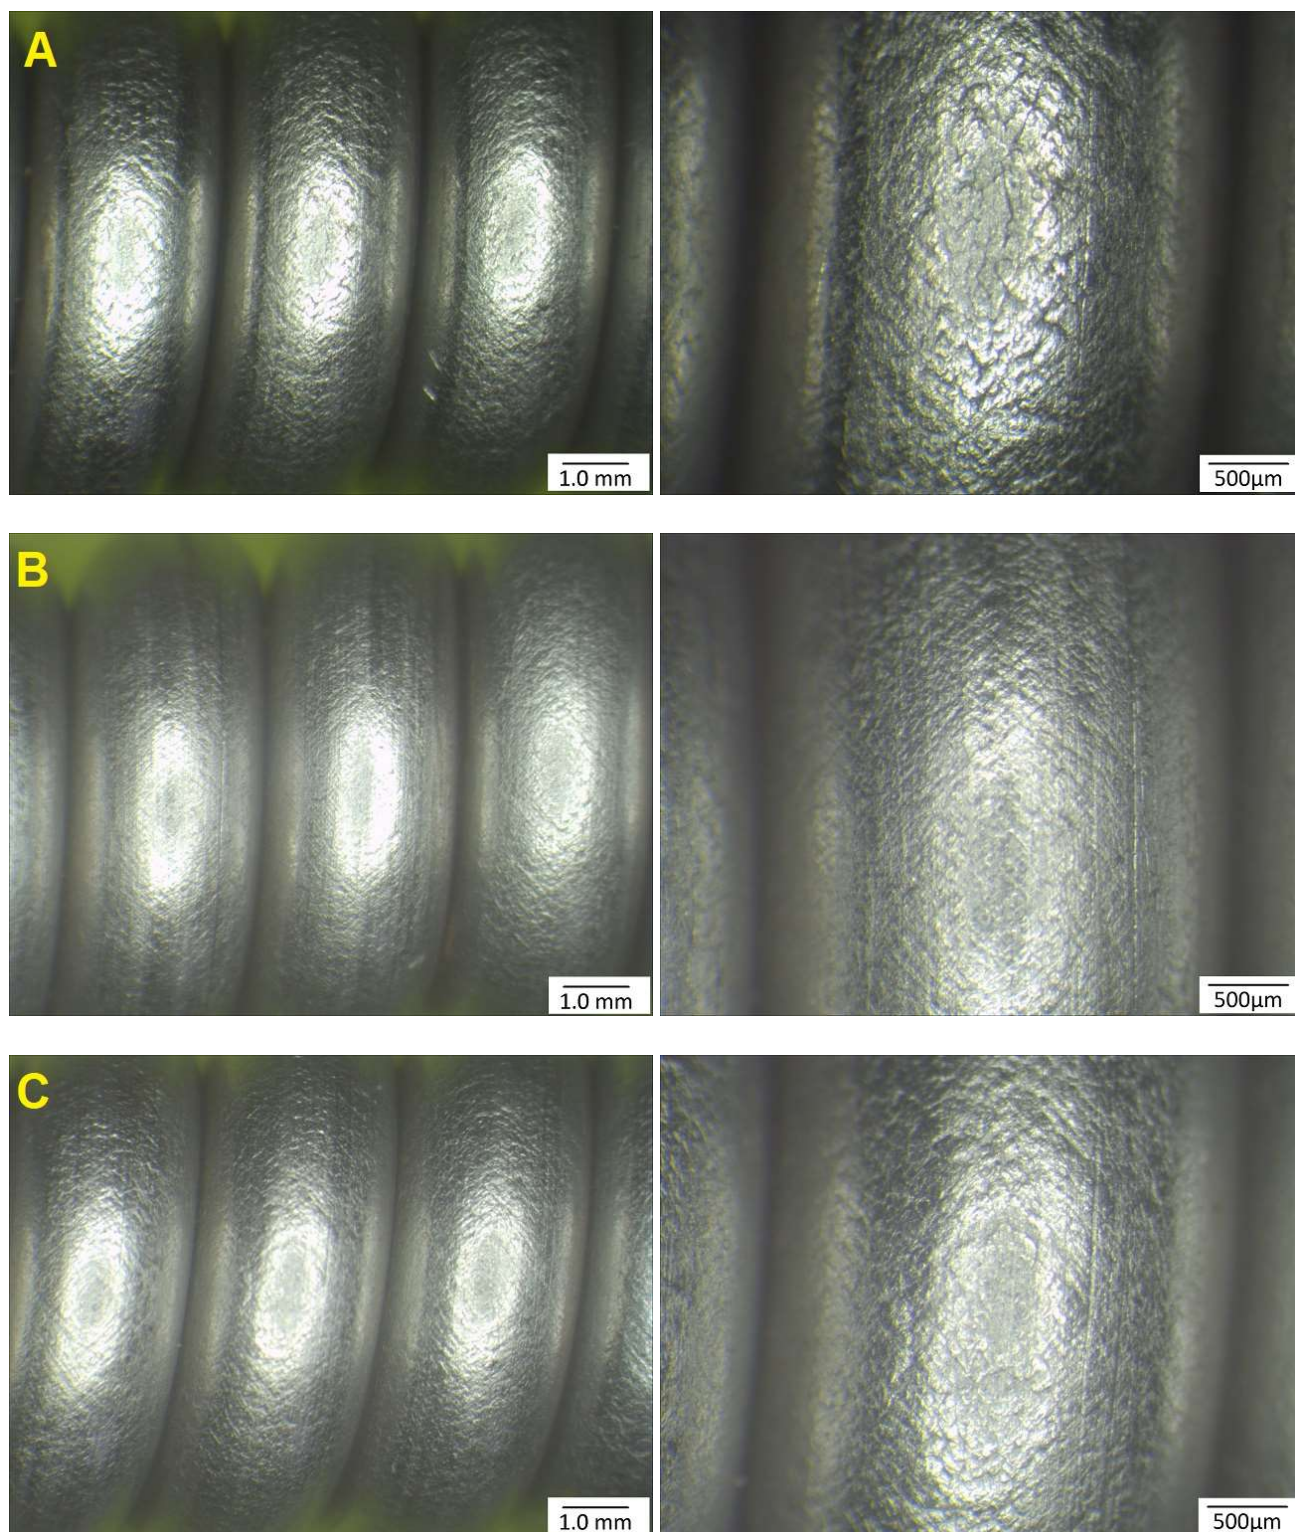
**Figure 18, macro images of the wrap test samples, all passed without cracking or rupturing.**

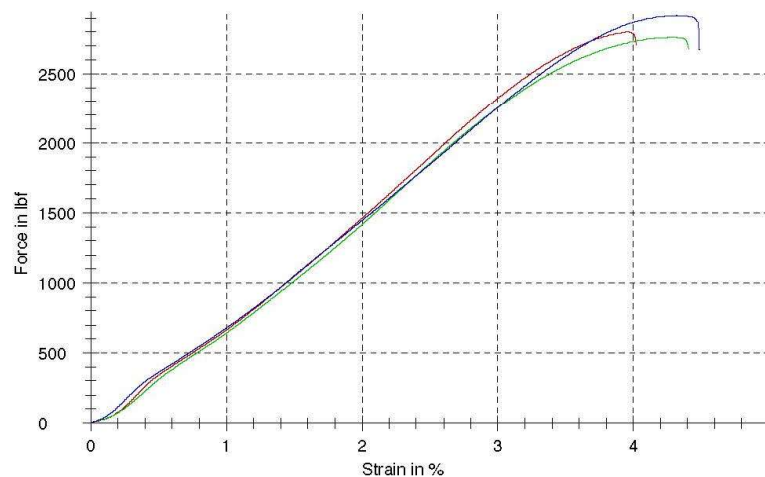
The diameter was measured using a set of Mitutoyo digital hand micrometer and found Samples A and B to be considerably undersize compared to the standard 0.125" +/-0.001" from the mill.

The knock on effect of the reduction in diameter is the loss of breaking load, for reference the test certificate 2103-067 achieved 2,950 lbf.

There is a reduction in diameter and subsequent breaking load at Locations A and B with less reduction at Location C. This is most likely due to the stretching of the line associated with the failure or repeated heavy jarring.

Figure 19, breaking load evaluation of the as received sample locations
