**Investigation of wireline failure**  
**Reference: Dimension Bid – CWR-1280**

**Danum Well Services Ltd**

The Laboratory was commissioned by Danum Well Services to assess wireline break that occurred during operational use by Dimension Bid.

Well : LARUT A-27L

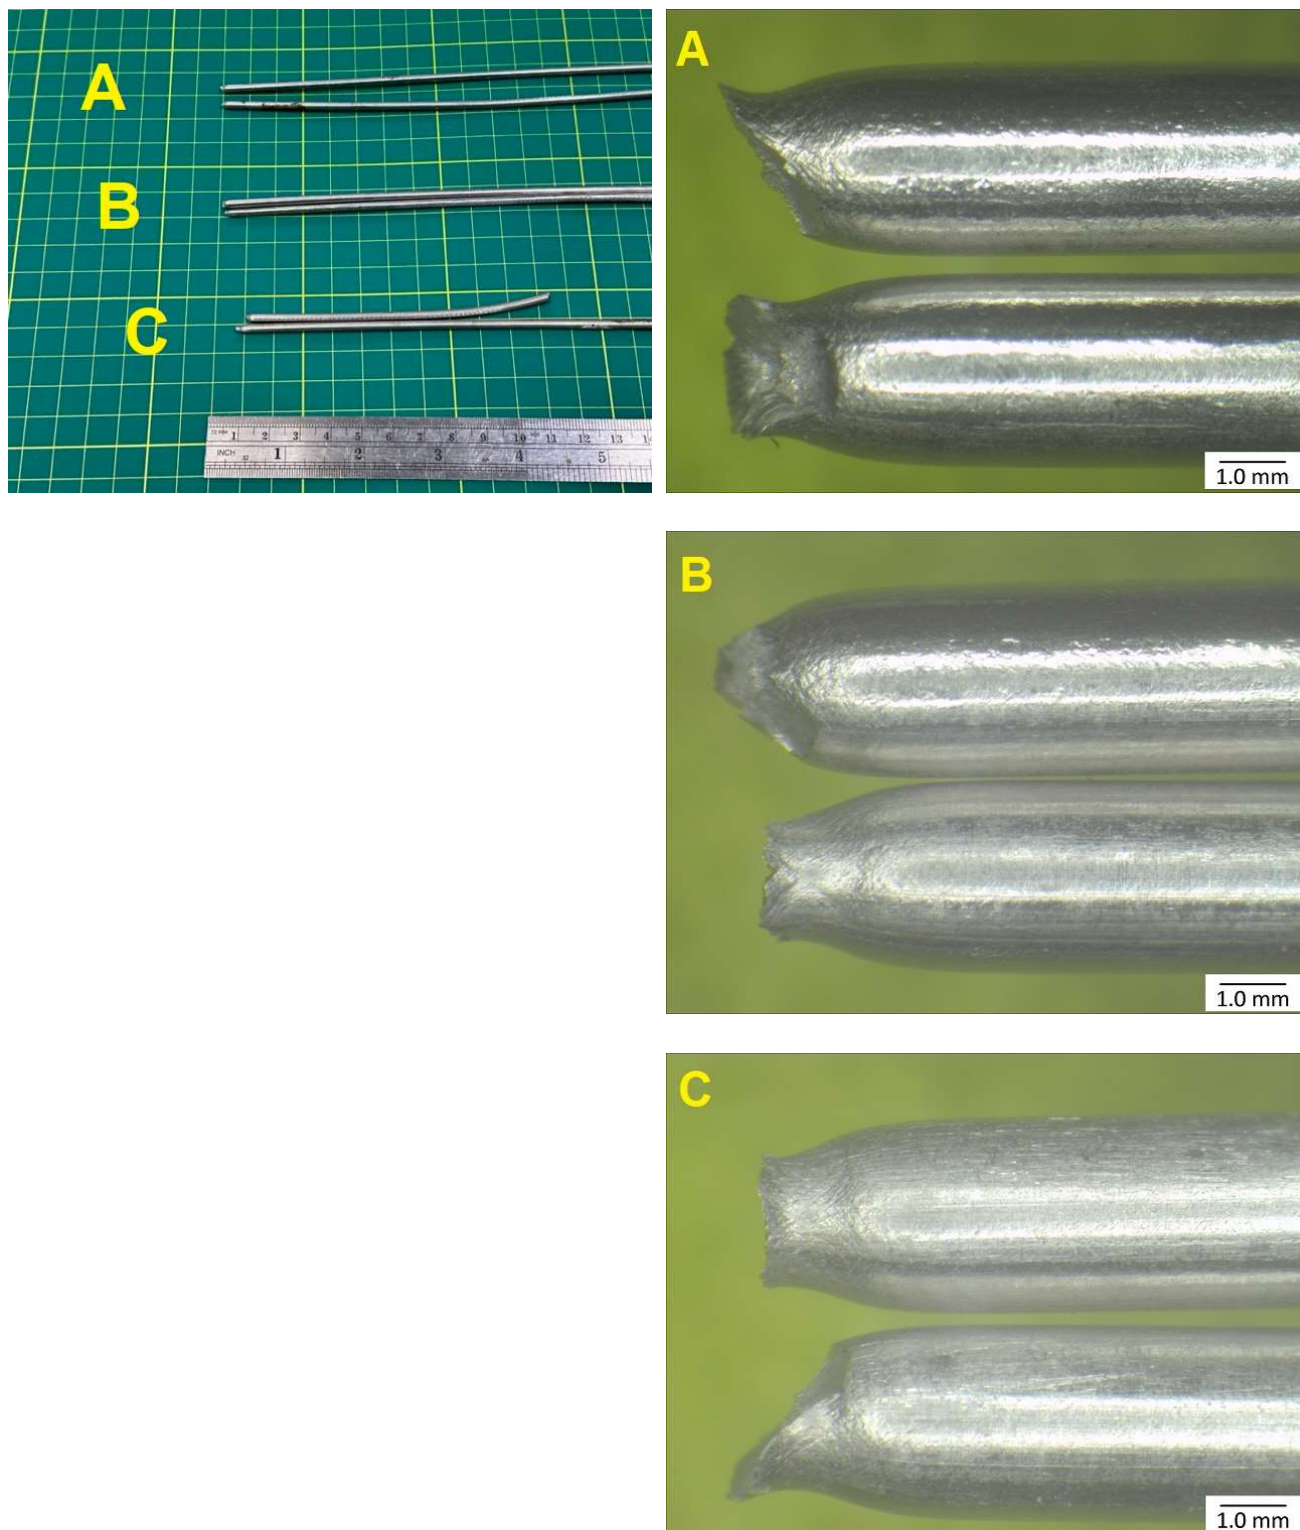
Photographs of the test pieces are presented in Figure 20, the fractures are similar to that found at location A-B with localised necking down before parting. Without further samples from the drum, the loss in diameter and breaking load is most likely due to the line being trapped and stretched down resulting from the failure.

**Figure 20, breaking load test pieces all revealed typical ductility with localised necking down**

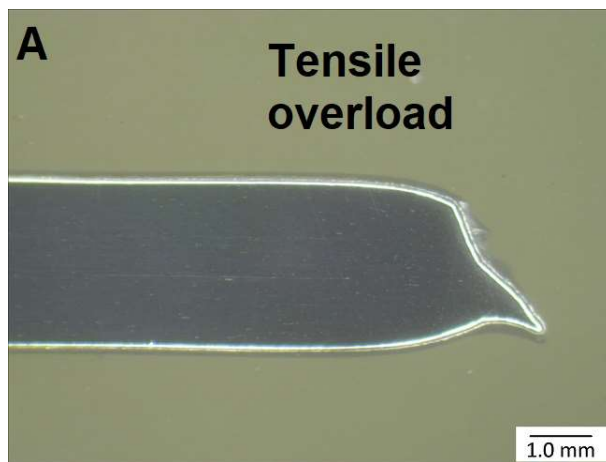
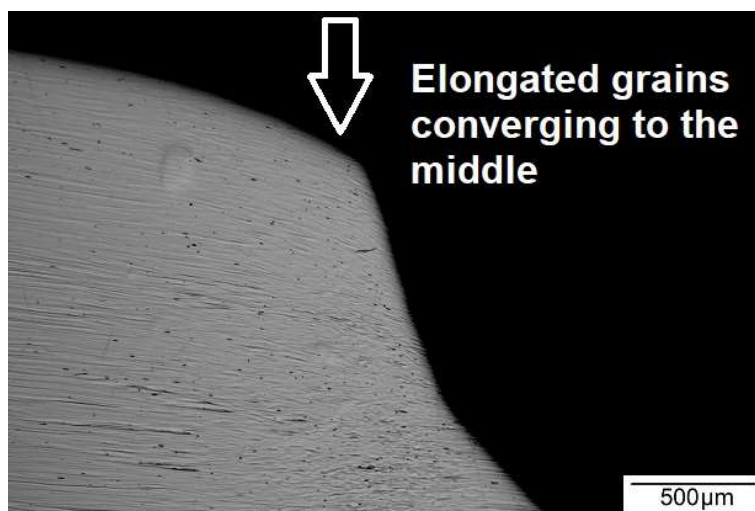
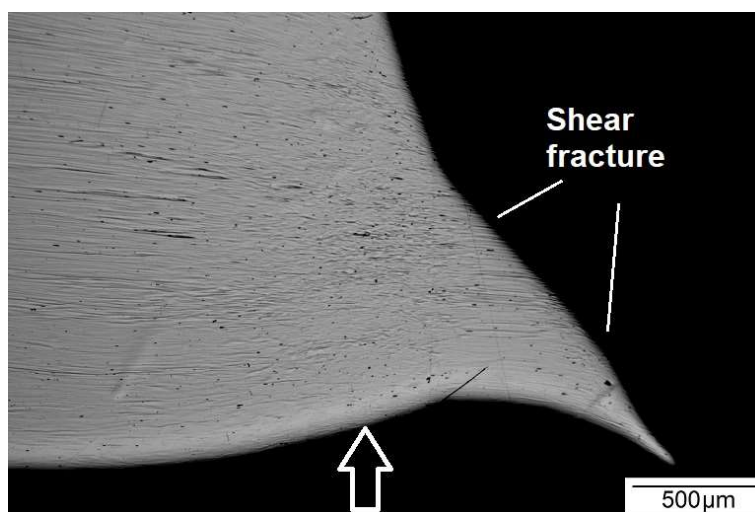
The fracture at Location A is presented in Figure 21. The region at the fracture has necked down causing the elongated grains to converge towards the middle from both sides. Final failure is semi-shear in nature.

**Figure 21, metallurgical section of fracture at Location A, elongated grains converging towards the centre due to necking down and final failure via shear**

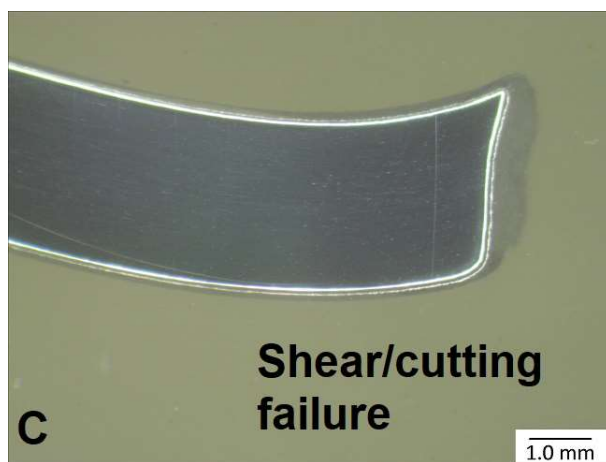
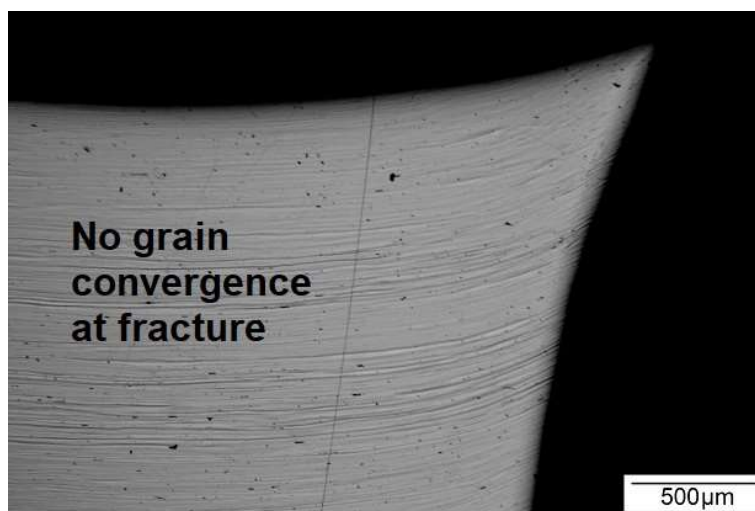
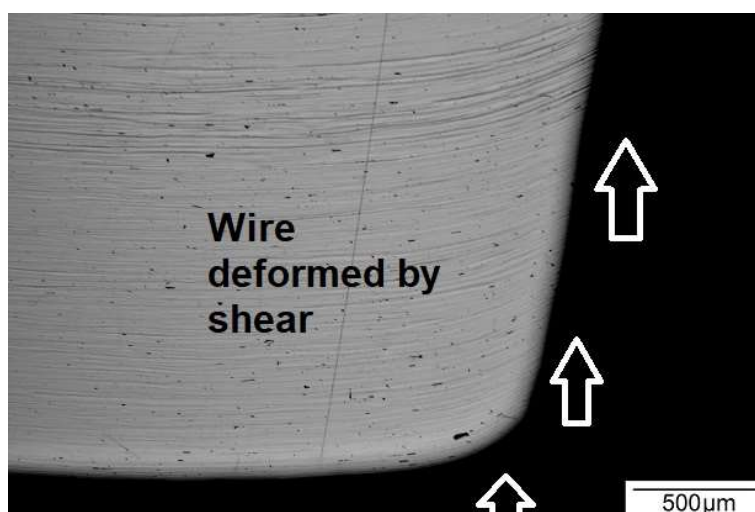
In contrast, Location C, Figure 22, there is no necking down at the fracture just a slight bend and shear failure cutting across the elongated grains.

**Figure 22, metallurgical section through fracture C, no converging of grains towards the middle, wire slightly bent in the shearing direction**
