Date	23 rd March 2022	Prepared by	Harith
Latest Revision	30 th March 2022		
Objective	To identify root cause of wire thinning issue (CWR-1288 SUPA75).		
Description of concern			
Received report from night crew GuC on March 21 st , 2022 by slickline operator Idlan. During random check on wire OD, he observed wire thinning at multiple spots. Reading varies at 0.087", 0.0975" and 0.0095".			
Potential Root Cause			
Wire thinning may be due to corrosive attack, overload or heavy friction.			
Action Taken and Findings			
<div>1. To enable operation progress, measures below are taken to ensure wire can be reuse:<ul style="list-style-type: none">Reconfirm on measurements at both vertical and horizontal axis of the wire. Operator confirmed on readings are below min tolerance.Remove thinning length and remeasure wire OD until no reading below min tolerance (0.1068") detected. 280 ft of wire is removed.Once wire is removed, around 5 ft of wire is cut to perform pull test and wrap test. Record pull test result and observe both fracture pattern and surface condition of wrapped sample. Results: Pull test value 2150lbs. Fracture pattern good (cup and cone shape). Wrap test good (no sign of crac

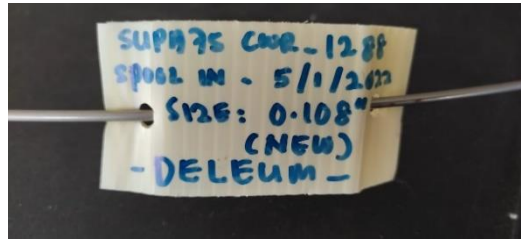
- Wire sample from CWR 1288 “as new” around 4 ft is straightened.

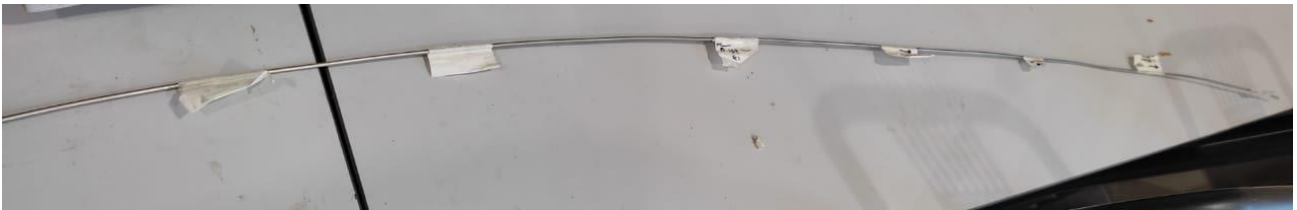
- 9 locations along the wire sample are identified.

Results: Initially, out of 9 locations measured, Location 5 (5.1) shows oval shape wire with 3 out of 4 axis are below minimum tolerance, at around 0.106". Laser OD results during first spooling has no reading recorded below minimum tolerance. These measurements could be a missed spot during the laser OD inspection or simply a measuring error by our inspector.

To verify on this, a few remeasuring attempts has been made on the same location 5. New measurement (5.2) shows OD values are around 0.108". We can conclude there's error in the early measurement (5.1). This shows simple mistake in the measuring method will alter the figures, and this could even happen to our experienced wire inspector with a calibrated device.

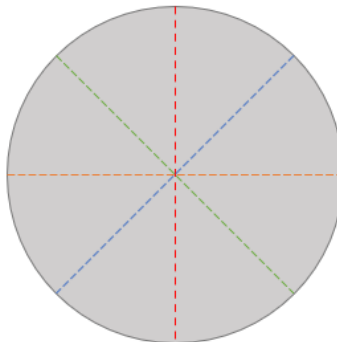
- Each location is measured by using digital micrometre at 4 different axis.

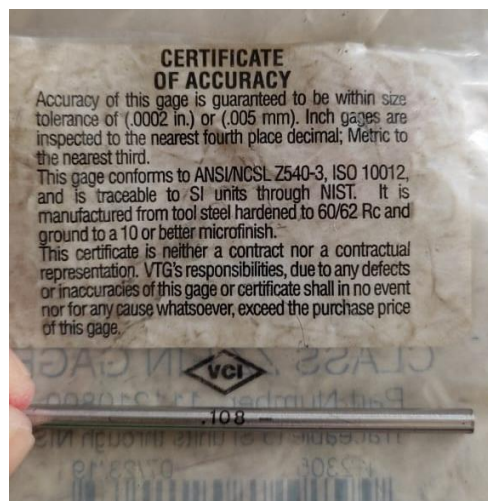
- Digital micrometer is calibrated using certified pin gauge size 0.108”.
