**CUSTOMER SUPPORT
ASSOCIATION**
Sponsored by Freightliner LLC

S60, MBE4000 & MBE900 Engine Updates

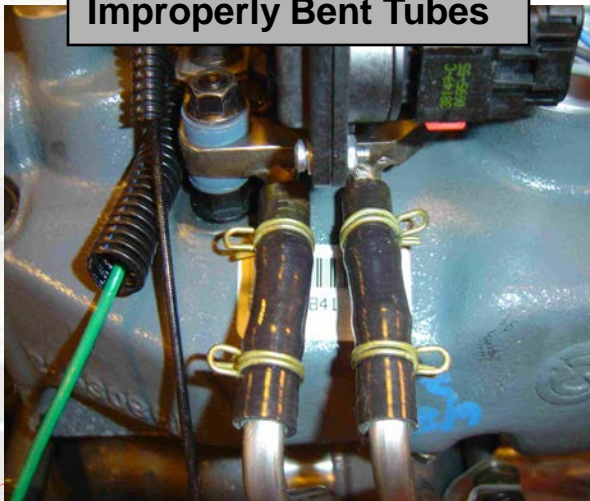
Improperly Bent Tubes

S60 EGR Broken Delta P Sensor Mounting Bracket – Ref 05 TS-53

- Hose Connection Points Crack or Break Due to Improper Repair Procedures or People Stepping on it (cleaning windshield, etc.)
 - To save time, technicians will pull tubes off the bracket & bend them
 - The tubes will then be pushed back onto the bracket, which creates a stress point on the bracket & subsequent failure
- Proper Repair Procedures for Removing the Delta P Tubes
 - Loosen the four hose clamps
 - Remove the P-clips to the exhaust manifold heat shield
 - Loosen the tubes at the venturi
- S60 Service Manual was incorrect & has been fixed
- Stronger bracket new p/n 23536986 replaced p/n 23535850 effective with s/n 06R0926421 on 6/30/06

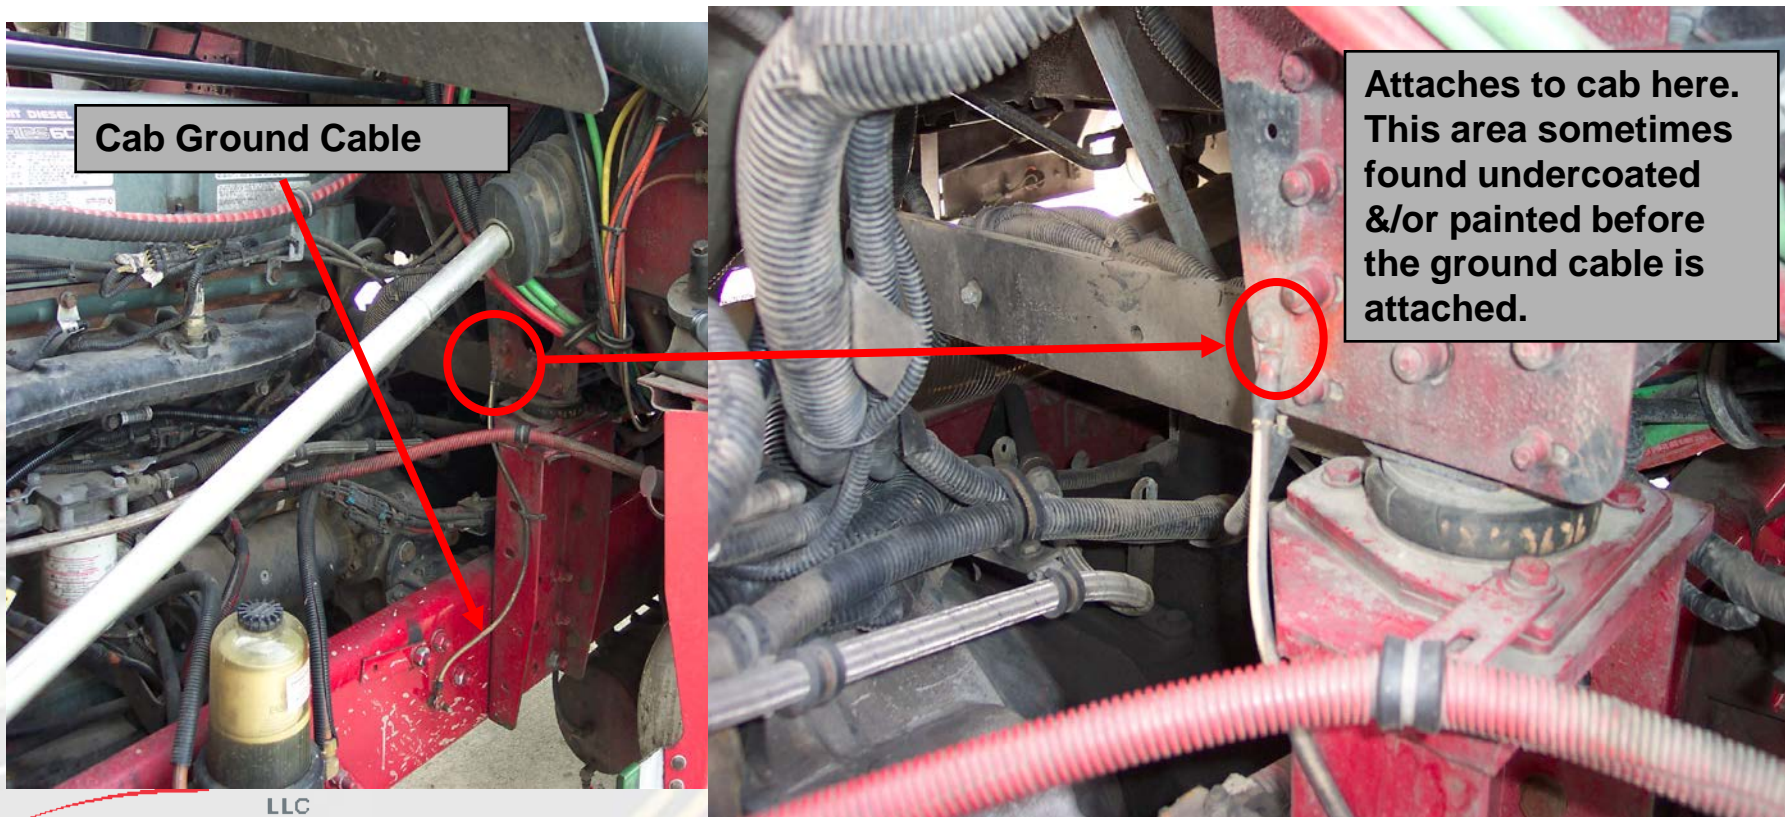
S60 EGR Delta P Sensor Issues

- High Number of No Trouble Found on Returned Sensors.
- SIB's 1-DDECV-05, 2-DDECV-05, & 2-SECM-05 Lists New DPS Counts to be 86-118 with Key On Engine Off (KOEO).
- For High DP Counts, Check for Undercoating Beneath Cab Ground Cable.
- Sensors with Moisture in Them Should be Cleaned, Dried & Reused.

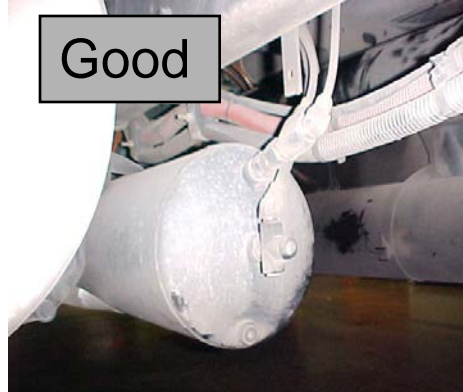
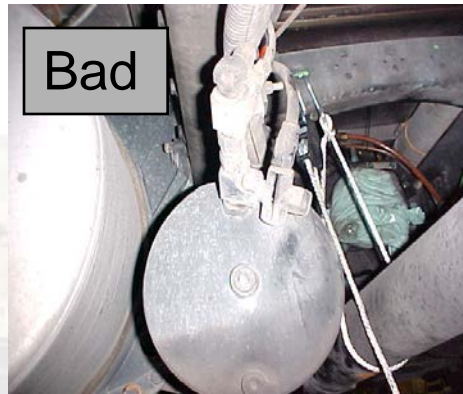
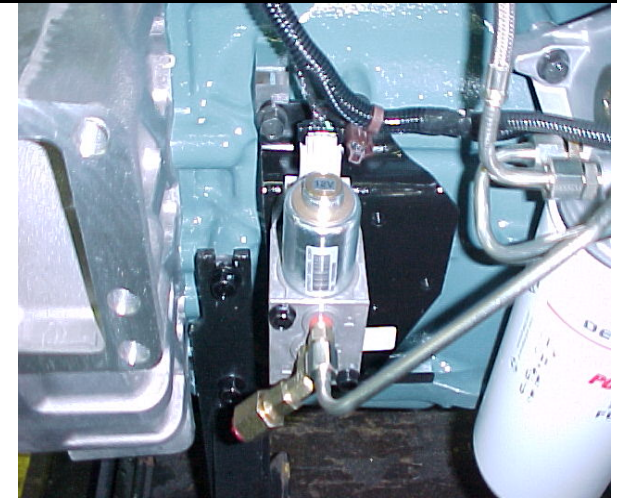
VPOD and Air Supply

- Possible Performance Problems Due To Shared Or Dirty Air Supply From Vehicle
- Must Be Dedicated Line From Secondary Air Tank
- Reference 04 TS-46, 05 TS-21, F/L Bulletin 01-81 & Campaign SF314A.

- Seal Injection Change To Eliminate Rubber Valve Seat Failures – Effective In Oct-03
- Air Inlet Filter Screen & Improved Viton Internal Seal – SOP 3Q06

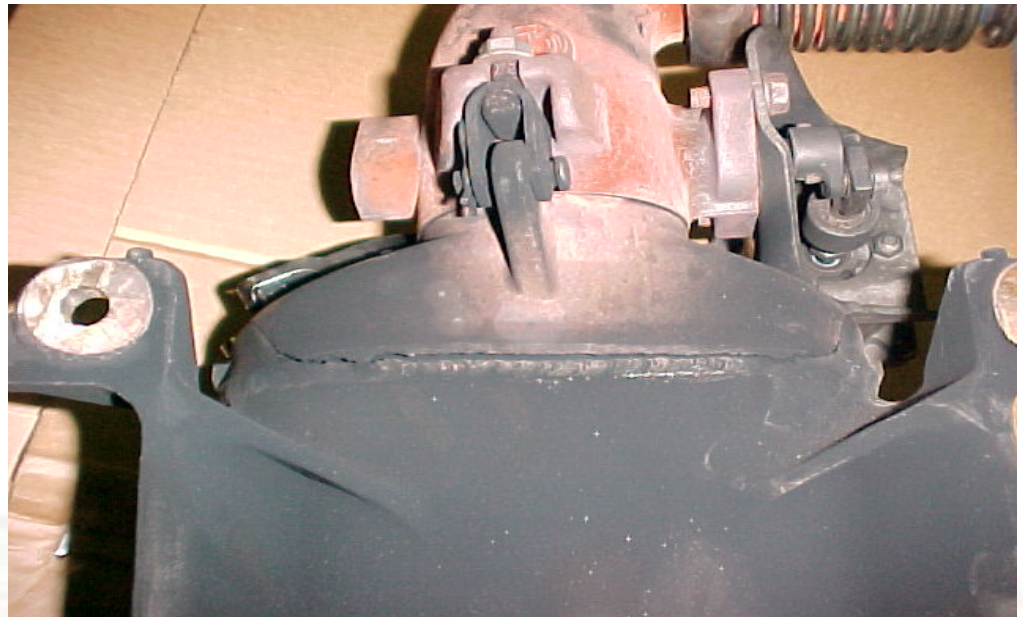
- **EGR Cooler**

• *An improvement to the EGR cooler was made in March, 2005, by using a thicker weld wire. This improvement was a running change to EGR cooler p/n 23533180. The first EGR cooler with this improvement is s/n IC-2770-M. The letter "I" is the year (H=2004, I=2005, etc.), & the letter "C" is the month (A=Jan, B=Feb, C=Mar, etc.) of EGR cooler manufacture, followed by the number serialization. For this type of failure, check the EGR cooler s/n to make sure it is before this changepoint. A rough engine s/n is 06R0832434 (made 1-Apr-05).*

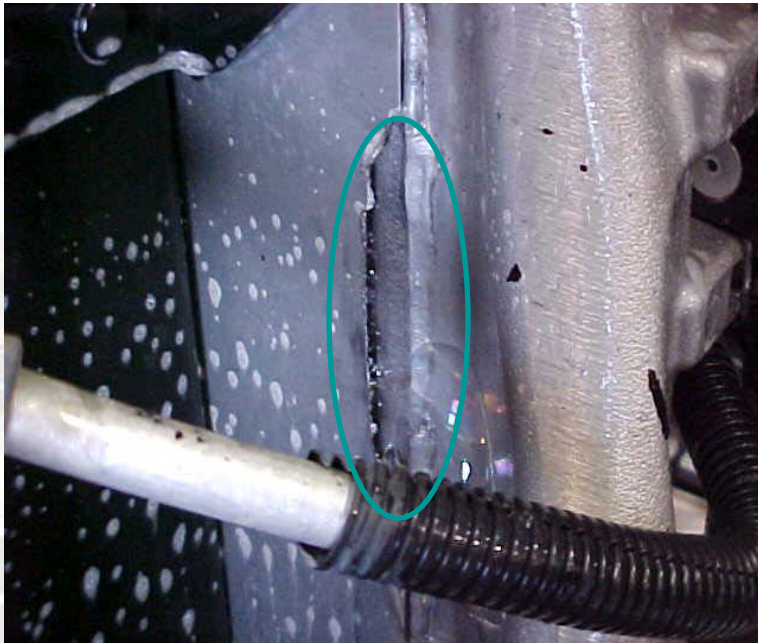
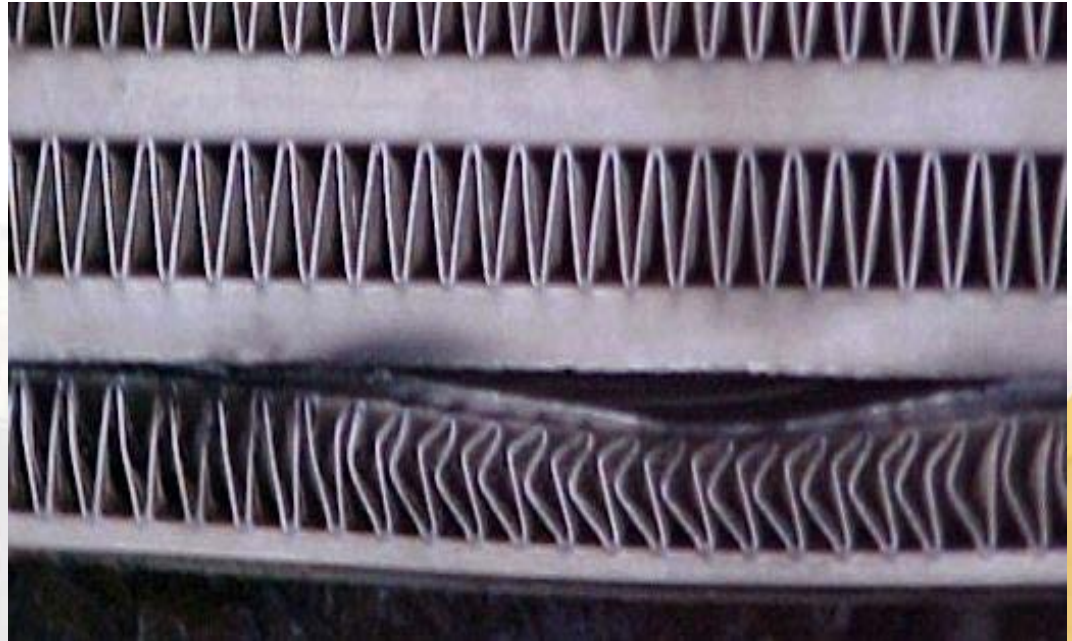
CAC Leaks – Ref 05 TS-01

- Results In Poor Performance, Reduced Fuel Economy, High Exhaust Temperatures, Warped Turbo Flanges & High Soot Levels In The Oil
- S60 Operators Guide 6SE484 States To Inspect The CAC System & The Air Inlet & Exhaust Piping Every 15,000 miles
- SIB #12-60-03 Details The CAC Inspection Procedure

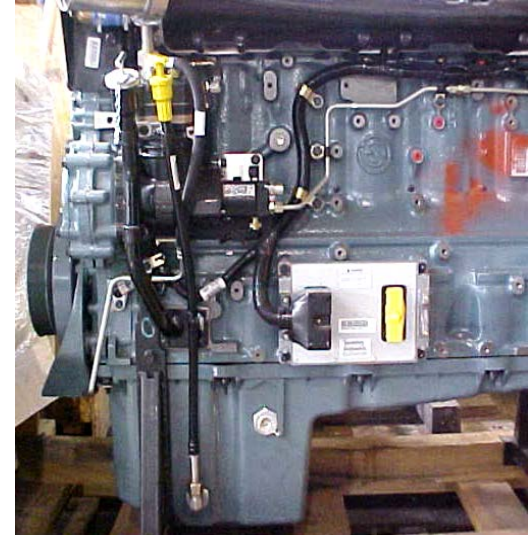
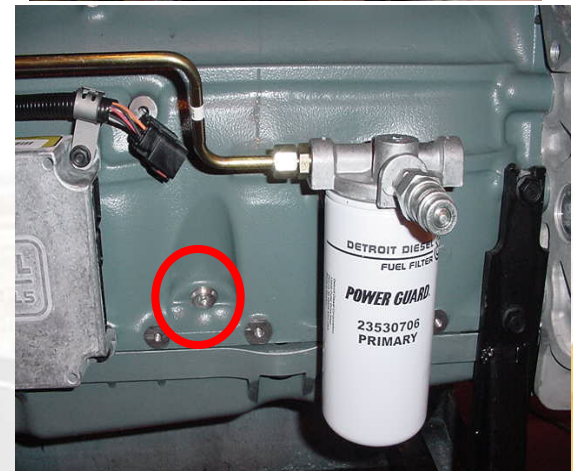
Properly Measuring Crankcase Pressure (blowby) – Ref 06 TS-15

- Measuring crankcase pressure on a dipstick tube that is submerged in oil in the bottom of the oil pan will not give accurate crankcase pressure readings.
- Do NOT measure crankcase pressure at the breather tube. Doing so can cause engine damage.
- To correctly measure crankcase pressure on engines with this style of dipstick, use the oil filler tube or the 1/4" NPT hole on the left side of the block along the pan rail.

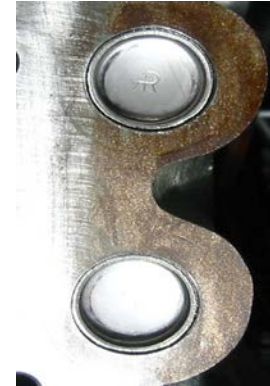
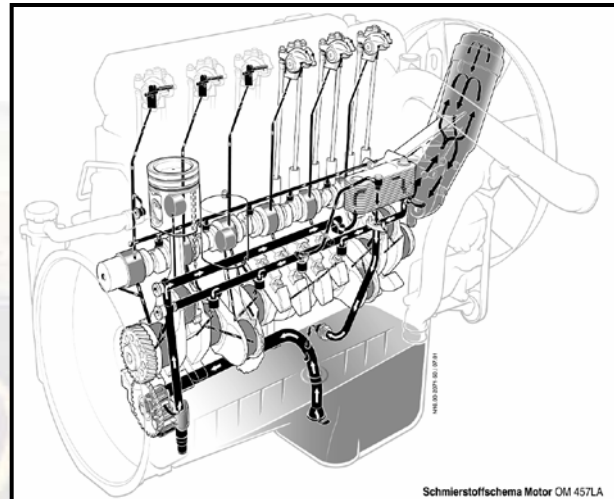
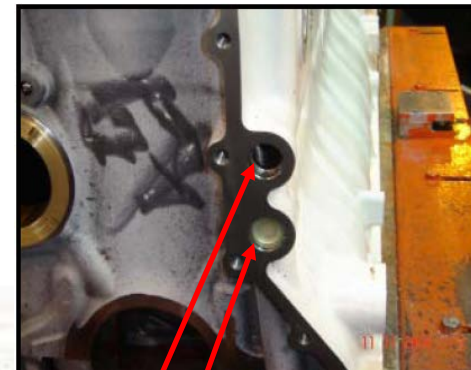
Cup Plug
Location On
Block

- Brazil went from a Threaded Oil Gallery Plug to a Cup Plug in May, 2005, with s/n 0460817468.
- In November, 2005, the Cup Plugs began Blowing Out in Cold Weather Locations in NAFTA.
- Brazil Returned to Threaded Plugs for NAFTA on 12-Dec-05, with s/n 0460840295
 - Block changed effective with 0460855264 on 2-May-06 resulting in plug being flush or recessed slightly in the block (no longer proud).
- Oil Travels from the Pan through the Oil Pump and up Past the Two Cup Plugs in the Rear of the Block. The Oil Pressure is Dampened by the Oil Cooler, so the Front Plug is Not a Concern.

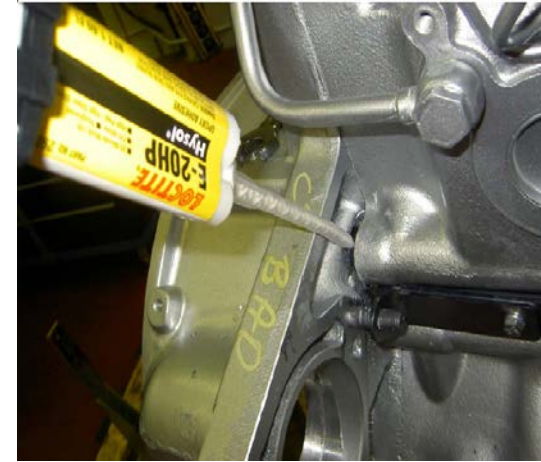
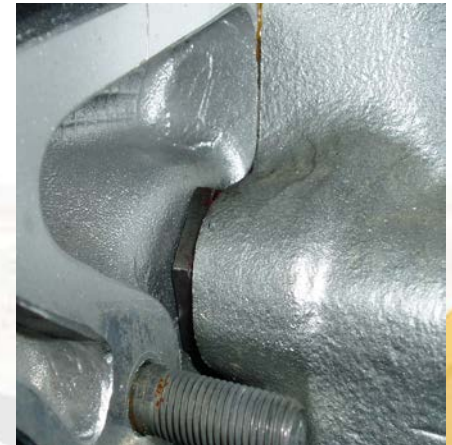
- A Bracket & Epoxy Kit (p/n 23536001) was Designed to Retain the Oil Gallery Cup Plugs.
 - The Bracket and Epoxy kit is effective in preventing catastrophic failures because it retains the cup plug in the bore. This will prevent the units from being disabled on the road.
 - Current service repair is to install brackets on all engines under **Modification 06 M-05**.
 - Reference Tool Letter 05TL-09 for dispenser tool information.
 - Oil cup plug failures will be covered under warranty.
- A Threaded Plug Kit (p/n 23536501) was Designed to Repair Engines that Suffer a Cup Plug Leak.
 - Reference Tool Letter 06 TL-05 for tapping tool information.

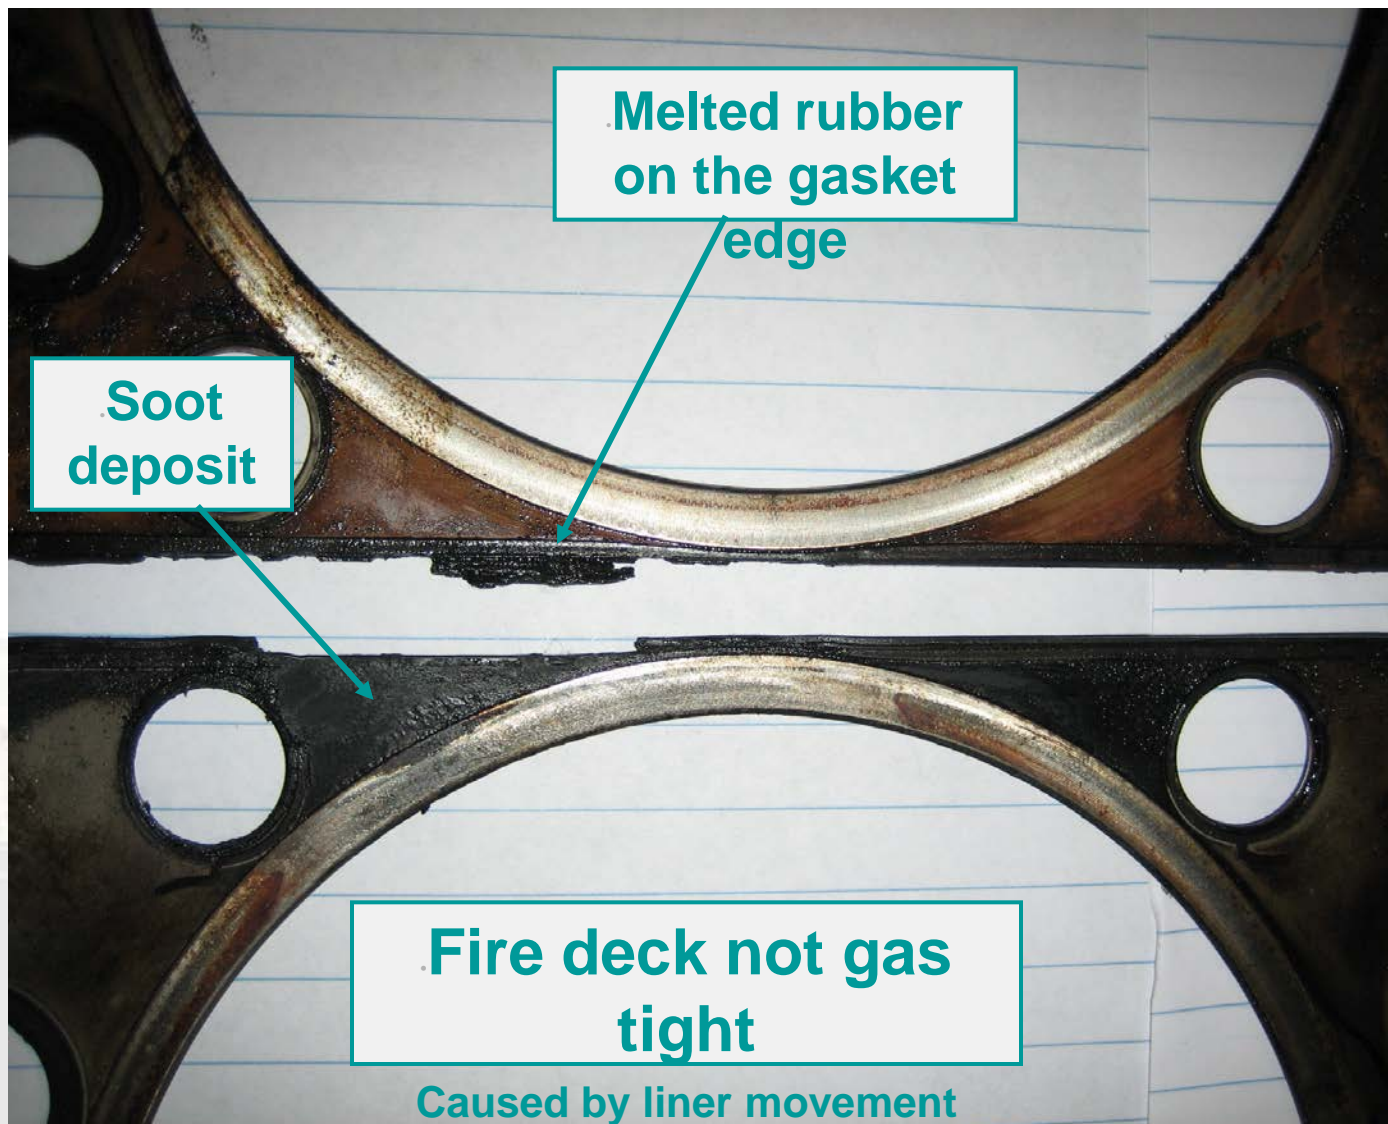
Coolant Leaks - Root Cause Evidence

- Sequence of events:
 - Liner movement
 - Causes exhaust gas leak
 - Melts gasket rubber seals
 - Results in coolant leak

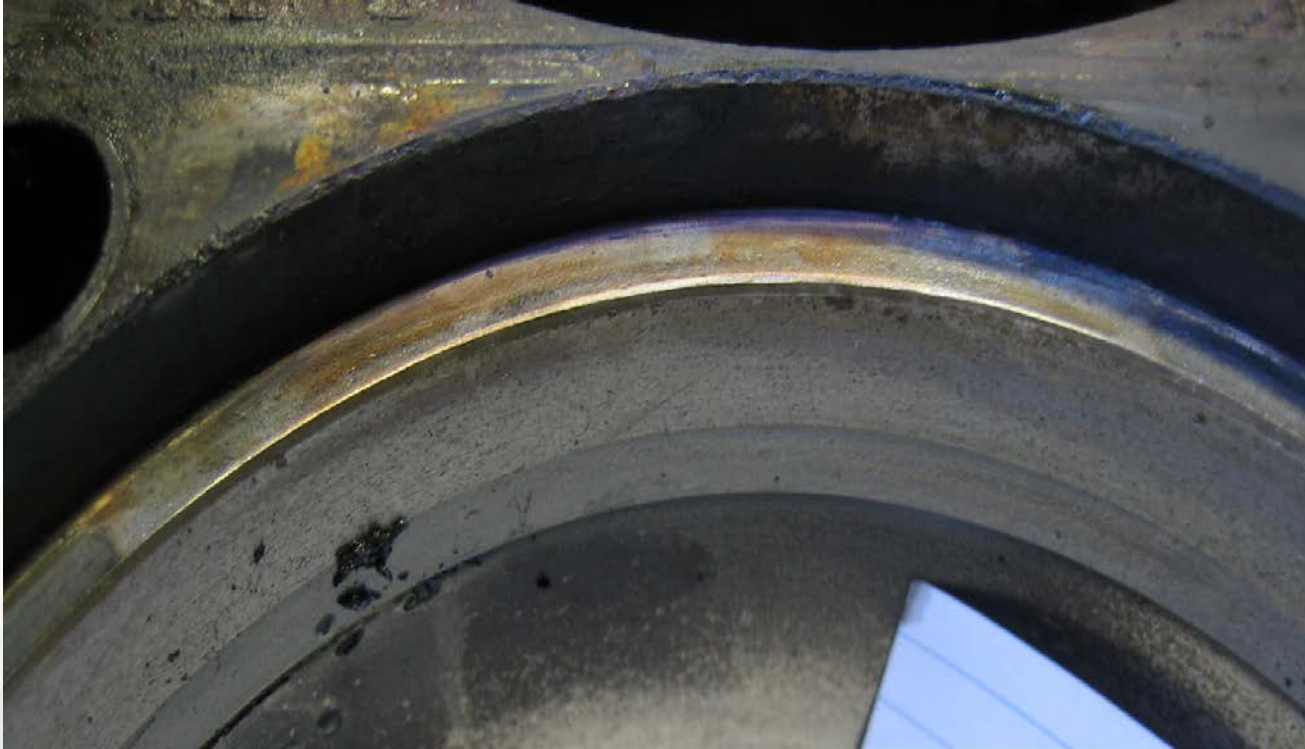
- **Sequence of events:**
 - Liner movement
 - Generates a gap between liner, seal ring, and counter bore
 - Results in coolant leak

**No contact between
Liner / Seal Ring / Counter bore**

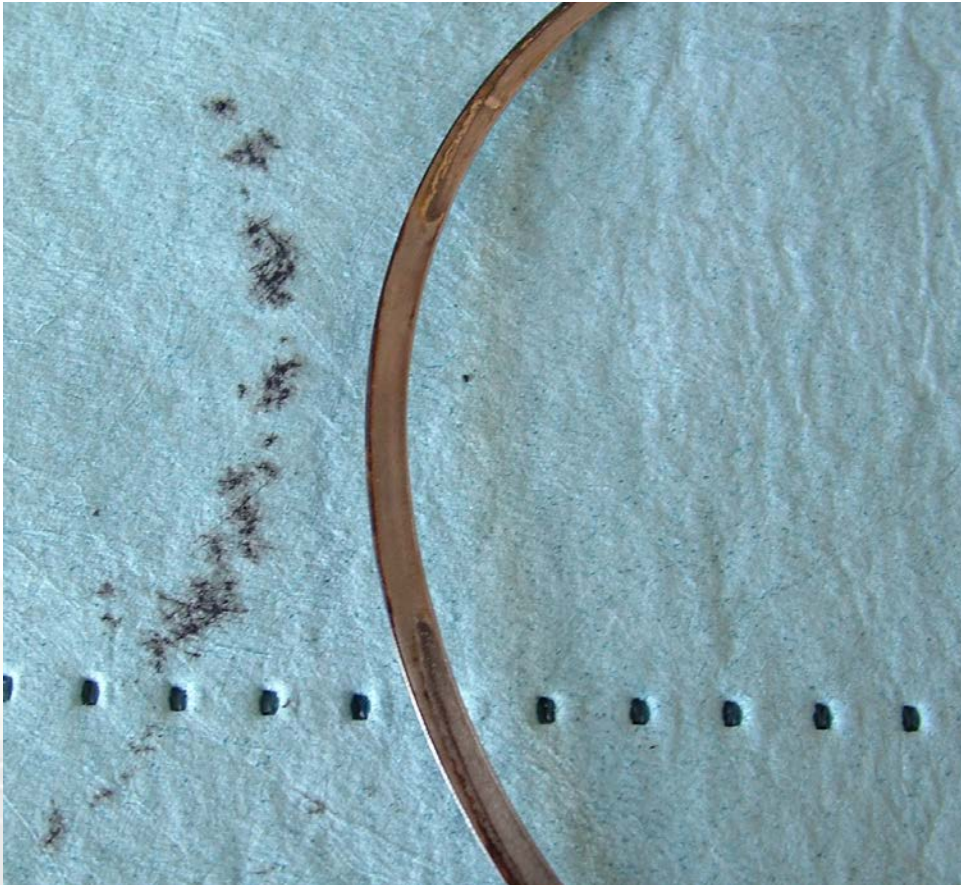
**No Contact between
Liner / Seal Ring / Counter bore**

- **Sequence of events:**
 - **Liner movement**
 - **Generates a gap between liner, seal ring, and counter bore**
 - **Results in coolant leak**

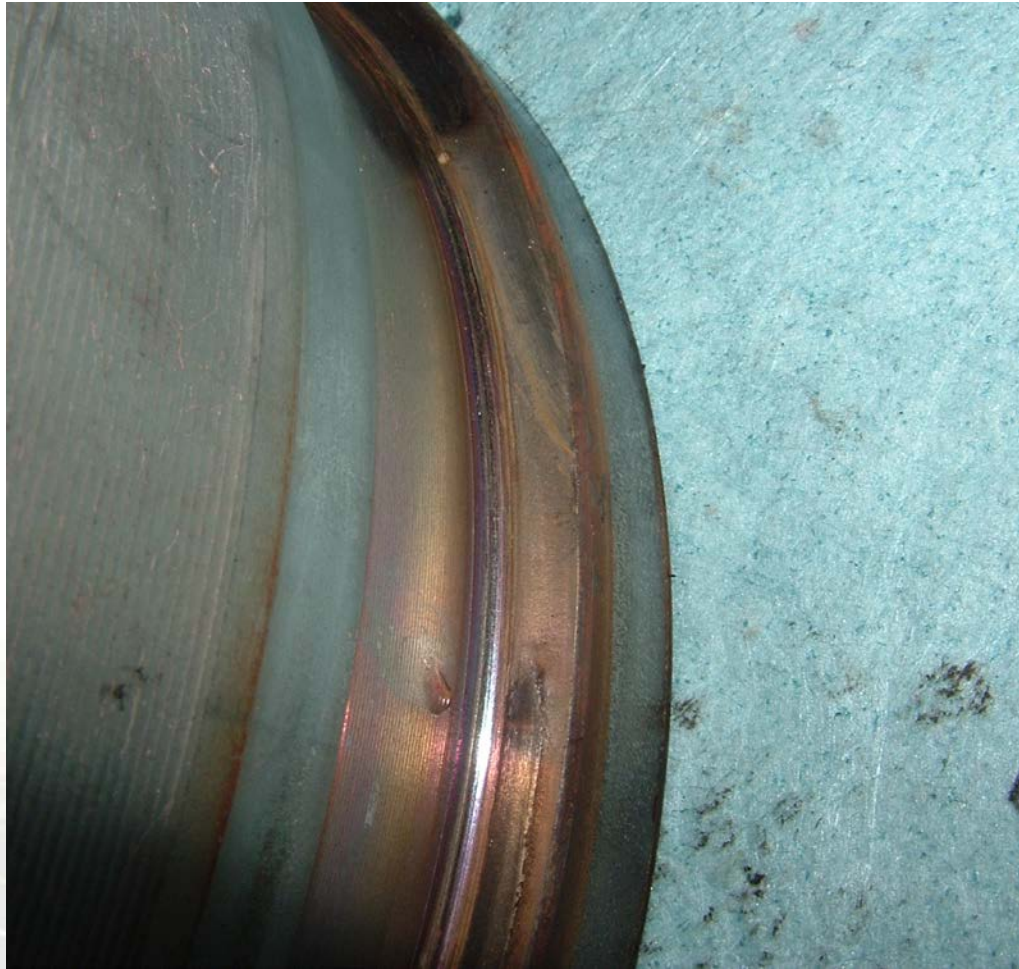
- Sequence of events:
 - Liner movement
 - Generates a gap between liner, seal ring, and counter bore
 - Results in coolant leak

**No Contact between
Liner / Seal Ring / Counter bore**

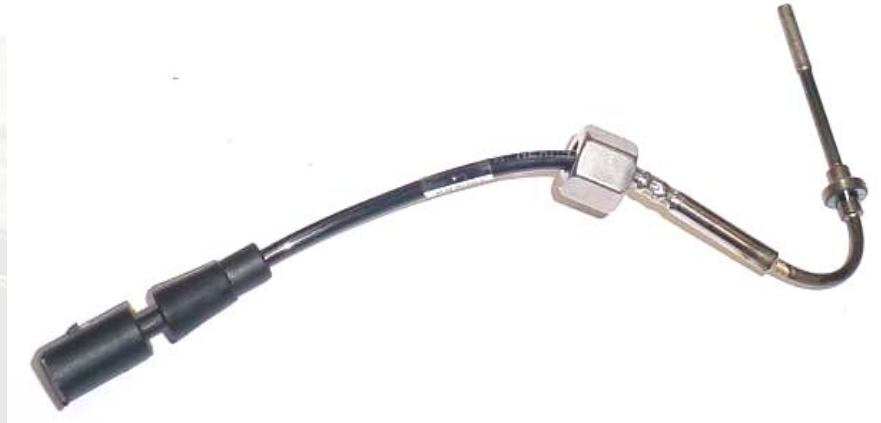
EGR Temperature Sensor Tip Failure – Ref 05 TS-40

- **Tips Breaking Off & Causing Downstream Damage**
- **Will Eliminate Sensor**
 - Remove sensor, plug hole & harness, & reflash PLD.
 - Revised TS letter deals with errors in reprogramming.
 - Be careful when removing the adaptor from the housing to prevent damaged threads.
 - Investigating using cap nut instead of removing adaptor.
 - Sensor eliminated effective with engine s/n 0460829623 on 9-Sep-05.
 - If tip breaks off, make reasonable effort to find the lost tip.

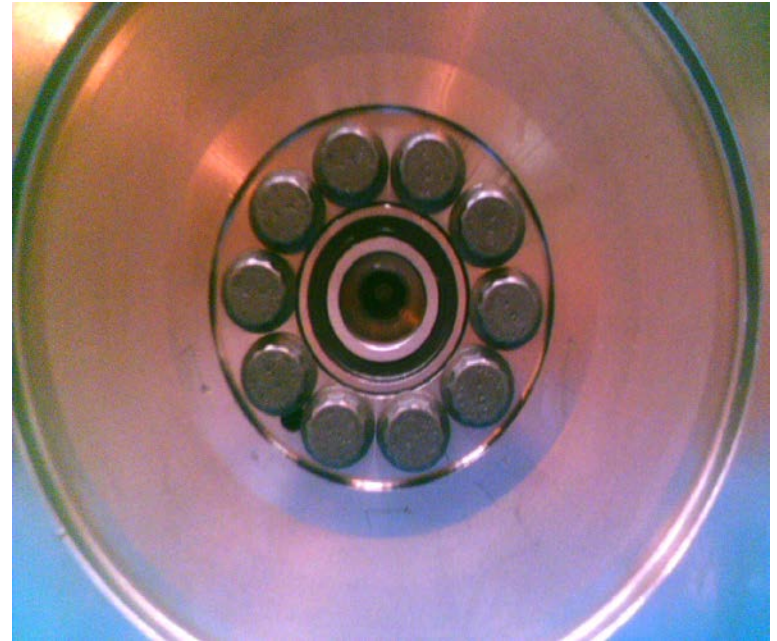
Pilot Bearing

- Bearing installed by DCX in Brazil.
- Bearing is overheating & failing.
- Day cabs have higher failure rate than Line Haul trucks due to increased clutch use.
 - Estimated that 70% of MBE 4000's are in day cabs.
- Improved bearing released for Service with higher temp grease:
 - New p/n 0099816525 replaces p/n 000625446206.
 - Not in Production yet on assembly line in Brazil.
- Current repair procedure is Fix-as-Fail.
- Don't forget the spacer in the flywheel.

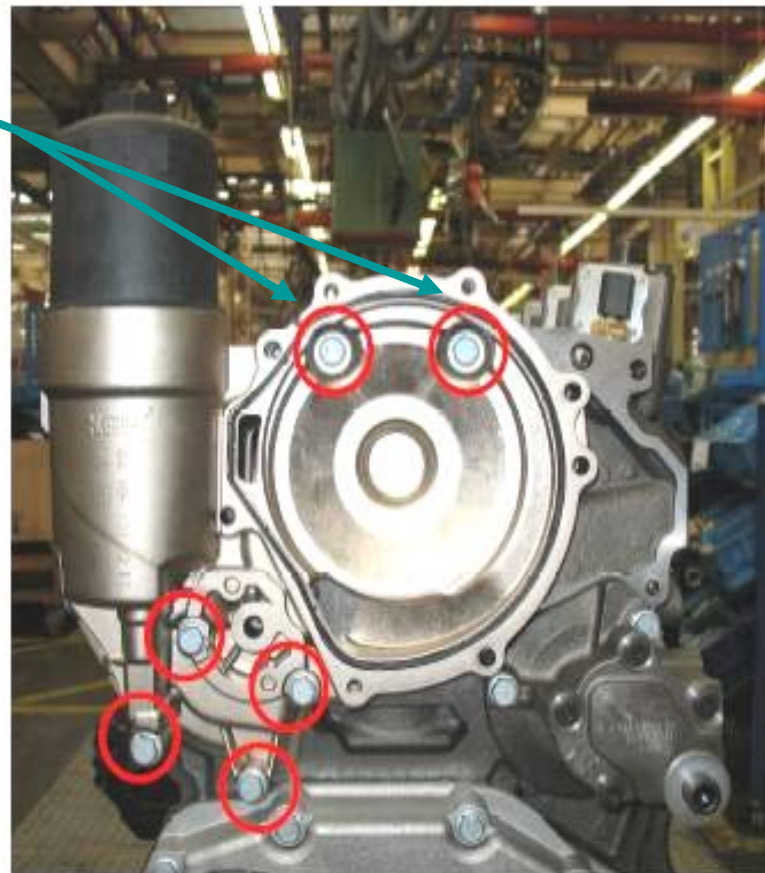
Coolant Intermediate Plate

- Water pump impeller failure due to internal bolts (top two pictured).
- Coming loose and contacting the back side of the water pump impeller.

6 bolts for EPA04

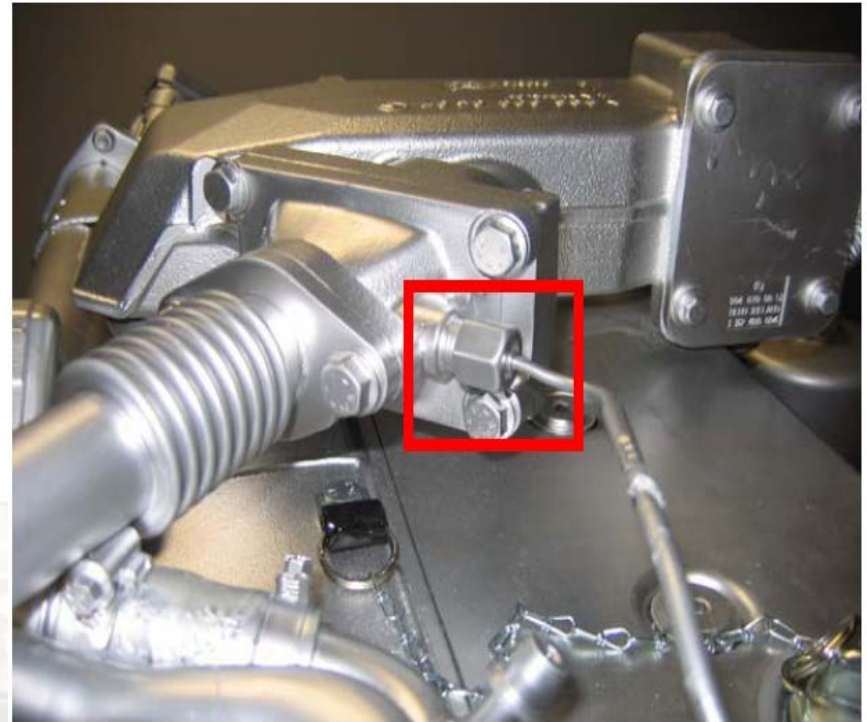
EGR Temperature Sensor Failure – Ref 05 TS-47

- **Sensor Stops Working, Resulting In Codes SID 146, FMI 0, 1, or 12**
- **Removed Sensor Effective With s/n 515294 on 7-Sep-05**
- **For Service, Do NOT Replace Sensors That Fail**
 - **Reflash PLD To Turn Off Sensor**
 - **Revised TS letter deals with errors in reprogramming.**

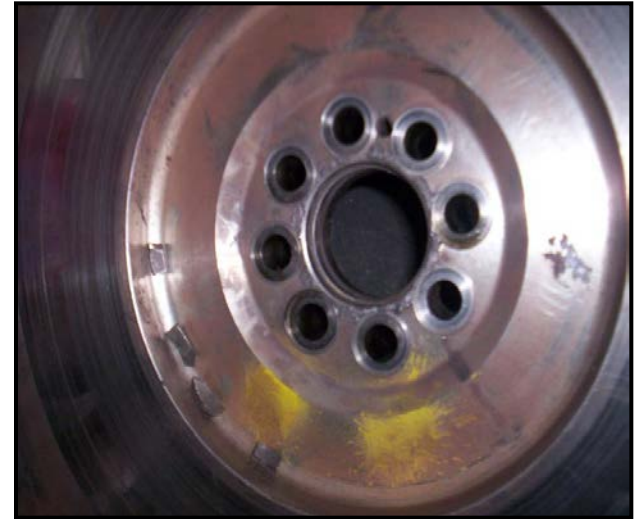
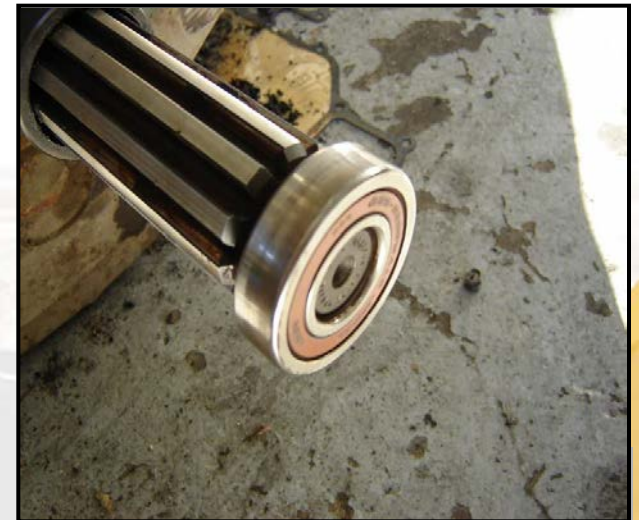
Pilot Bearing

- Installed by Freightliner at their assembly plants – not DCX.
- Failures can be attributed to a tolerance issue:
 - ID of hole in flywheel is too large
 - OD of bearing is too small
- Replace the bearing & flywheel when bearing fails.
