# **Detroit Diesel Engine Updates**

## **Dale Allemang and Rick Dziadzio**

September 9, 2008

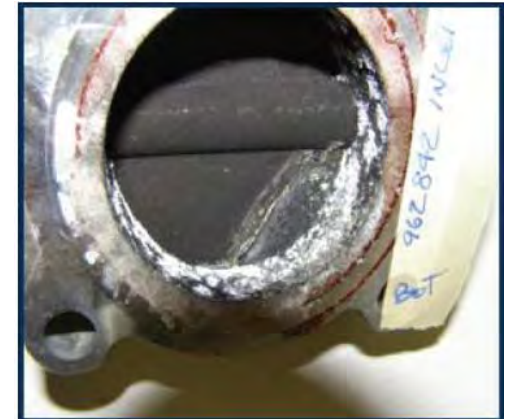
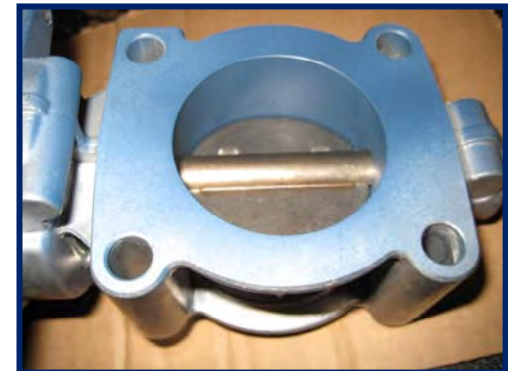
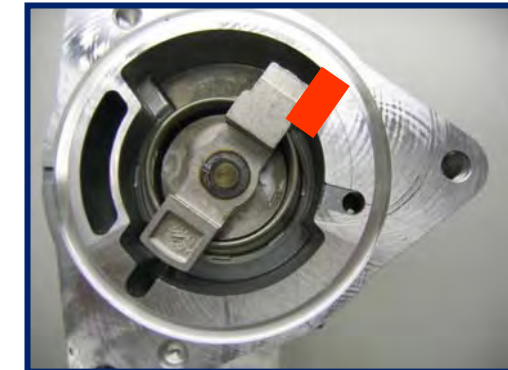
## EGR Valve

- Sticking EGR valve resulting in code:
  - SPN 2791 FMI 7 - EGR Valve Position Incorrect
  - or FMI 4 - EGR Valve Circuit Failed Low
- Inspect the Valve for White Deposits:
  - if found, evaluate for possible coolant ingestion (EGR cooler failure)
  - If no coolant loss is evident, the valve can stick as a result of corrosion, both galvanic from dissimilar metals and from the acid condensation from the exhaust. This will result in white deposits in the valve from aluminum oxide.
- New Teflon coated valve p/n 23538240 replaced former valve p/n 23535548 on 26-Nov-07 with engine s/n 06R0988932. Note new blue or black Teflon coating.
- New Internal Valve Stop Machined in Housing allows Positive Valve Stop without Butterfly Valve to Housing Contact. New internal stop valve p/n 23538928 replaced former valve p/n 23538240 on 28-Apr-08 with engine s/n 06R1003375.

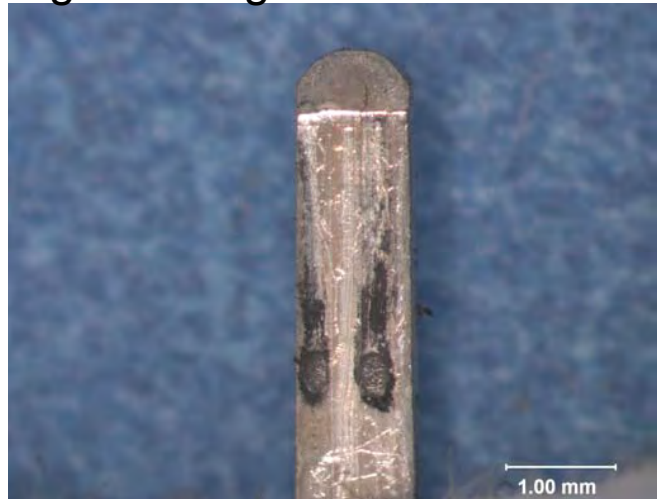
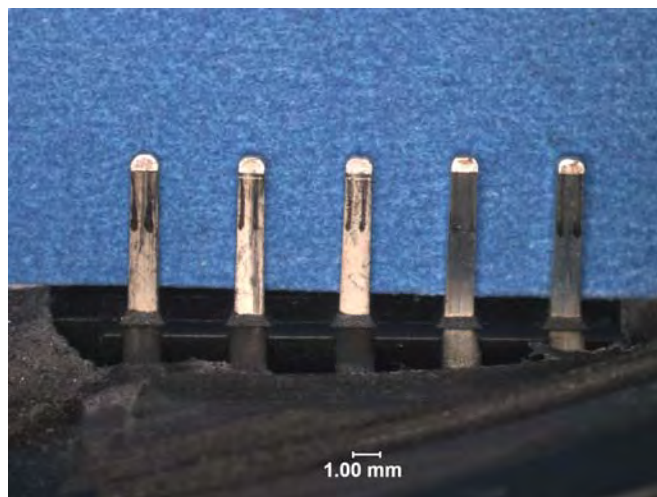
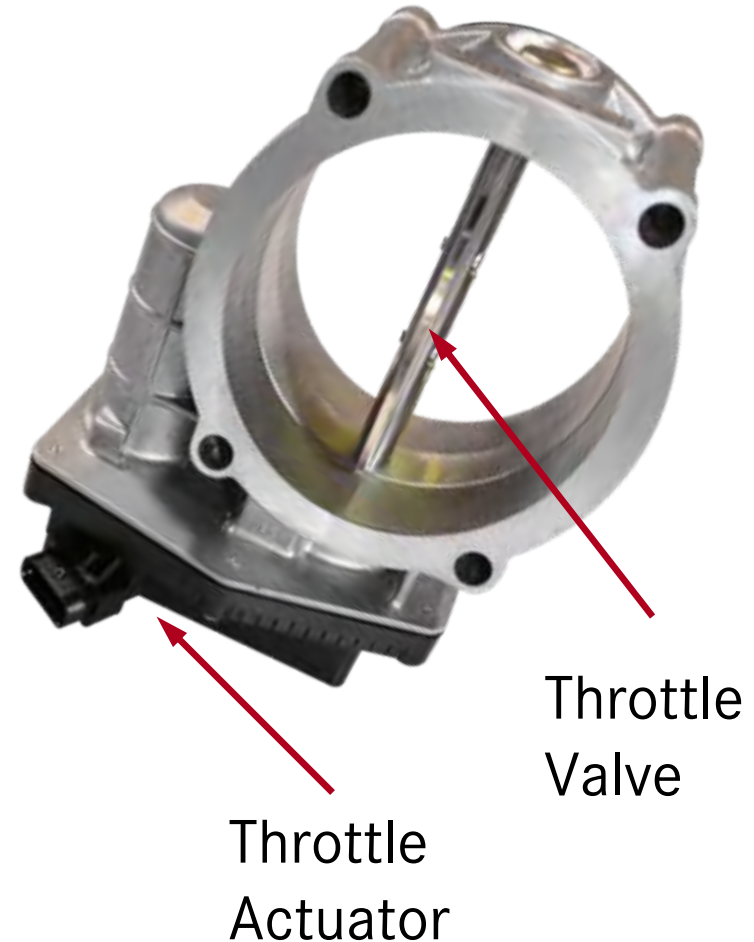
## Intake Throttle Valve

- Failed ITV is from connector pin fretting resulting in code SPN 51.

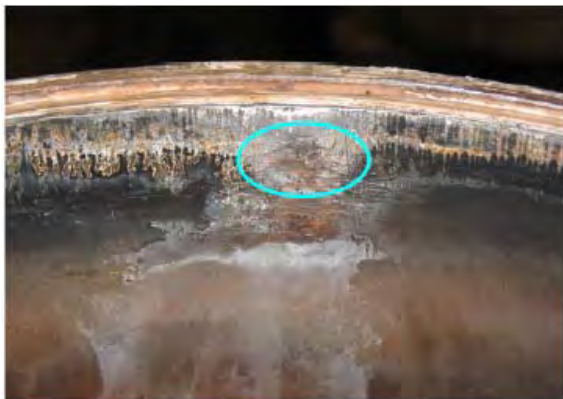
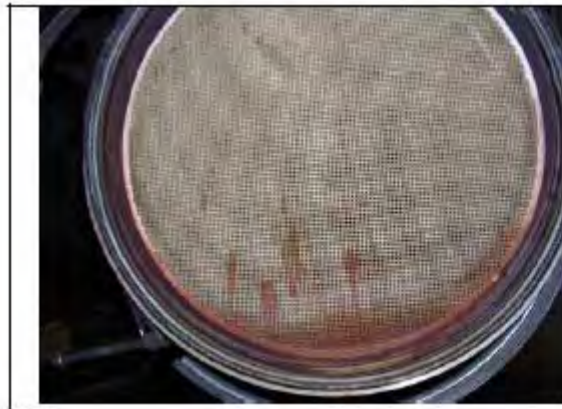
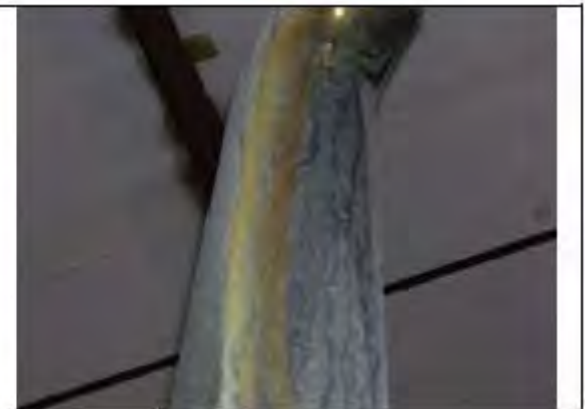
## Horizontal ATD Drain Hole Plugging

- Horizontal ATD Drain Holes can Sometimes get Plugged with Rust
- Traps Water in the ATD
- When this Occurs and the Engine is Throttled Up:
  - Water gets blown up the stacks and down the outside
  - It stains the finish on chrome pipes
  - Non-chrome stainless steel stacks are not staining
- FTL is Following Up with the Vendor on the Exhaust Stack Material Specification
- Drain Hole has been Enlarged to 0.25" on the Blueprint and current ATD Assemblies
- DPF pictured is functional and should NOT be replaced

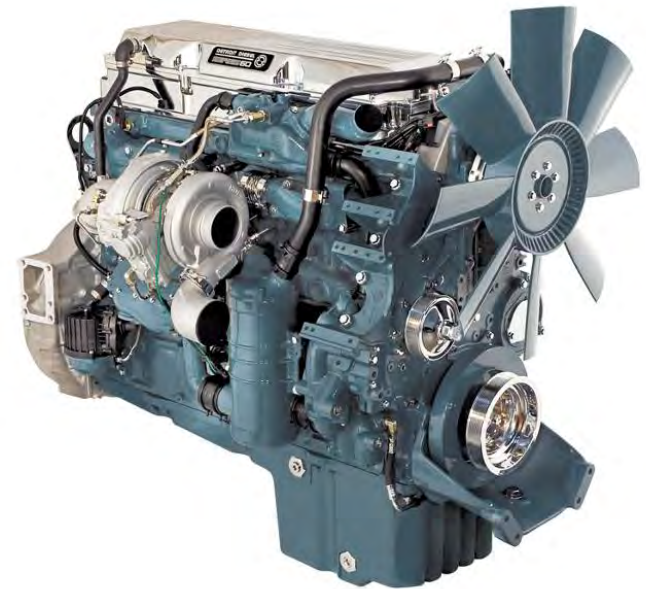
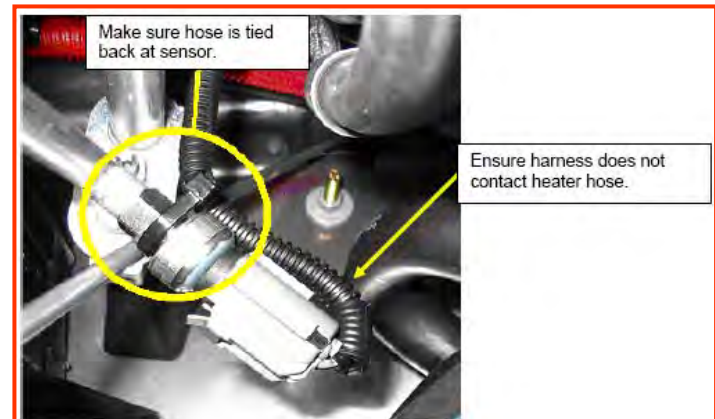
- Two Issues found After the Release:
  - Experiencing difficulty with cooling fan operation.
  - Experiencing performance issues associated with noise control.
  - Root Cause was CPC Software r4.00
- New CPC Software r4.01 Released to Address these Two Issues
  - Reference 08 TS-18Rev3
- Routing of the A/C Pressure Sensor Harness has also been a Source of Excessive Fan On Time
  - Heater Hose rubs thru the Harness and Shorts the Wires Locking Fan On

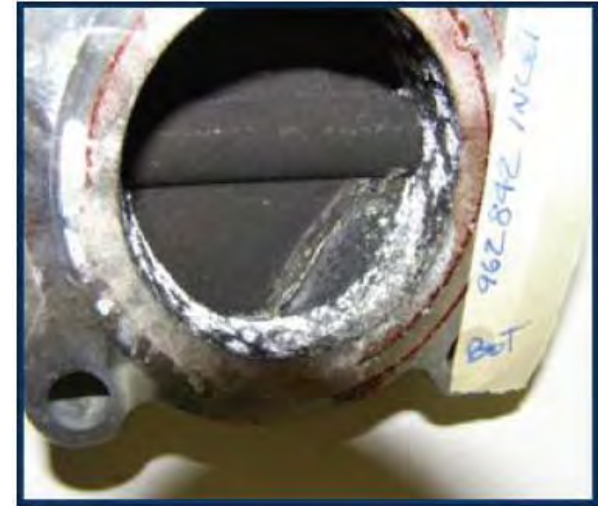
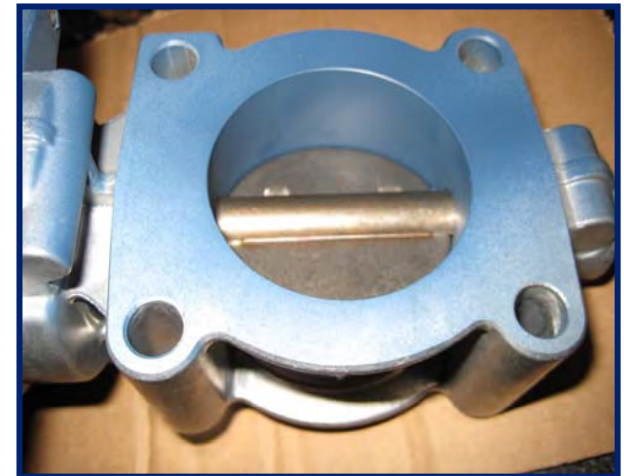
## EGR Valve

- Sticking EGR valve resulting in code SPN 2971 FMI 7 or 4 for EGR Valve Circuit or Position Problem.
- Same as Series 60 EGR Valve
- Inspect the valve for white deposits:
  - If found, evaluate for possible coolant ingestion (EGR Cooler)
  - If no coolant loss is evident, the valve can stick as a result of corrosion, both galvanic from dissimilar metals and from the acid condensation from the exhaust. This will result in white deposits in the valve from aluminum oxide.
- New Teflon coated valve was implemented on 29-Feb-08 with engine s/n 0460911568 (p/n A4601420619 did NOT change).
- Became effective at Canton on 12-Jun-08. All parts are Teflon (p/n's RA4601420619 and EA4601420619).
- Non-Teflon stock at F/L PDC's and on dealer/distributors shelves is NOT to be returned.

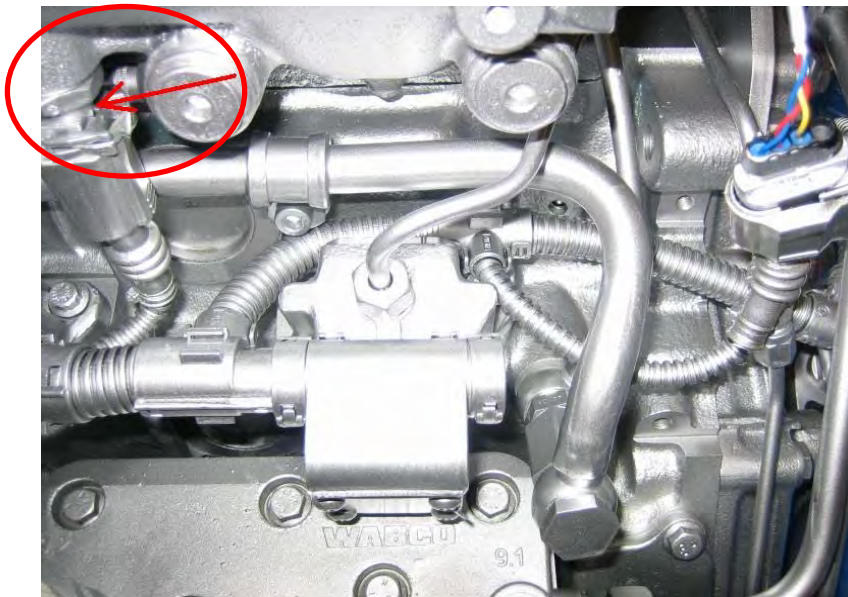
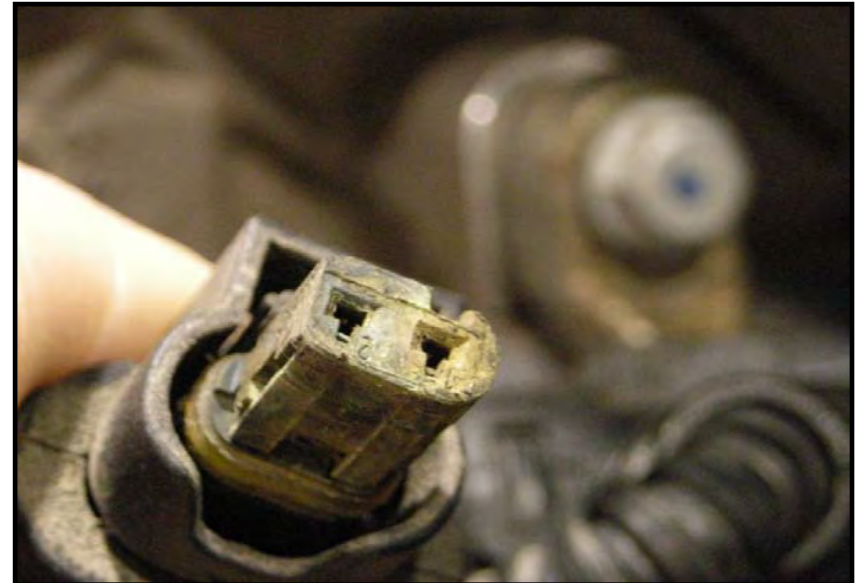
## Intake Air Temperature Sensor

- Corrosion issues have been noted on the charge air temperature sensor that is installed in the intake manifold underneath the beauty cover between cylinders 5 and 6
- This usually results in a code SPN 1636
- Can also affect the combustion process due to inaccurate readings & cause the cooling fan to run excessively
- A sealing resin was added to prevent the intrusion of corrosive gases. New sensor p/n A0071533928 replaced former sensor p/n A0061535228 on April 10th with engine s/n 0460915165.
- Besides changing the sensor, note that the engine sensor harness p/n A4601501833 & the MCM should be replaced if heavy corrosion is present in the 120-pin connection.

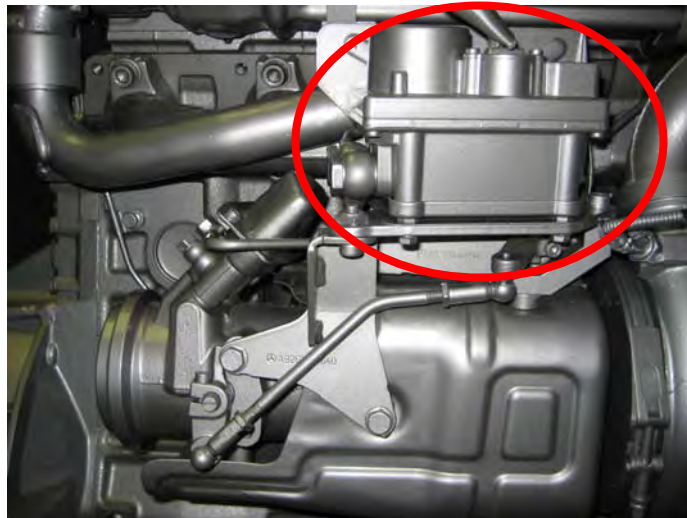
## DDEC VI Code SPN 615, FMI 14, 9, & 7

- Certain EPA07 MBE 900 engines are equipped with an electronic Smart Remote Actuator (SRA2) for the exhaust gate instead of being pneumatically controlled. This system sometimes experiences low power and the above fault code.
- Problems traced to rusting of ball joints at end of actuator linkage & rusting/seizing of exhaust flap inside exhaust housing.
- Look for upcoming revision to 07 TS-57rev to show new corrective procedures:
  - For fault code SPN 615/FMI 9 - Smart Remote Actuator 2, Failsafe Mode, Motor Off: replace actuator linkage.
  - For fault codes SPN 615/FMI 7 - Smart Remote Actuator 2, Failsafe Mode, Motor On and SPN 615/FMI 14 - Smart Remote Actuator 2; No Failsafe Mode; Motor Off: replace actuator linkage & replace exhaust flap housing.

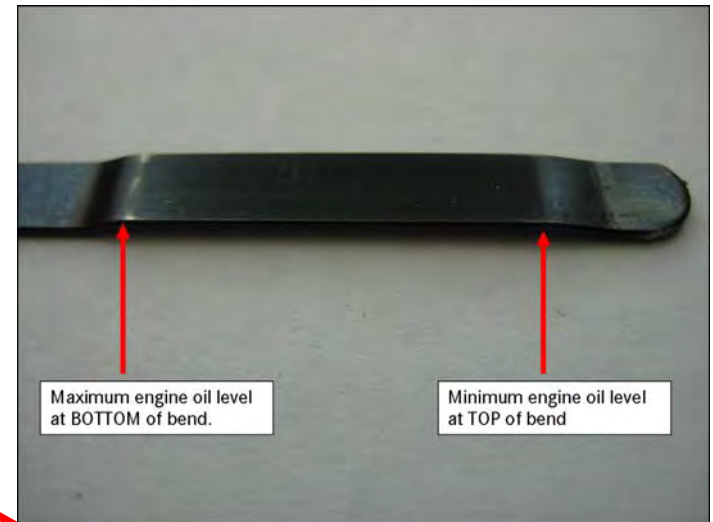
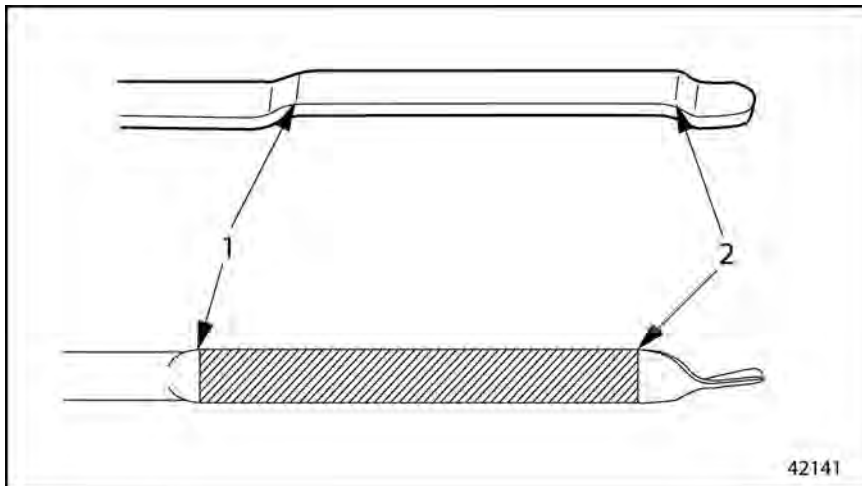
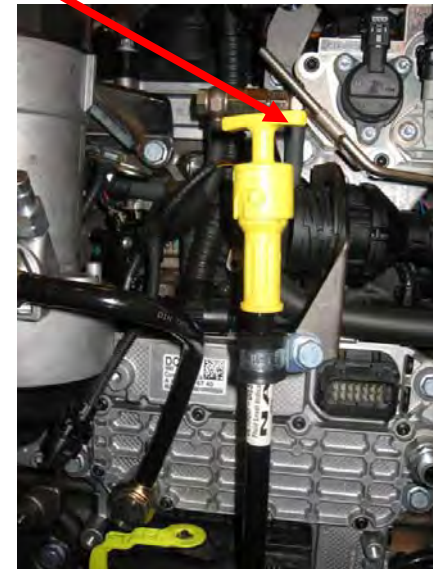
## Incorrect Oil Level Measurements

- Original dipstick was non-vented & bends created confusion (Reference 07 TS-61)
- Reworked in Jan-08 with vent & cross hatch pattern (no part number change).
- New twist lock design released is also vented and has cross hatch
- Included in the oil consumption Service kits.

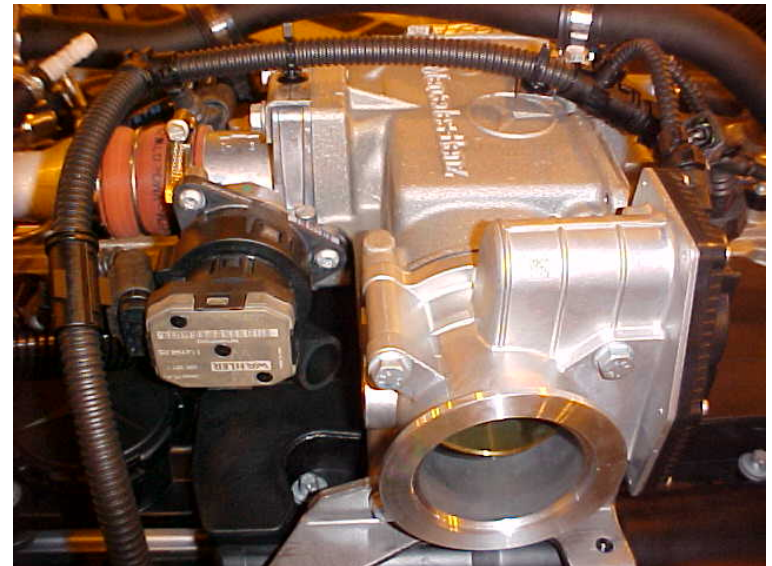
## EGR Valves

- Sticking EGR valve resulting in code SPN 2791 FMI 7 - EGR Valve Position Incorrect or FMI 4 - EGR Valve Circuit Failed Low.
- Vehicles sitting for extended periods can encounter a sticking EGR valve.
- Inspect the valve for white deposits and if found, evaluate for possible coolant ingestion (EGR cooler failure).
- If no coolant loss is evident, the valve can stick as a result of corrosion, both galvanic from dissimilar metals and from the acid condensation from the exhaust. This will result in white deposits in the valve from aluminum oxide.
- New Teflon coated valve p/n A9261420419 replaced former valve p/n A9261420219 on 26-Mar-08 with engine s/n 926961S0012409. Available for Service in Aug-08.

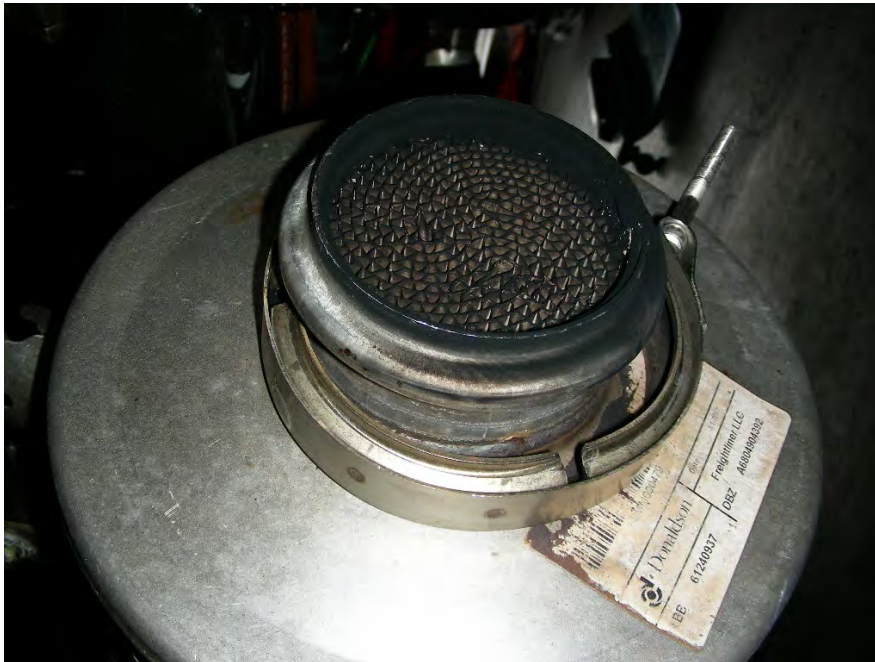
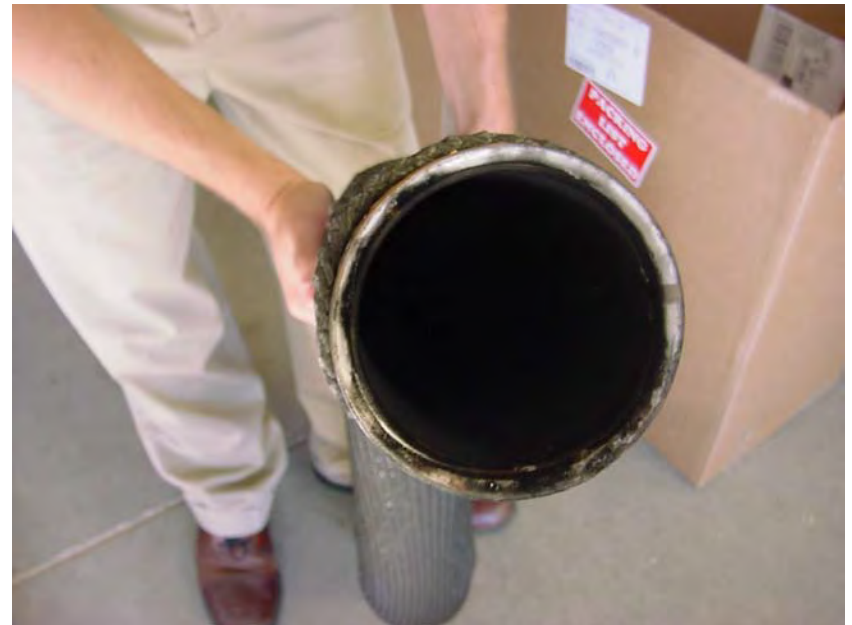
## FCCC Exhaust S-Pipe

- Leaks at both ends of the vehicle exhaust pipe joining the turbo outlet & ATD.
- Created a graphite gasket to be used on both ends of the pipe.
- FCCC began using the gasket on 14-Apr-08 with VIN AJ4981.
- Reference 08 TS-19.
