TRINETRA
PROPERTY INSPECTION

INSPECTION REPORT

T6 – 1307, My Home Tridasa
Hyderabad, TG – 502032

Inspection Date
Dec 23, 2025

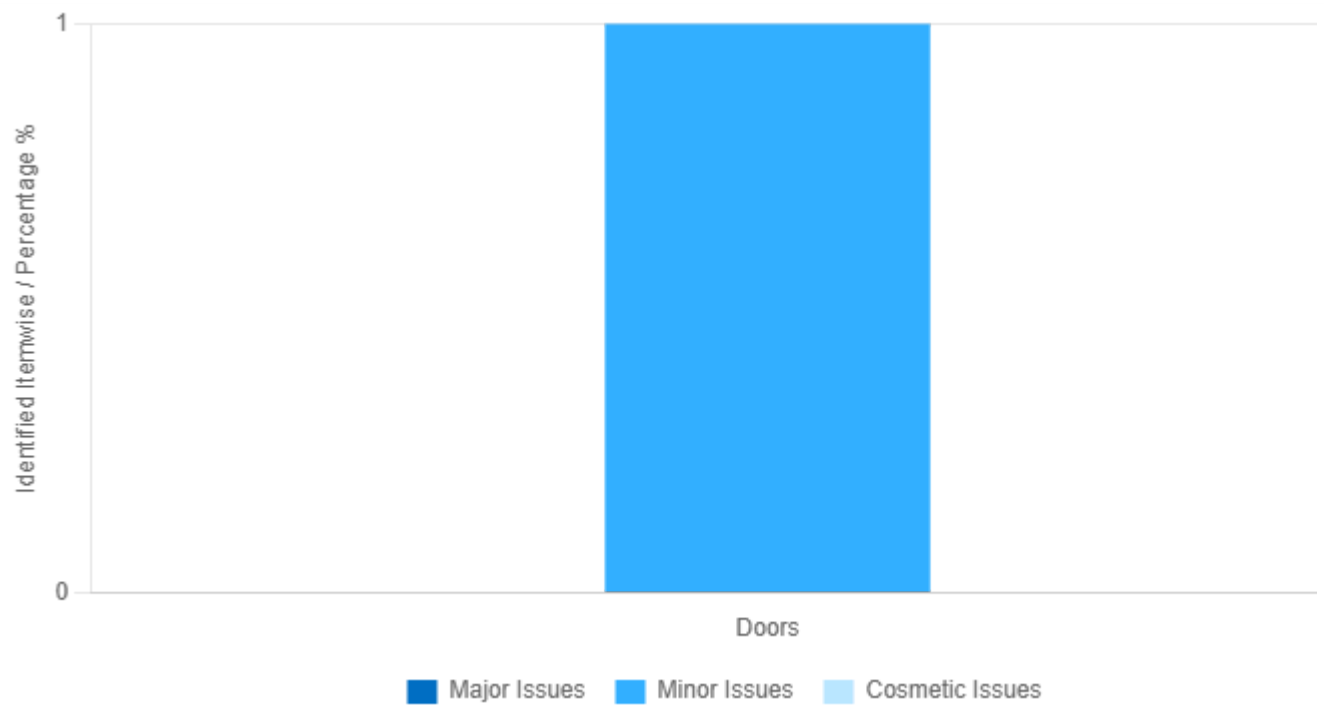
S. NO.	ISSUE	PICTURE
1	Gap between door and frame
