Telah dilakukan OSI pada tanggal 2024-12-26 pada peralatan 20HC31312LKJ dengan hasil sebagai berikut:

On Stream Inspection Checklist for Piping Systems

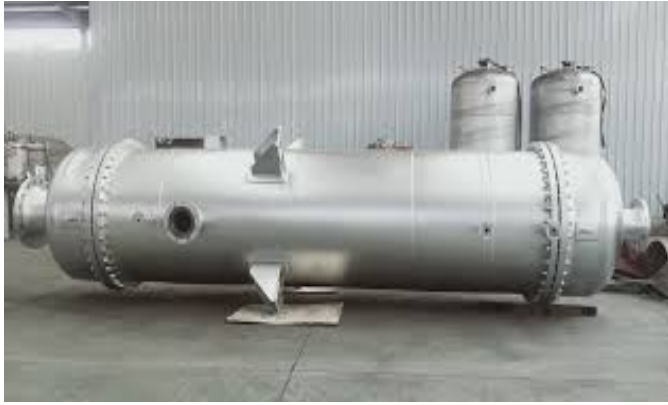
terdapat Perbaikan yang wajib dilakukan pada reboiler ini

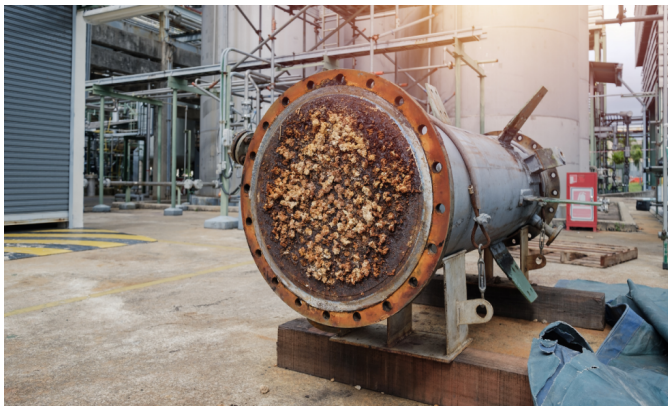
terdapat Perbaikan yang wajib dilakukan pada reboiler ini
