An ESD Case Study with High-Speed Interface in Electronics Manufacturing and its Future Challenge

Rita Fung (1), Richard Wong (2), James Tsan (2), Jatin Batra (2)

Abstract – A networking semiconductor component with 25 Gbps high-speed interface experienced high manufacturing failure rate with CDM-like failure signature at contract manufacturer; design of experiment was performed and ESD source was located. Problem details, solution, future challenge and industry awareness are discussed in this paper.

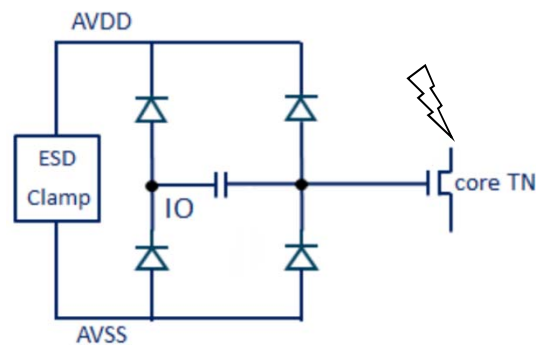
All failed parts were sent to perform failure analysis (FA), functional failure was first confirmed by running final test program. However, the leakage could not be easily detected by external I-V sweep. The AC decoupling cap at the differential pairs prevent proper curve trace from the pad, as in Figure 1. Destructive failure analysis and fine probing are needed to find the leakage location. High leakage was measured at a transistor gate at the receiver side. Focus Ion Beam (FIB) and Transmission Electron Microscopy (TEM) result shows the gate oxide was damaged in Figure 2, resulting in I-V shift in Figure 3. The leakage of one transistor could hardly be detected by any current test except functional test. Other failure units all demonstrated different level of leakage at gate similar to Figure 3, a classic CDM failure signature. This is also confirmed that the same failure signature is observed through CDM qualification.

Figure 1. Standard ESD design with Dual Diodes and Coupling Cap for High-Speed Interface, Core TN was found to be damaged by ESD

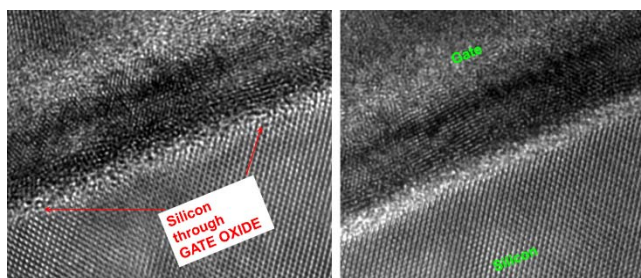
Figure 2. pFA shows gate rupture. Left is ESD damaged unit, right is good unit.

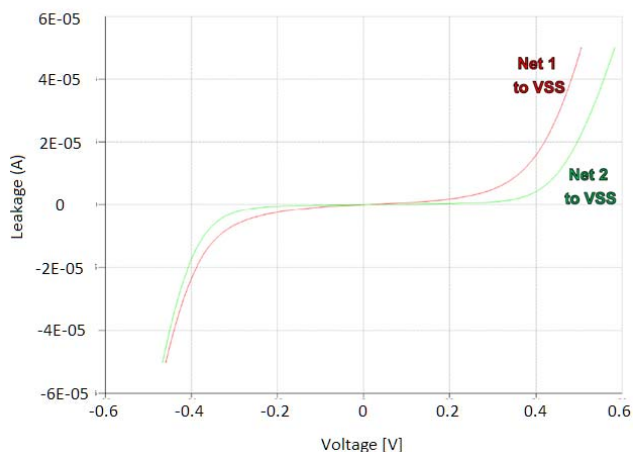
Figure 3. All failure unit demonstrates I-V drift that could hardly be detected by any current test except functional test

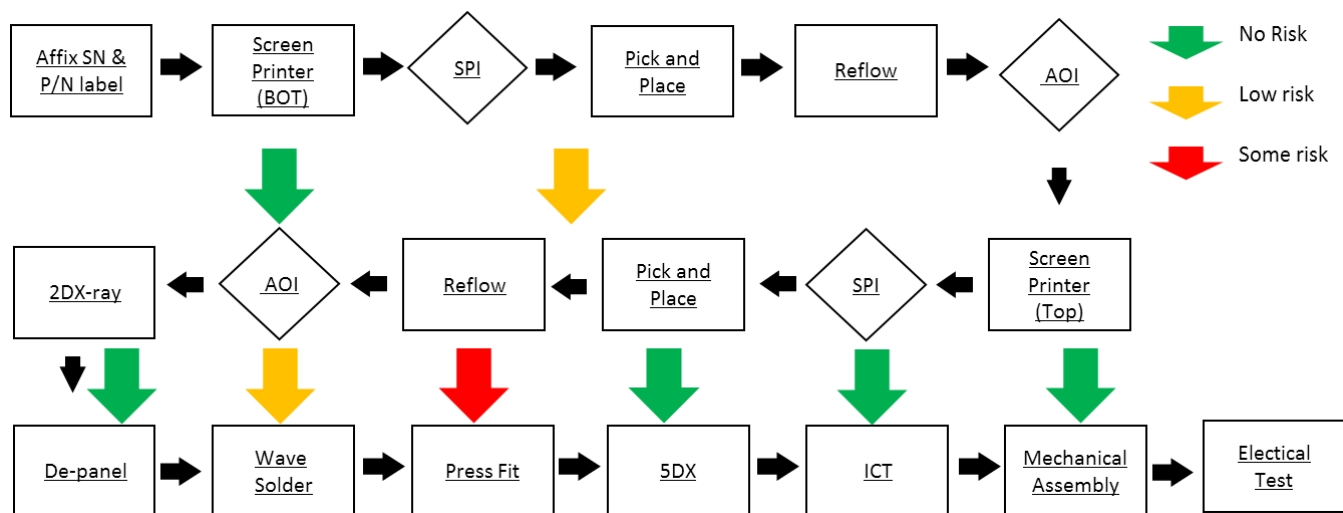
A few manufacturing process steps, as shown in Figure 4, were identified where ESD may possibly happen to “P”:

- Scenario 1: When “P” is picked up from tray and placed on board by pick-and-place machine on the SMT line
- Scenario 2: When a connector is press-fit (PF) onto board which causes a direct discharge to “P” through trace
- Scenario 3: When a charged test module is inserted into front port connector and discharge to “P”

Figure 4. Assembly Process Flow with risk level

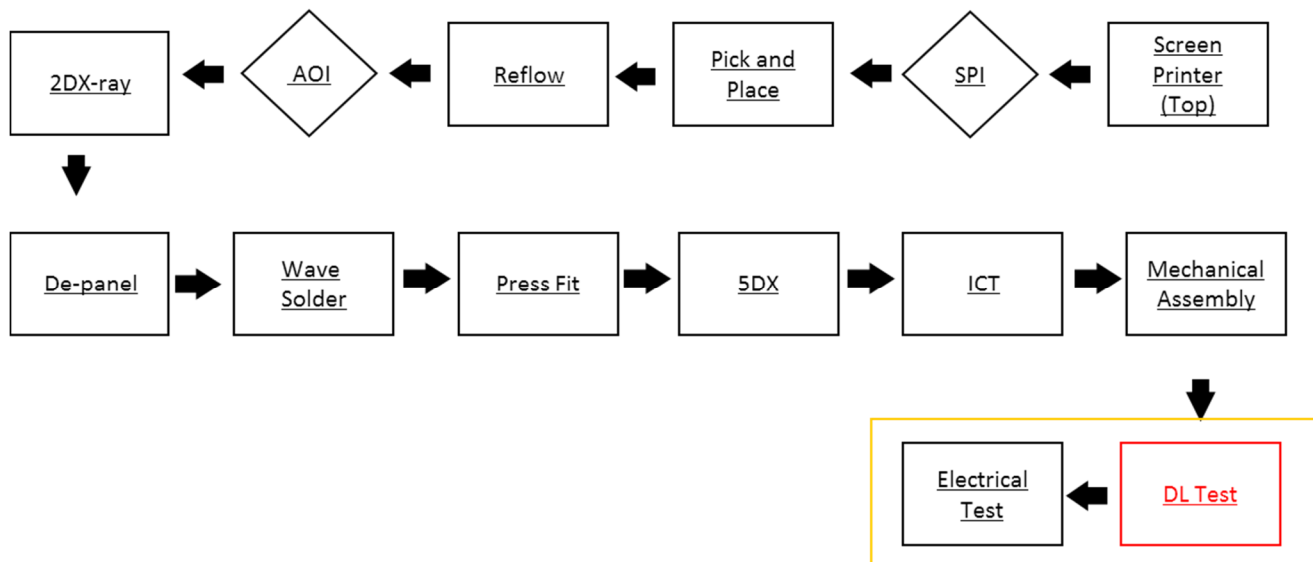
In order to isolate the problematic area, design of experiment (DoE) was set up as in Table 2 with slightly modified process as shown in Figure 5. Additional test (DL Test) was added to facilitate validation of split B, which is a very simple functional test that could test the basic functionality of “P” without any press-fit connector as well as inserting any test module as required at the Electrical Test step.

Figure 5. Modified assembly process with additional DL test

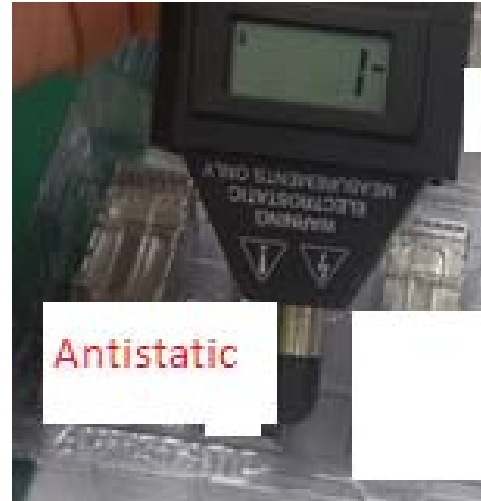
- Connector tray had a word “Antistatic” printed on the tray but it shows off-scale surface voltage, beyond 2000 V (Figure 6). Supplier was later found not to have any proper and effective outgoing inspection test to verify the “Antistatic” properties.
- Connector inside the tray is charged, the electrostatic voltage can have several hundred volts (Figure 7).
- Connector signal pin area exhibits tens of surface voltage when connector is held by a grounded operator.
- Charges with maximum value of 2.9 nC was measured on signal pins when connector is sitting inside tray (Figure 8).
- Charges with maximum value of 1.7 nC was measured on signal pins when connector is held by a grounded operator (Figure 9).

Figure 6. Surface field >2000 V was measured on tray marked with ‘Antistatic’

“Antistatic”, also known as “Low Charging”, is commonly used in ESD products. However, there is no clear definition of properties and testing methodology of “Antistatic” materials. In this case, the supplier measures surface resistivity instead of surface field potential. Per the Packaging standard ANSI/ESD S541, it is stated that there is no correlation between resistance measurements and the ability of a material to be antistatic. Apparently, this is not fully understood by the industry.

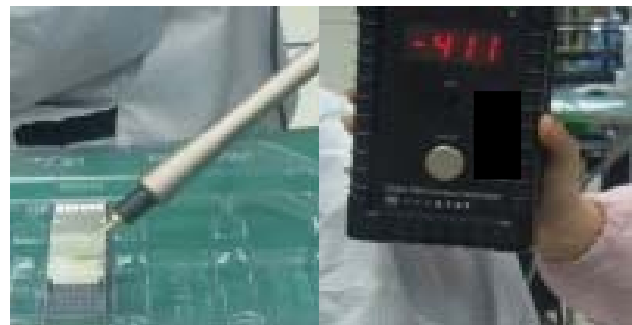
Figure 7. Surface voltage of -411 V on connector metal cage

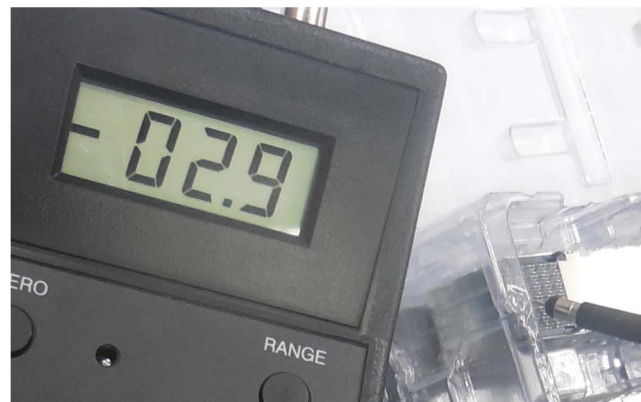
Figure 8. At maximum 2.9 nC charges were measured from connectors sitting inside tray

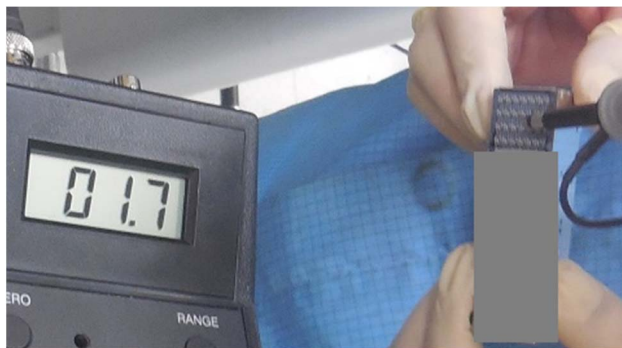
Figure 9. At maximum 1.7 nC charges were measured on signal pins held by grounded operator

First of all, when a grounded operator holds the connector metal case, it grounds the external case, but the signal pins or ground pins are isolated by the

connector dielectric with volume resistivity of 10^{14} ohm-cm. Grounding the case does not neutralize charges on the signal pins.

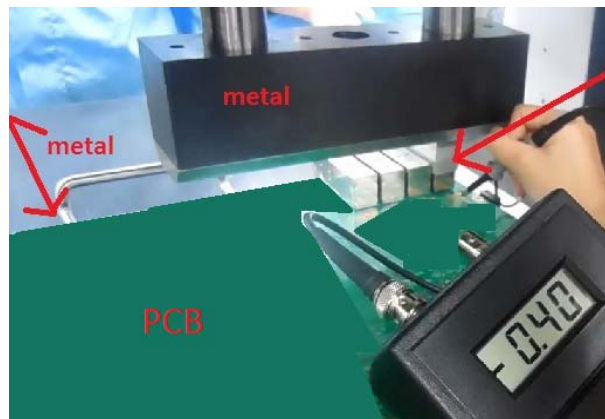
- Charges with maximum value of 0.40 nC was measured from the other end of trace when connector is pressed into PCB demonstrating that there is a direct charge transfer from the connector signal pin to the networking chip (Figure 10), there was no alternate path.

Figure 10. 0.40 nC charges were measured from the other end of trace when connector is pressed into PCB

- Connectors are taken from the tray and placed on ESD grounded table map with ionizer air blowing towards signal pins of connectors
- All connectors have to be sitting under ionized environment for over 5 seconds
- Unused standby materials have to be placed at least 1 meter away from the ionized area where connectors sitting

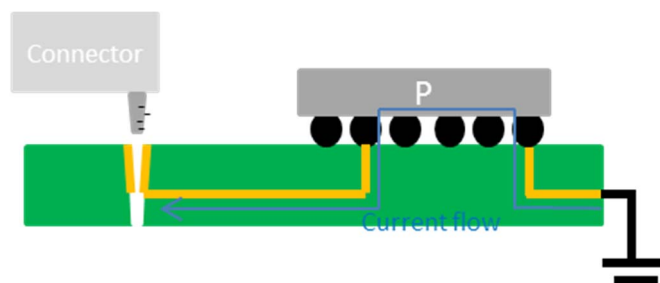
Secondly, the PCB trace connecting the connector pins and “P” is a very short trace without any extra components or test point for testing purpose. If the signal pins carry charges and come into contact to the trace connected to “P” with solder. The current path would be GND → “P” → Trace → Connector signal pins or vice versa depending on the polarity of the charges on the connector pins.

Thirdly, the Vias on PCB for the signal pins are back-drilled for better signal integrity, when the board is sitting on a grounded fixture, the Vias do not have physical contact to the fixture. There is no alternate path to shunt the discharge current. All the charges go through “P” to ground as Figure 11.

Figure 11. Direct discharge from the connector through P to the ground. If the positive charges are accumulated on the connector, the current flow will be in an opposite direction.
